Federal Lands Highway Road Inventory Program

Road Inventory and Condition Assessment

Flight 93 National Memorial FLNI

Cycle 5 Report

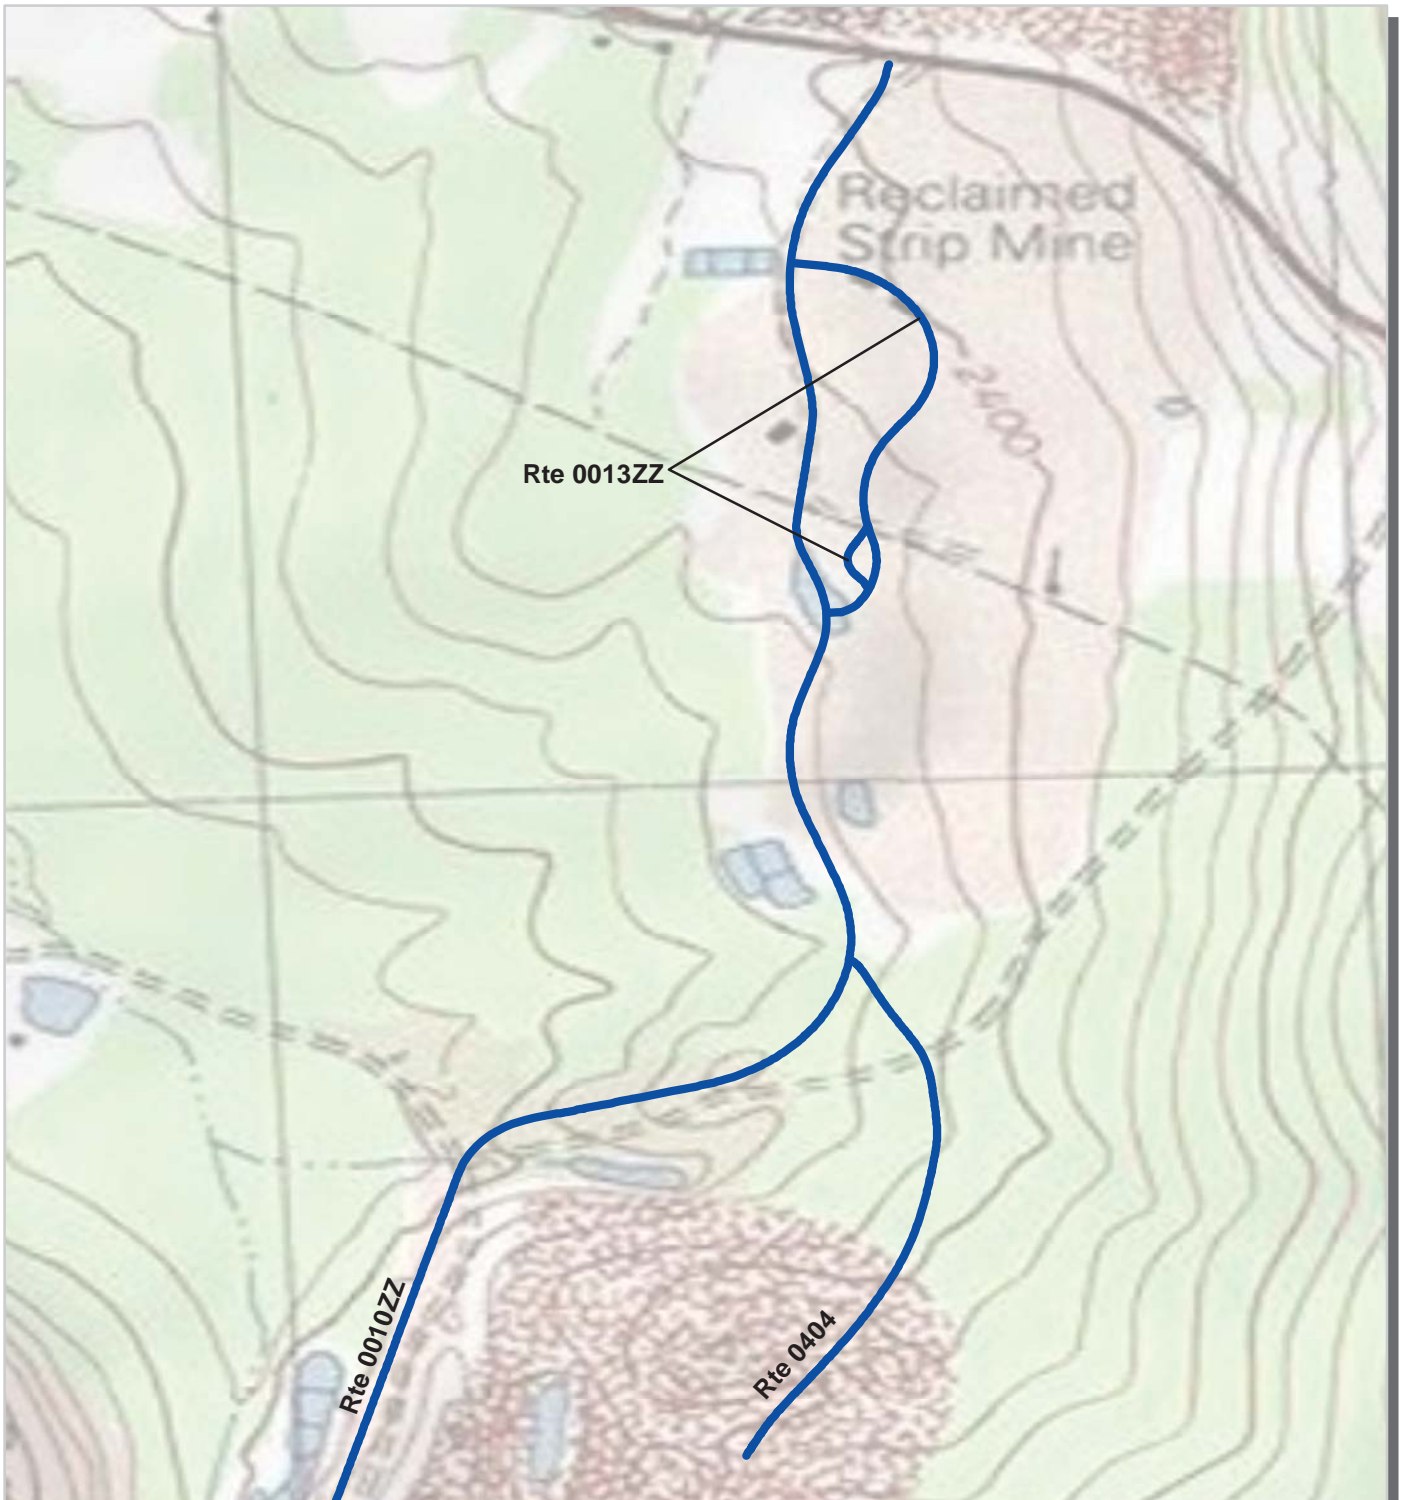
Flight 93 National Memorial Route Condition Map PCR - Mile by Mile Area 1

PCR	Poor		Fair		Good		Excellent		No Data	
	(0 - 60)		(61 - 84)	(85 - 94)	(95 - 100)

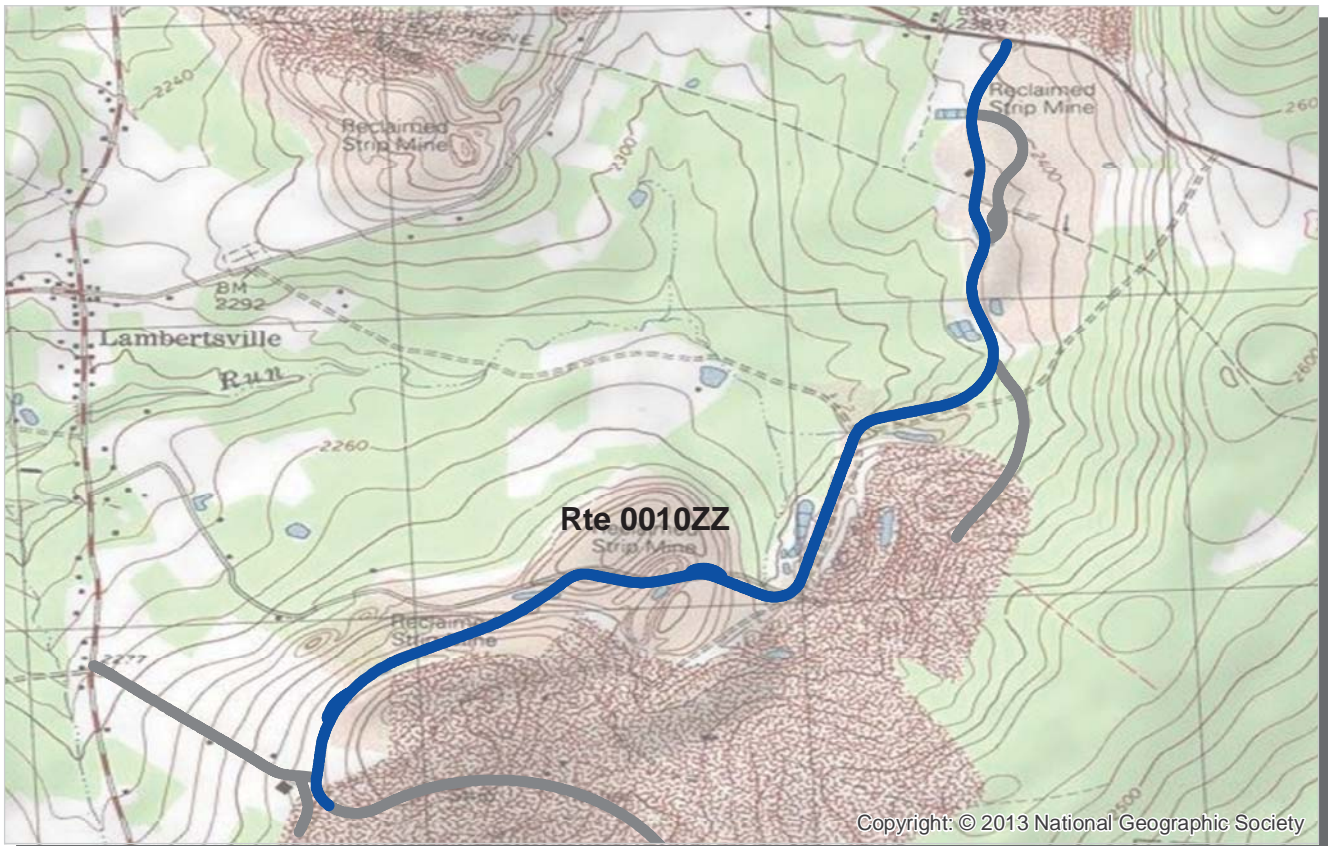
PCR Poor ■ Fair ■ Good ■ Excellent ■ No Data ■
 (0 - 60) (61 - 84) (85 - 94) (95 - 100)

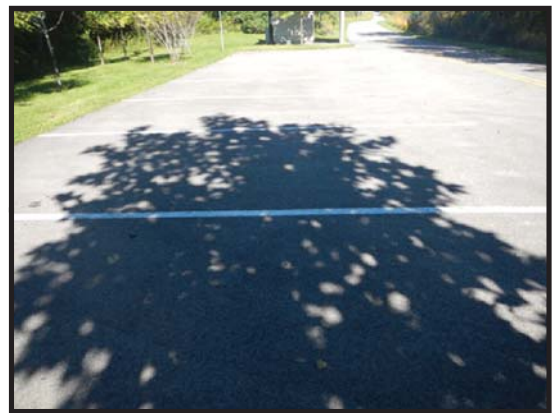
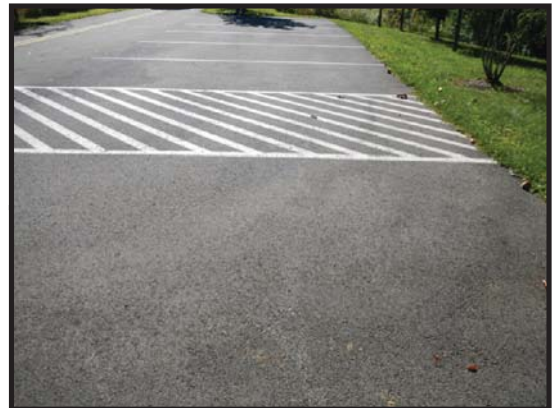
Route 0901

Route Number	Public / NonPublic	Date Visited	Area (sq ft)	Lane Miles *	Surface Type
0900	NONPUBLIC	9/17/2013	1,504	0.03	AS
Culverts	Drop Inlets	Gates	Curb & Gutter	Curb	PCR
0	0	0	NO CURB AND GUTTER	NO CURB	EXCELLENT/97

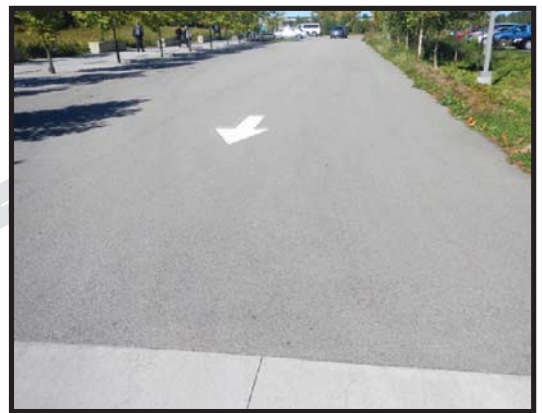
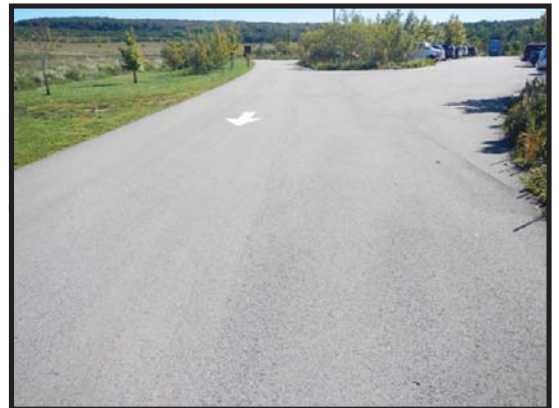
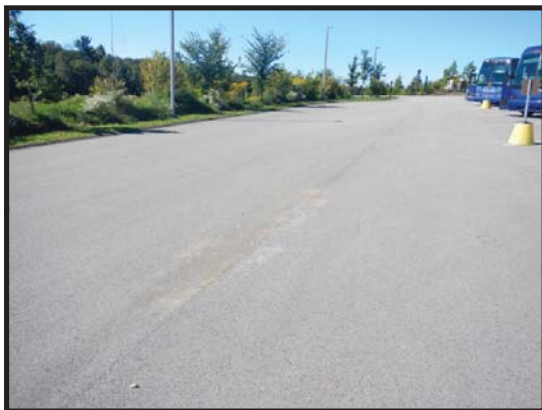
Route 0902ZZ

Route Number	Public / NonPublic	Date Visited	Area (sq ft)	Lane Miles *	Surface Type
0901	PUBLIC	9/17/2013	85,143	1.47	AS
Culverts	Drop Inlets	Gates	Curb & Gutter	Curb	PCR
3	5	0	NO CURB AND GUTTER	ASPHALT CURB	GOOD/90

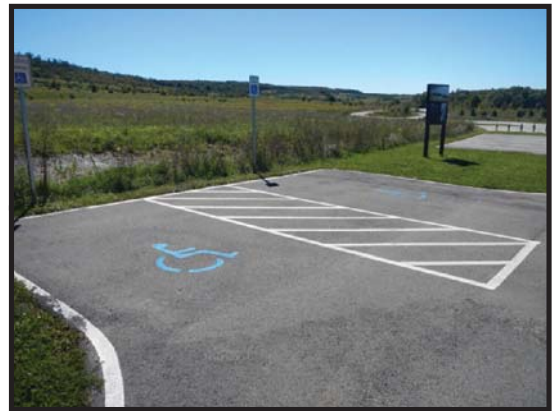
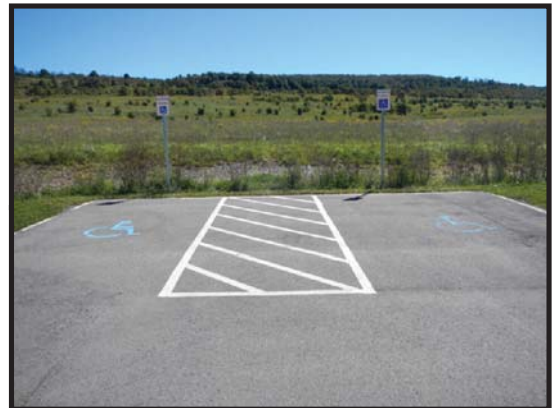
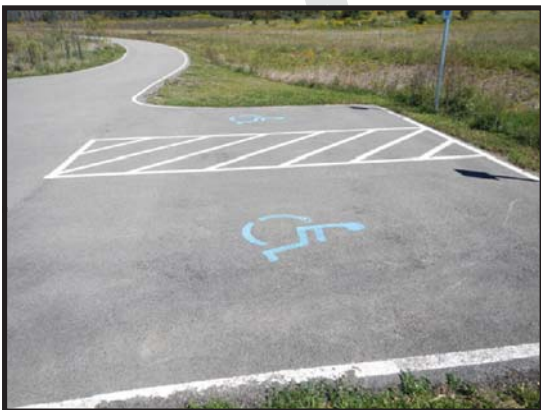
FLIGHT 93 NATIONAL MEMORIAL
Route 0902BZ
 TOWER OF VOICES PARKING AREA B
 ADJACENT TO ROUTE 0013AZ (TOWER OF VOICES ROAD) ON LEFT

Route Number	Public / NonPublic	Date Visited	Area (sq ft)	Lane Miles *	Surface Type
0902BZ	PUBLIC	9/17/2013	941	0.02	AS
Culverts	Drop Inlets	Gates	Curb & Gutter	Curb	PCR
0	0	0	NO CURB AND GUTTER	NO CURB	GOOD/90

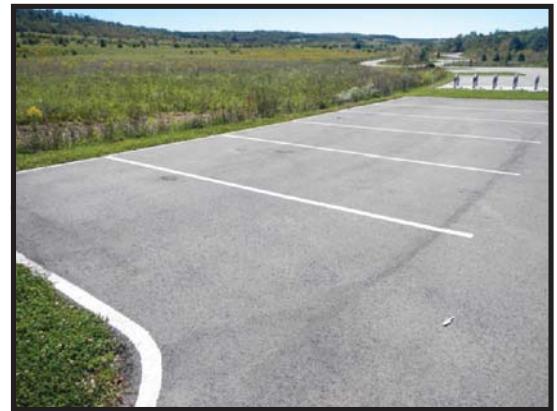
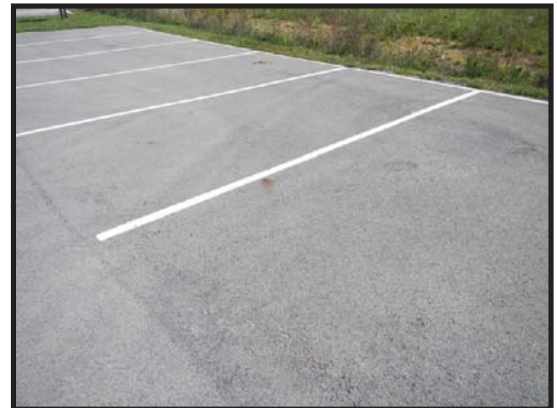
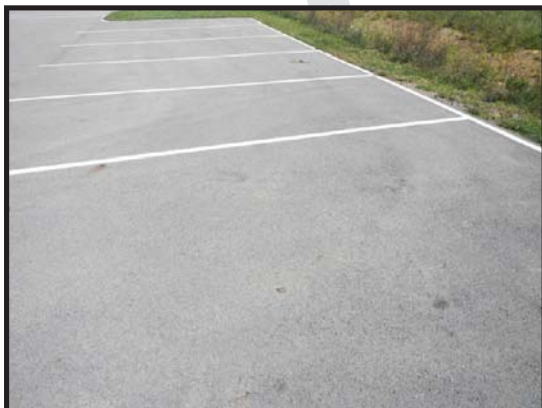
Route 0902CZ

Route Number	Public / NonPublic	Date Visited	Area (sq ft)	Lane Miles *	Surface Type
0902CZ	PUBLIC	9/17/2013	926	0.02	AS
Culverts	Drop Inlets	Gates	Curb & Gutter	Curb	PCR
0	0	0	NO CURB AND GUTTER	NO CURB	GOOD/90

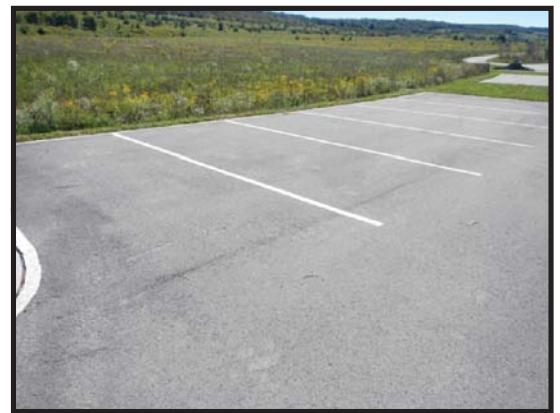
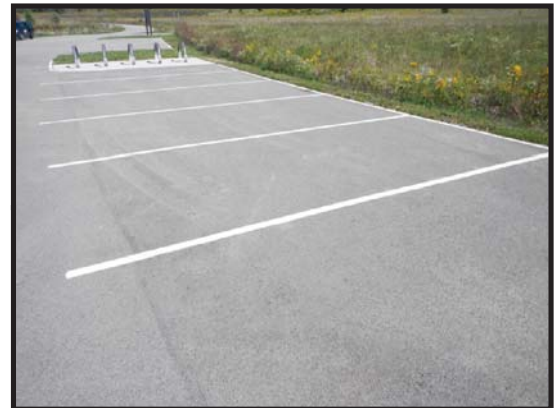
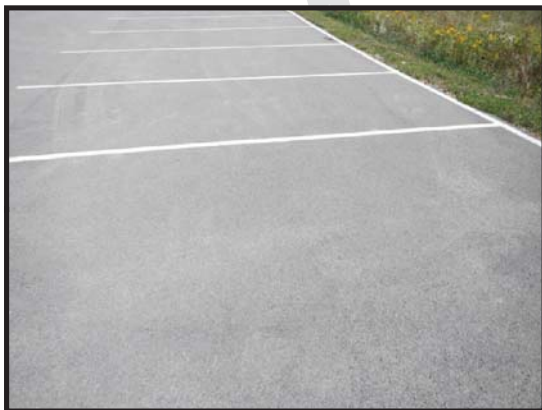
Route 0902DZ

Route Number	Public / NonPublic	Date Visited	Area (sq ft)	Lane Miles *	Surface Type
0902DZ	PUBLIC	9/17/2013	973	0.02	AS
Culverts	Drop Inlets	Gates	Curb & Gutter	Curb	PCR
0	0	0	NO CURB AND GUTTER	NO CURB	GOOD/90

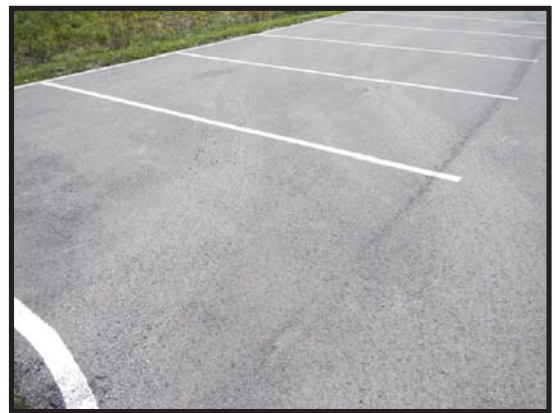
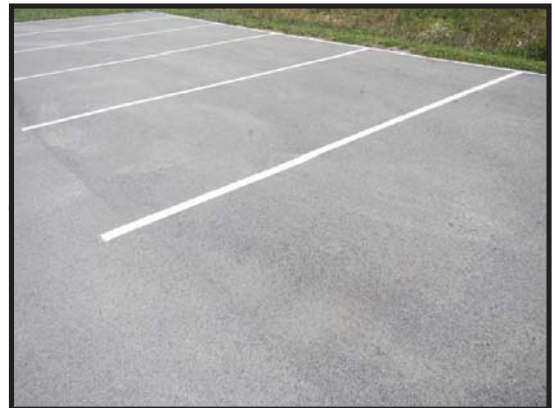
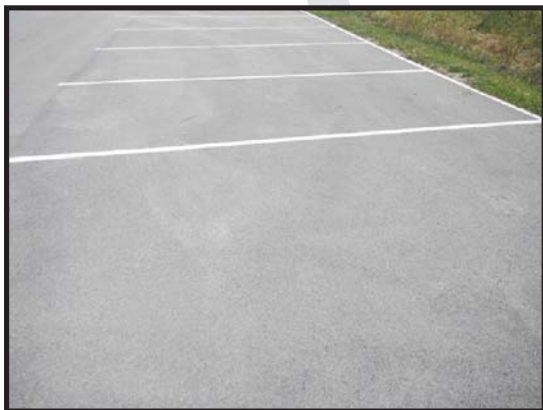
Route 0902EZ

Route Number	Public / NonPublic	Date Visited	Area (sq ft)	Lane Miles *	Surface Type
0902EZ	PUBLIC	9/17/2013	1,815	0.03	AS
Culverts	Drop Inlets	Gates	Curb & Gutter	Curb	PCR
0	0	0	NO CURB AND GUTTER	NO CURB	GOOD/90

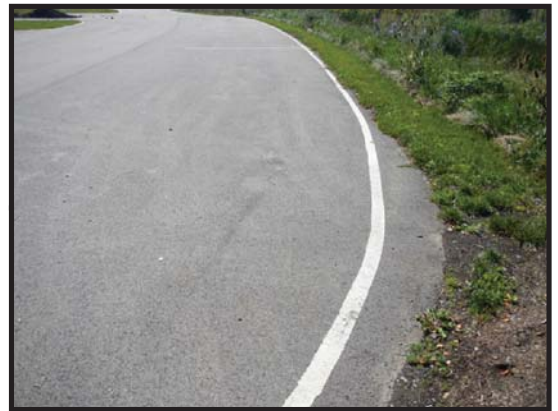
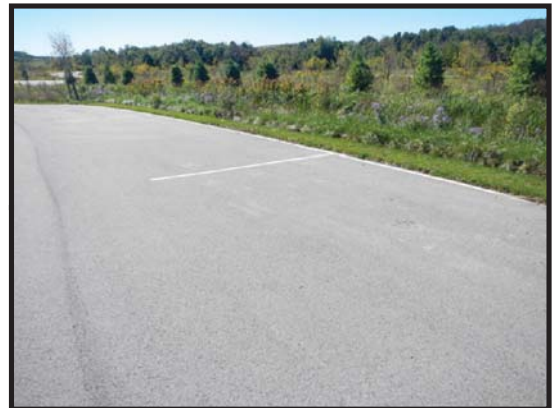
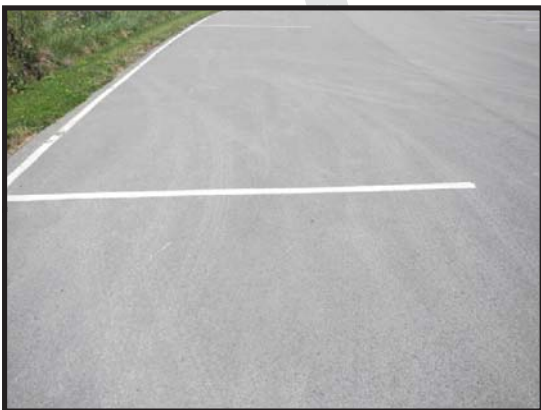
Route 0902FZ

Route Number	Public / NonPublic	Date Visited	Area (sq ft)	Lane Miles *	Surface Type
0902FZ	PUBLIC	9/17/2013	869	0.02	AS
Culverts	Drop Inlets	Gates	Curb & Gutter	Curb	PCR
0	0	0	NO CURB AND GUTTER	NO CURB	GOOD/90

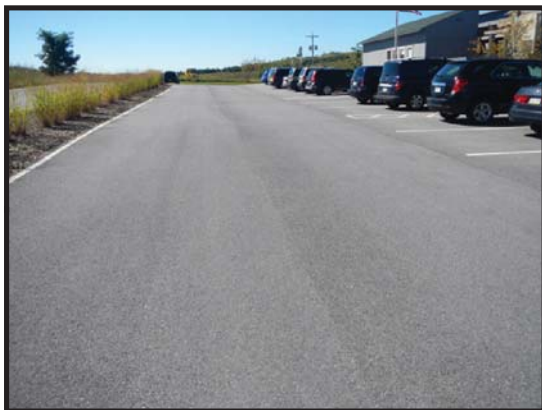
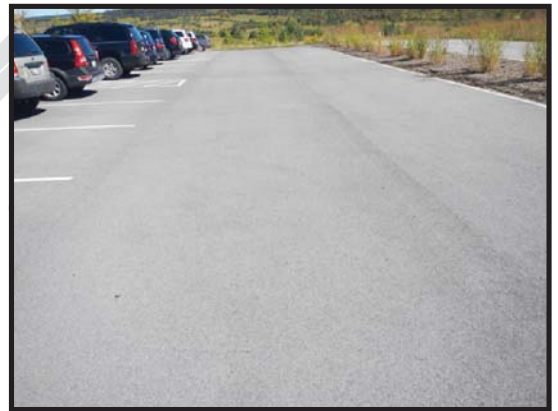
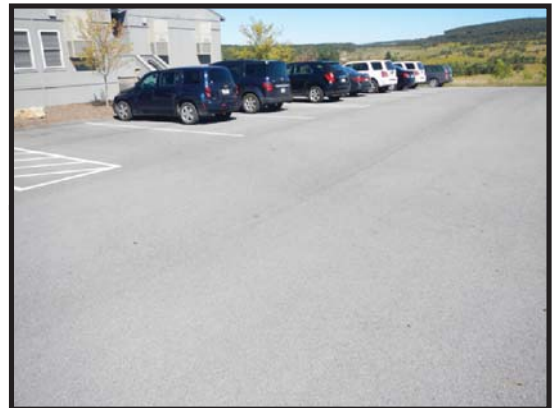
Route 0903

Route Number	Public / NonPublic	Date Visited	Area (sq ft)	Lane Miles *	Surface Type
0903	NONPUBLIC	9/17/2013	9,348	0.16	AS
Culverts	Drop Inlets	Gates	Curb & Gutter	Curb	PCR
0	0	0	NO CURB AND GUTTER	NO CURB	GOOD/90
