Federal Lands Highway Road Inventory Program

Road Inventory and Condition Assessment

Fort Bowie National Historic Site FOBO - 8640

Cycle 5 Report

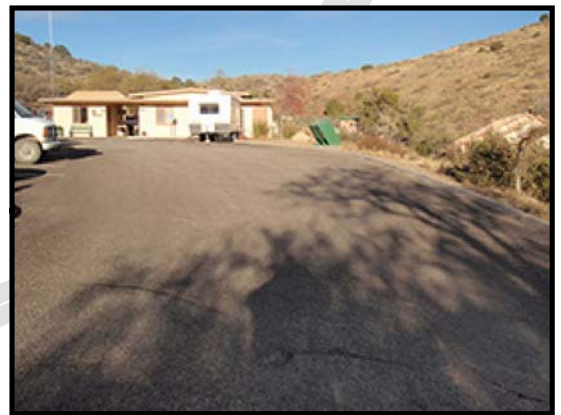
Route Number	Public / NonPublic	Date Visited	Area (sq ft)	Lane Miles *	Surface Type
0901	NONPUBLIC	12/6/2010	6,399	0.11	AS
Culverts	Drop Inlets	Gates	Curb & Gutter	Curb	PCR
0	1	0	NO CURB AND GUTTER	CONCRETE CURB	FAIR/73
