Federal Lands Highway Road Inventory Program

Road Inventory and Condition Assessment

Fort Laramie National Historic Site
FOLA-1420

Cycle 5 Report

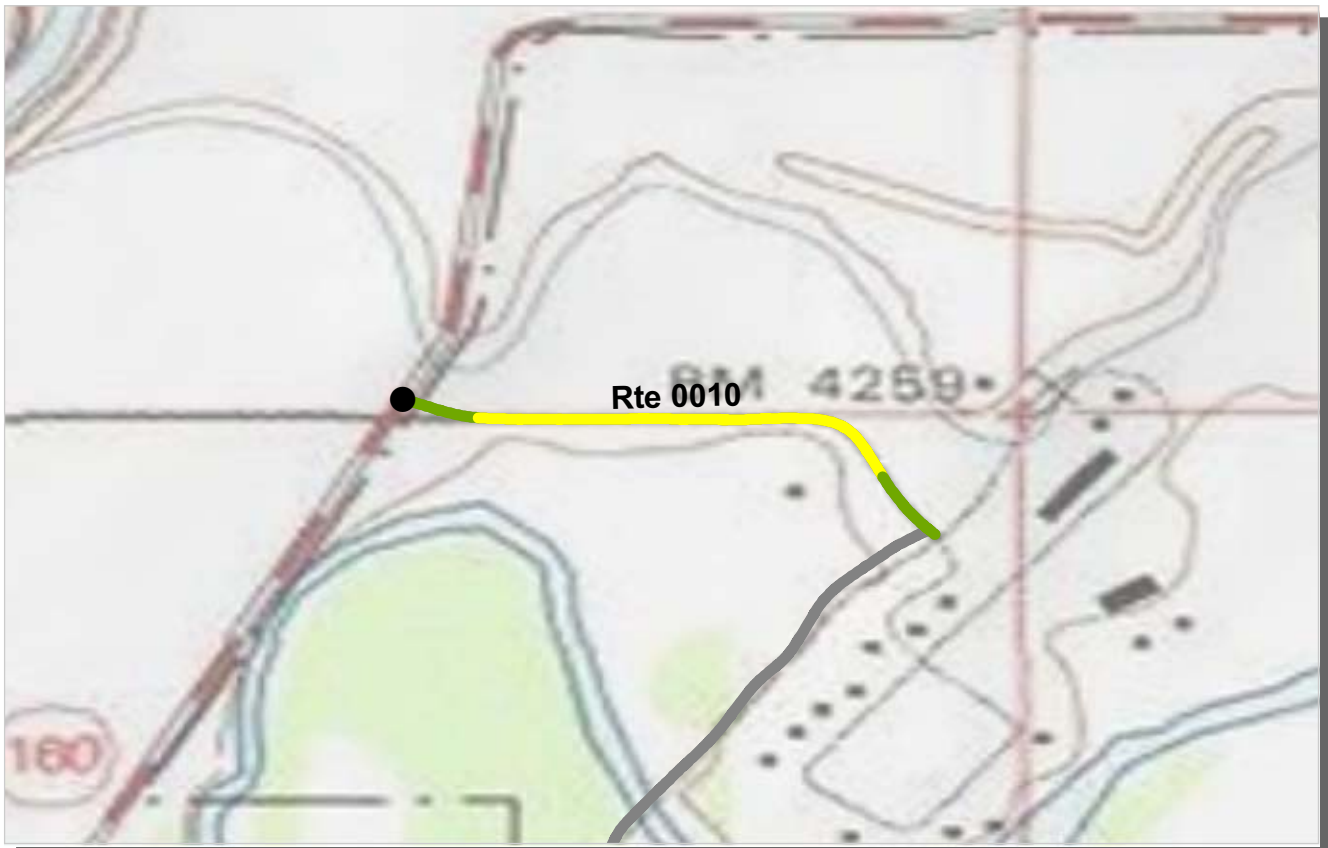
ROUTE: 0010 MAIN ENTRANCE ROAD

Section Number	0				
Section Length (mi)	0.30				
Cross Section Information					
Number of Lanes	2				
Paved Width (ft)	20				
Lane Width (ft)	9				
Roadway Condition Information					
SCR (Surface Condition Rating)	82				
PCR (Pavement Condition Rating)	82				
Distress Index Values					
Structural Crack Index	82				
Transverse Cracking Index	87				
Patching Index	100				
Rutting Index	96				
Roughness Condition Index (RCI)	NC

Structural Crack Index is a combination of the Longitudinal Cracking Index and Alligator Cracking Index.
 See Section 10 for explanation of SCR, PCR, & all Distress Index Values.

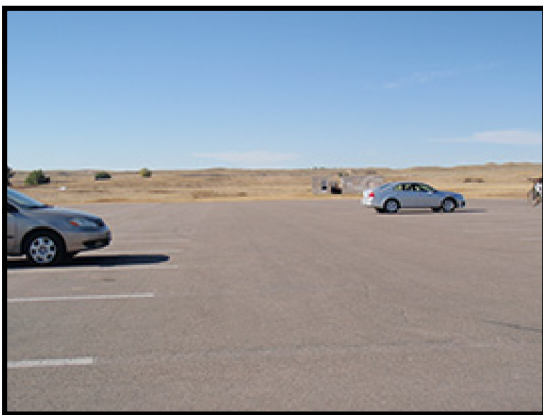
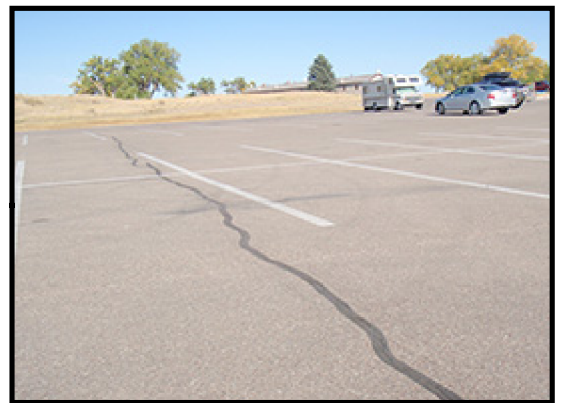
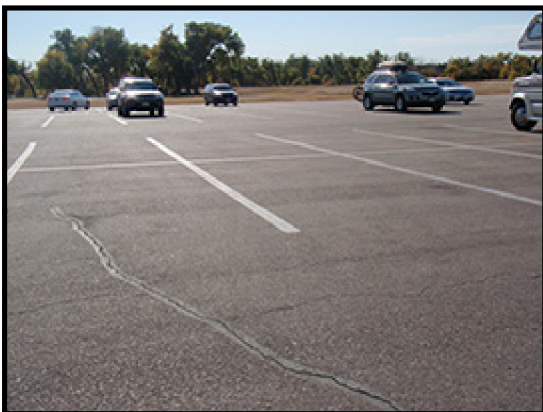
Route Number	Public / NonPublic	Date Visited	Area (sq ft)	Lane Miles *	Surface Type
0900	PUBLIC	10/1/2010	45,332	0.78	AS
Culverts	Drop Inlets	Gates	Curb & Gutter	Curb	PCR
0	0	0	NO CURB AND GUTTER	NO CURB	FAIR/73

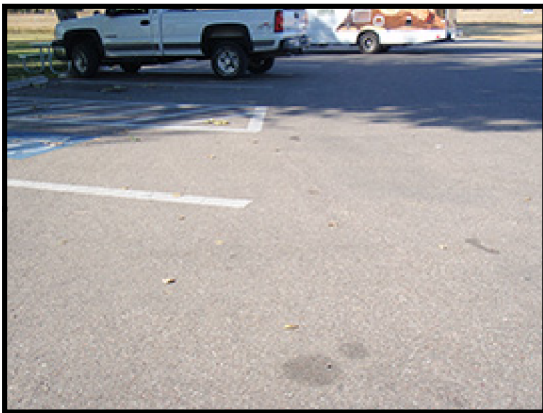
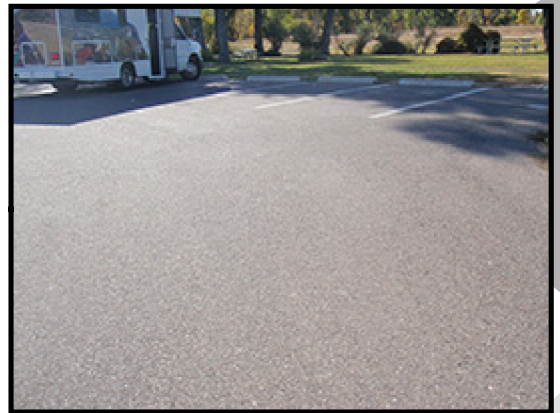
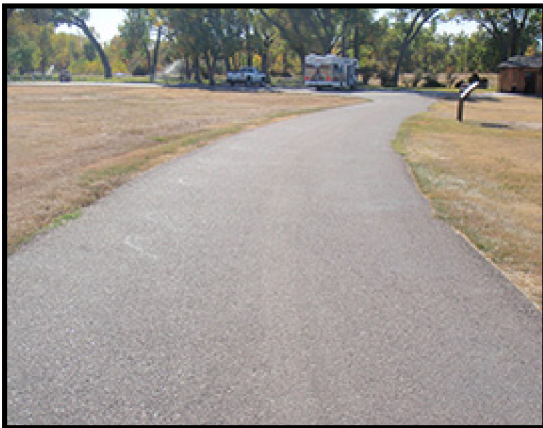
Route Number	Public / NonPublic	Date Visited	Area (sq ft)	Lane Miles *	Surface Type
0901	PUBLIC	10/1/2010	7,778	0.13	AS
Culverts	Drop Inlets	Gates	Curb & Gutter	Curb	PCR
0	0	0	NO CURB AND GUTTER	NO CURB	FAIR/73

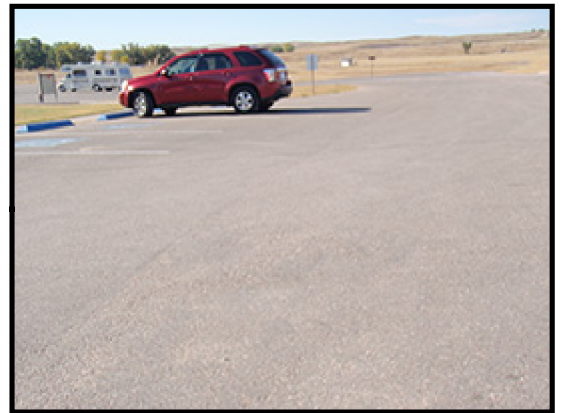
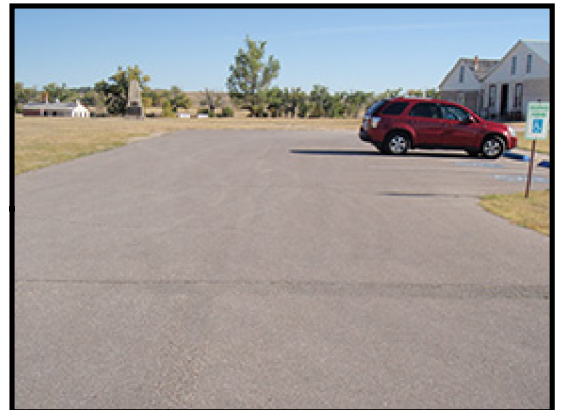
Route Number	Public / NonPublic	Date Visited	Area (sq ft)	Lane Miles *	Surface Type
0904	PUBLIC	10/1/2010	3,636	0.06	AS
Culverts	Drop Inlets	Gates	Curb & Gutter	Curb	PCR
0	0	0	NO CURB AND GUTTER	NO CURB	GOOD/90
