# Federal Lands Highway Road Inventory Program

Road Inventory and Condition Assessment

## Fort Larned National Historic Site FOLS - 6340

### Cycle 5 Report

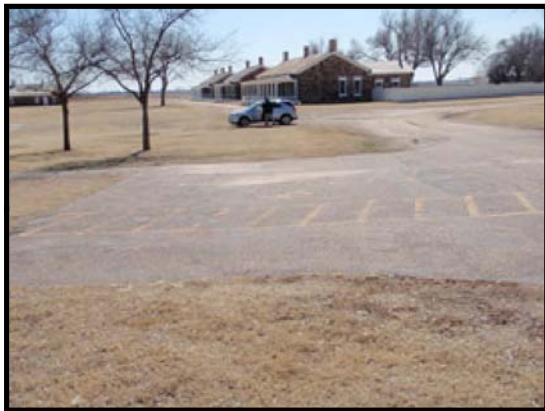
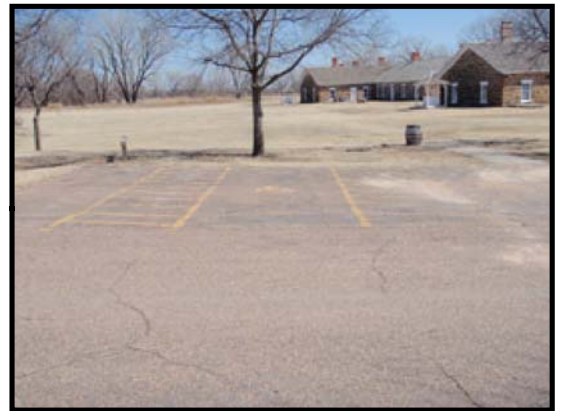
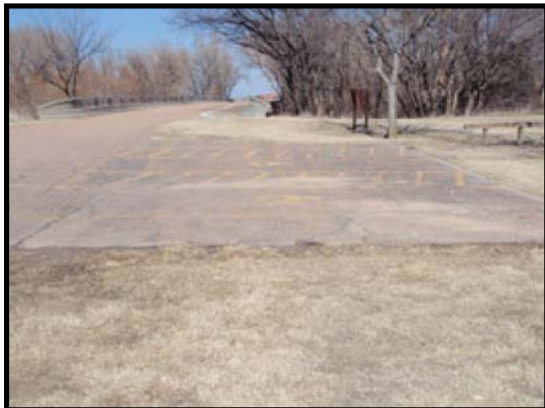
Route Number	Public / NonPublic	Date Visited	Area (sq ft)	Lane Miles *	Surface Type
0900	PUBLIC	3/15/2011	1,000	0.02	AS
Culverts	Drop Inlets	Gates	Curb & Gutter	Curb	PCR
0	0	0	NO CURB AND GUTTER	NO CURB	POOR/45

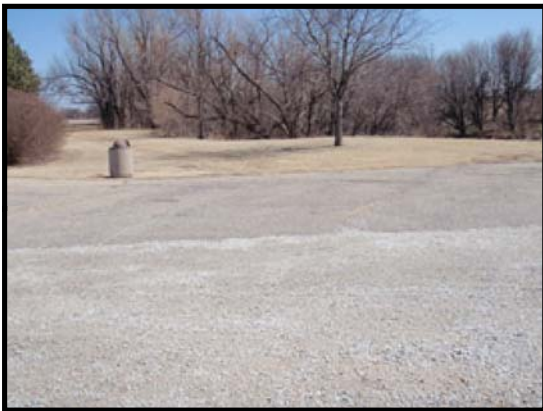
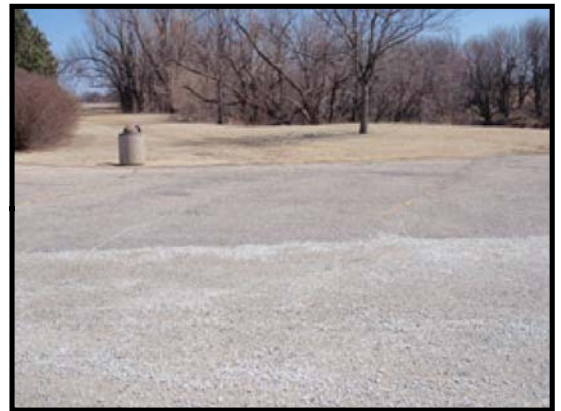
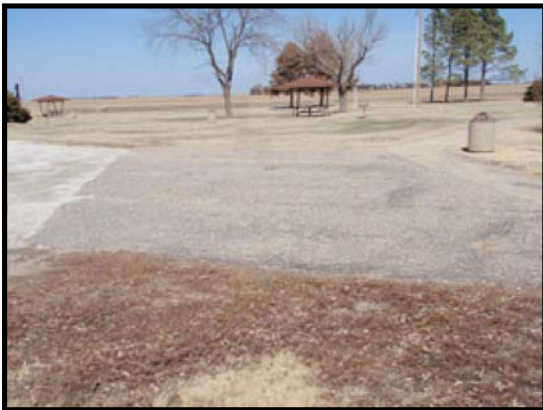
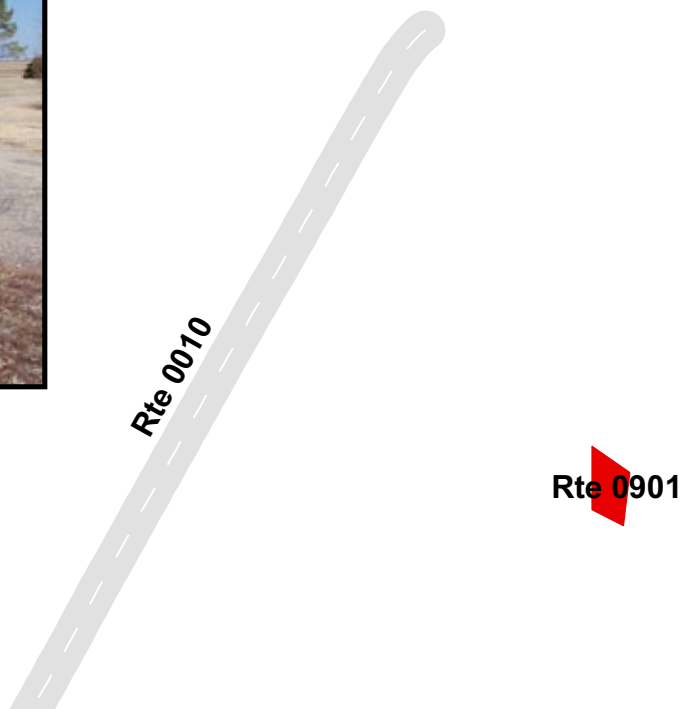
## Route 0901

Route Number	Public / NonPublic	Date Visited	Area (sq ft)	Lane Miles *	Surface Type
0901	PUBLIC	3/15/2011	1,054	0.02	AS
Culverts	Drop Inlets	Gates	Curb & Gutter	Curb	PCR
0	0	0	NO CURB AND GUTTER	NO CURB	POOR/45
