Federal Lands Highway Road Inventory Program

Road Inventory and Condition Assessment

Fort Necessity National Battlefield FONE

Cycle 5 Report

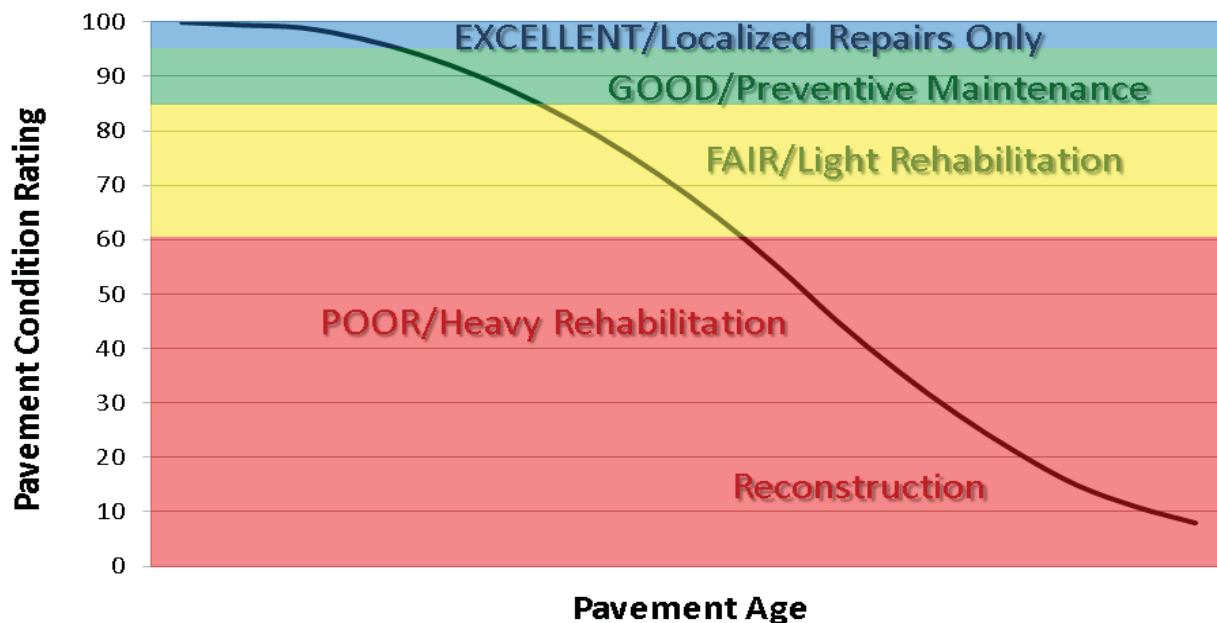
Condition Categories and Treatments

- Excellent/New: PCR of 95-100. Pavements in this range will require only spot repairs
- Good: PCR of 85-94. Pavements in this range will likely be candidates for Preventive Maintenance. Examples include Chip and Slurry Seals, Micro Surfacing and Thin Overlays.
- Fair: PCR of 61-84. Pavements in this range will likely be candidates of Light Rehabilitation (L3R). Examples include single-lift overlays up to 2.5 inches in total thickness, milling and overlays.
- Poor: PCR of 0-60. Pavements in this range will likely be candidates of Heavy Rehabilitation or Reconstruction (H3R or 4R). Examples include Pulverization, Multiple Lift Overlays, and Reconstruction.

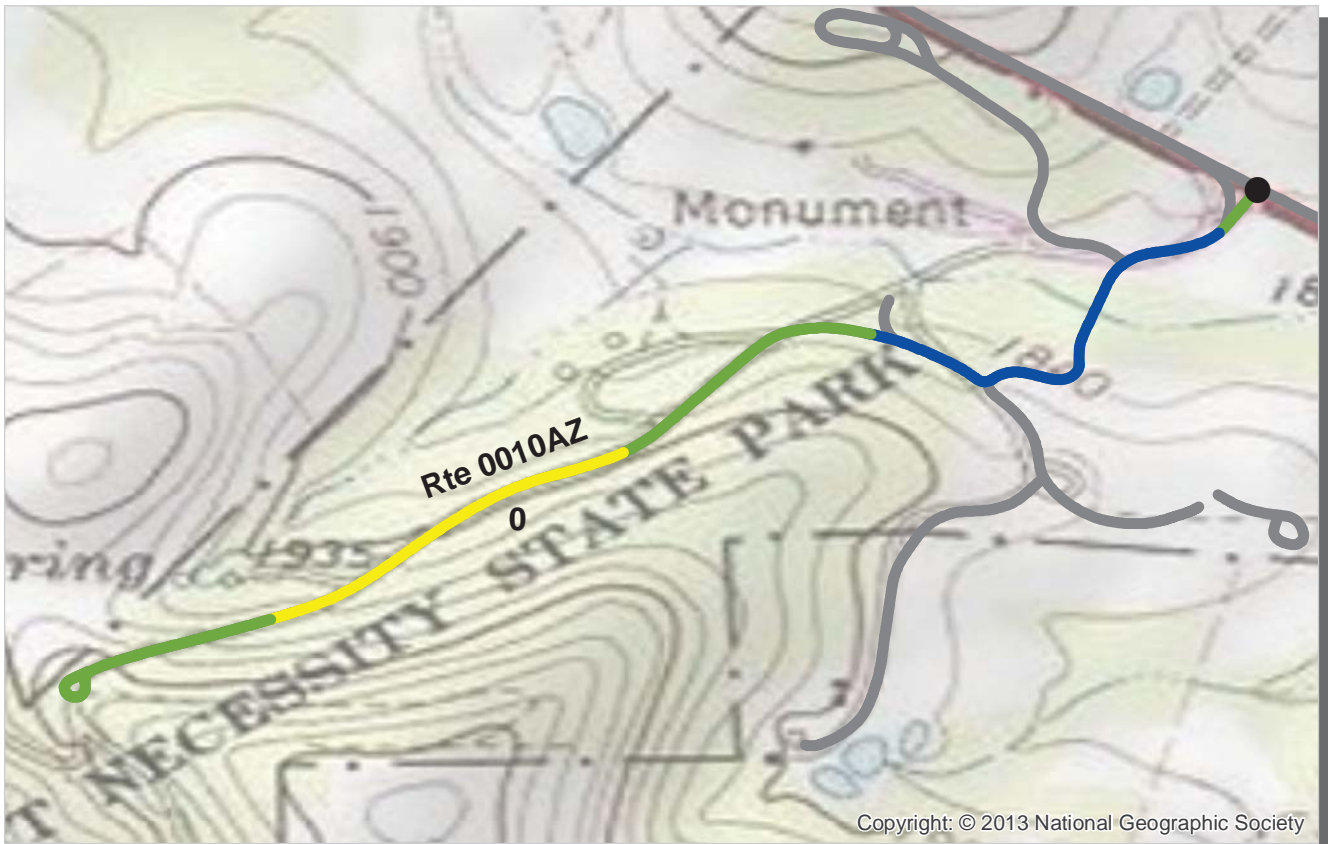
ROUTE: 0010ZZ MAIN ENTRANCE ROADS

Section Number	0				
Section Length (mi)	0.90				
Cross Section Information					
Number of Lanes	2				
Paved Width (ft)	19				
Lane Width (ft)	10				
Roadway Condition Information					
SCR (Surface Condition Rating)	89				
PCR (Pavement Condition Rating)	89				
Distress Index Values					
Structural Crack Index	99				
Transverse Cracking Index	100				
Patching Index	100				
Rutting Index	89				
Roughness Condition Index (RCI)	NC

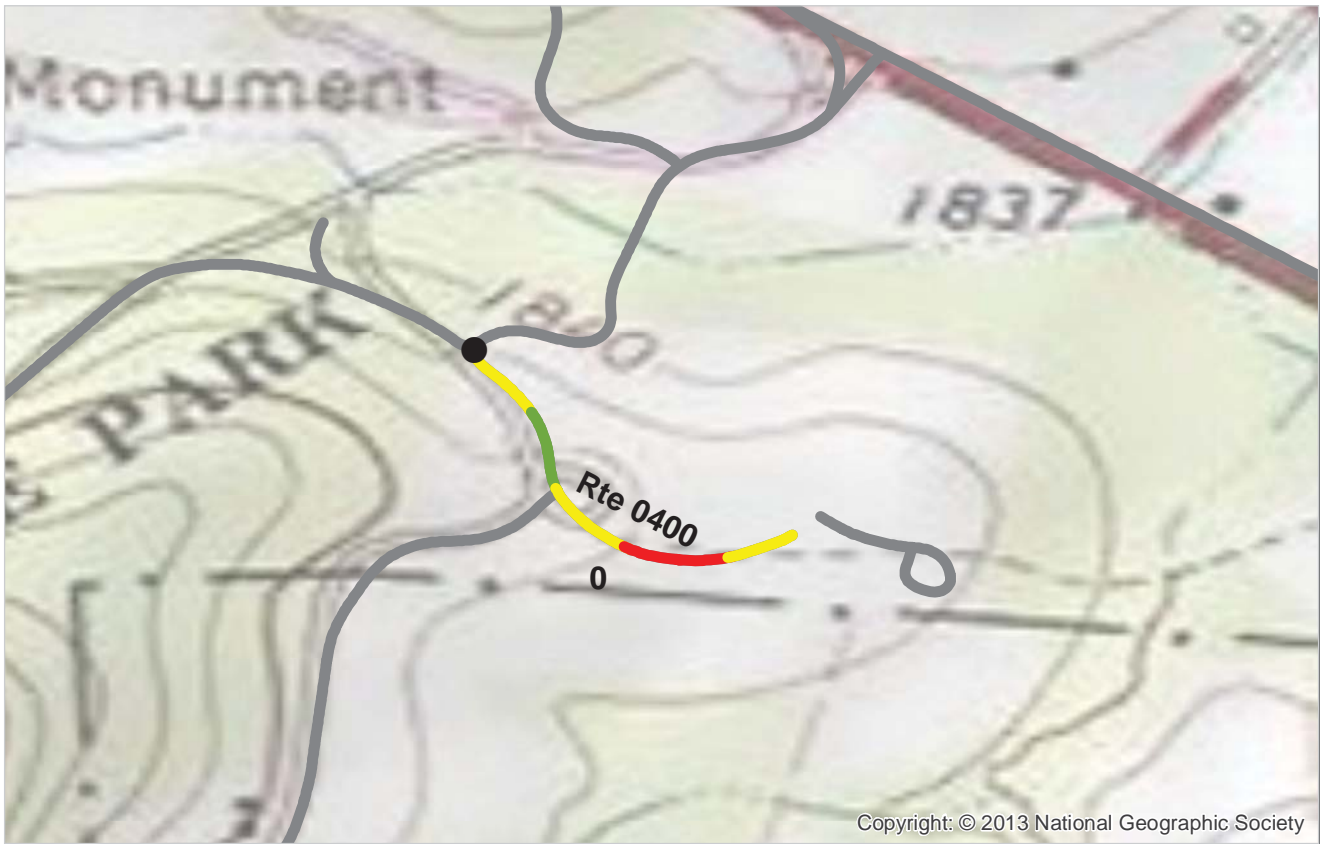
ROUTE: 0101 FORT ACCESS ROAD

Section Number	0				
Section Length (mi)	0.18				
Cross Section Information					
Number of Lanes	2				
Paved Width (ft)	22				
Lane Width (ft)	11				
Roadway Condition Information					
SCR (Surface Condition Rating)	41				
PCR (Pavement Condition Rating)	41				
Distress Index Values					
Structural Crack Index	41				
Transverse Cracking Index	98				
Patching Index	100				
Rutting Index	91				
Roughness Condition Index (RCI)	NC

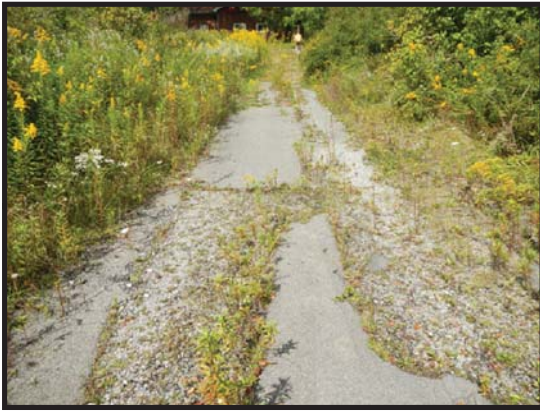
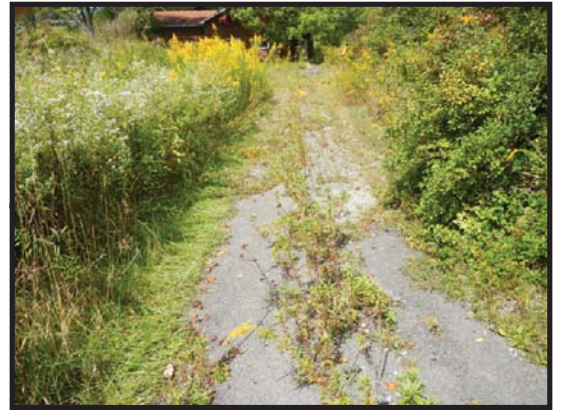
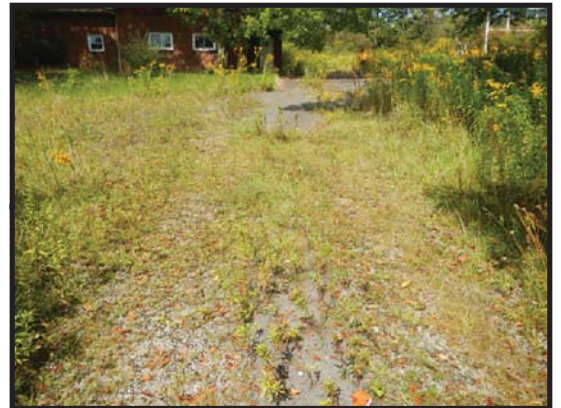
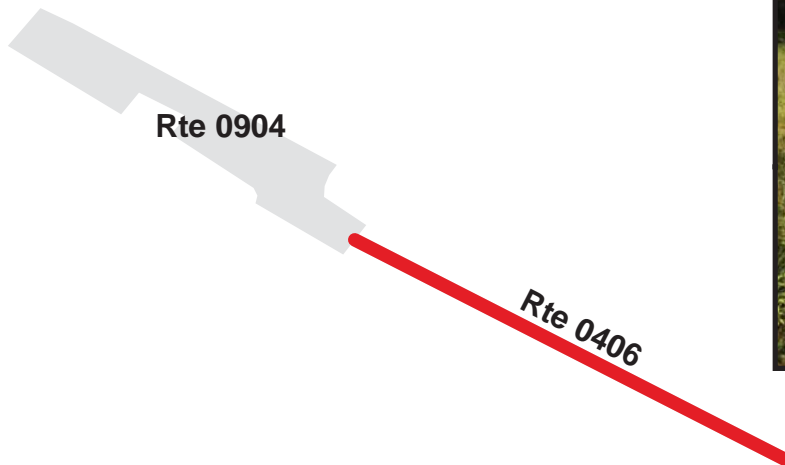
Route 0406

Route Number	Public / NonPublic	Date Visited	Area (sq ft)	Lane Miles *	Paved Length (mi)	Paved Width (ft)
0406	PUBLIC	9/18/2013	2,091	0.04	0.03	12
Culverts	Drop Inlets	Gates	Curb & Gutter	Curb	PCR	Surface Type
0	0	1	NO CURB AND GUTTER	NO CURB	POOR/45	AS
