Road Inventory Program

Road Inventory and Condition Assessment

Fort Smith National Historic Site FOSM - 7320

Cycle 5 Report

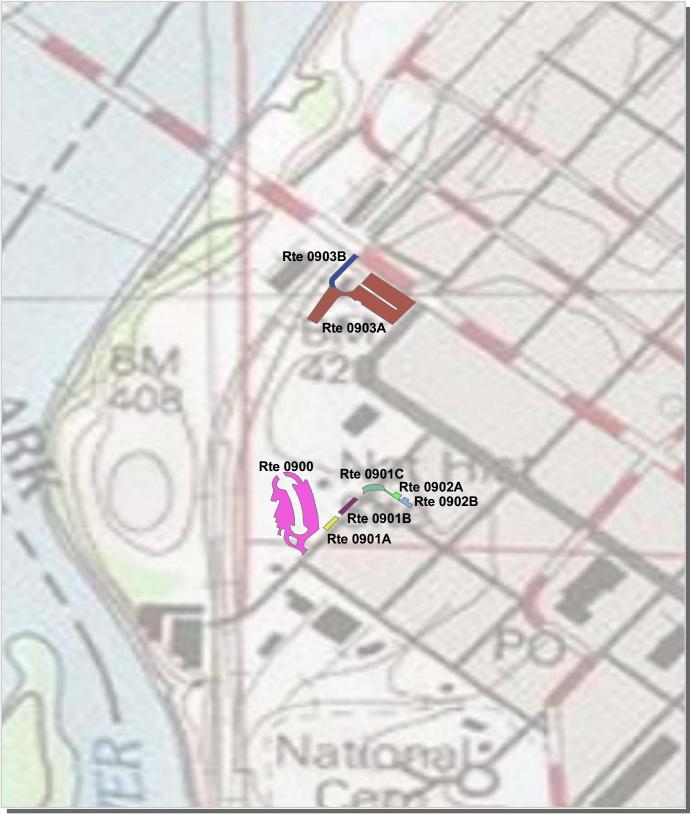
Fort Smith National Historic Site Route Location Map Area 1

Unique colors used to differentiate routes

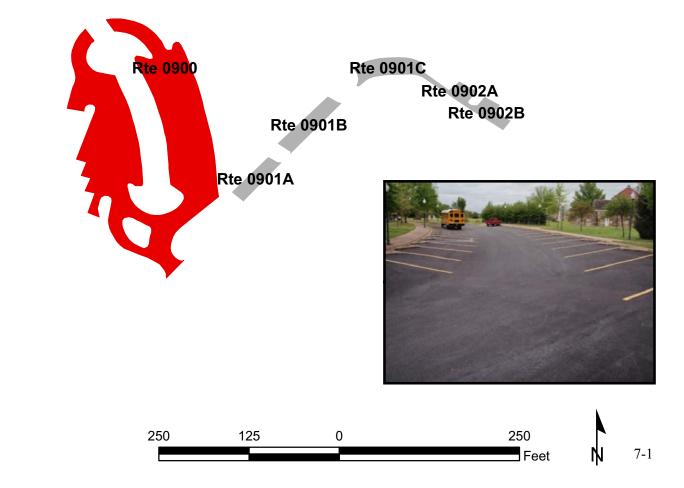
FORT SMITH NATIONAL HISTORIC SITE Route 0900

VISITOR CENTER PARKING FROM SOUTH THIRD STREET TO PARKING

| Route | Public / | | | | |
|---|---|---|---|---|---|
| 0900 | PUBLIC | 4/15/2011 | 27,890 | 0.48 | AS |
| 0 | 1 | 0 | AND GUTTER | NO CURB | GOOD/90 |

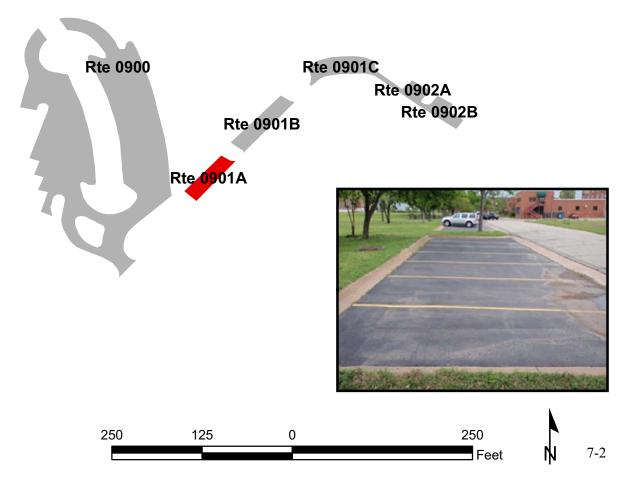
FORT SMITH NATIONAL HISTORIC SITE Route 0901A

VISITOR STREET PARKING A ADJACENT TO SOUTH THIRD STREET

| Route | Public / | | | | |
|---|---|---|---|---|---|
| 0901A | PUBLIC | 4/15/2011 | 1,142 | 0.02 | AS |
| 0 | 0 | 0 | AND GUTTER | NO CURB | GOOD/90 |

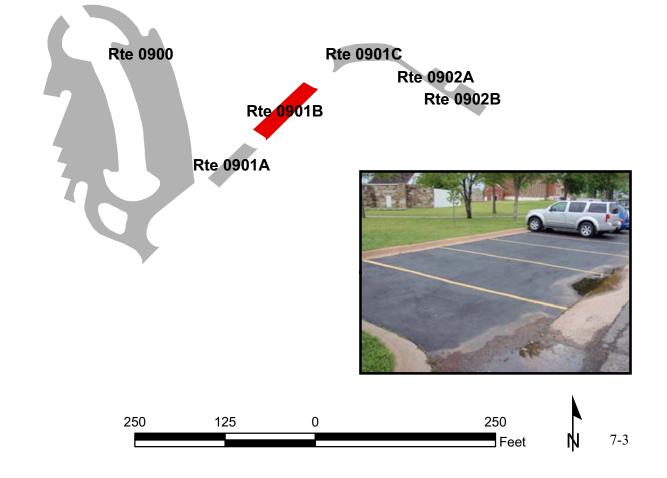
FORT SMITH NATIONAL HISTORIC SITE Route 0901B

VISITOR STREET PARKING B ADJACENT TO SOUTH THIRD STREET

| Route | Public / | | | | |
|---|---|---|---|---|---|
| 0901B | PUBLIC | 4/15/2011 | 1,653 | 0.03 | AS |
| 0 | 0 | 0 | AND GUTTER | NO CURB | GOOD/90 |

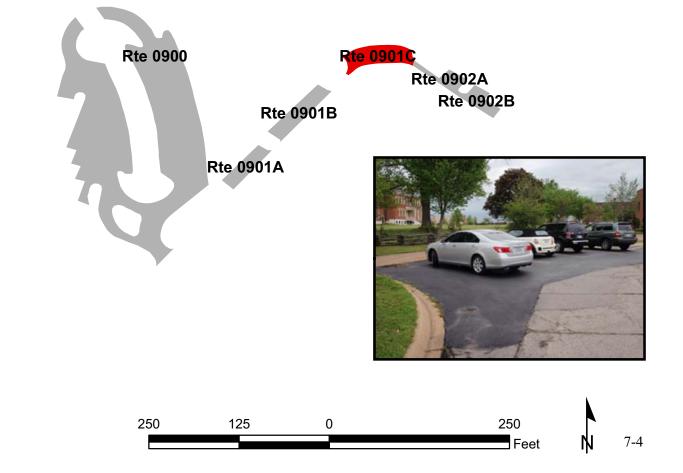
FORT SMITH NATIONAL HISTORIC SITE Route 0901C

VISITOR STREET PARKING C

| Route | Public / | | | | |
|---|---|---|---|---|---|
| 0901C | PUBLIC | 4/15/2011 | 1,827 | 0.03 | AS |
| 0 | 1 | 0 | AND GUTTER | CURB | GOOD/90 |

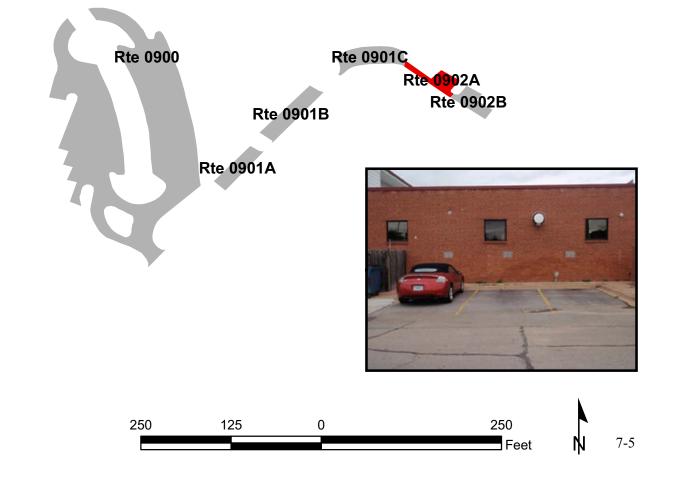
FORT SMITH NATIONAL HISTORIC SITE Route 0902A

EMPLOYEE STREET PARKING A ADJACENT TO PARKER AVENUE

| Route | Public / | | | | |
|---|---|---|---|---|---|
| 0902A | PUBLIC | 4/15/2011 | 853 | 0.02 | AS |
| 0 | 0 | 0 | AND GUTTER | CURB | FAIR/73 |

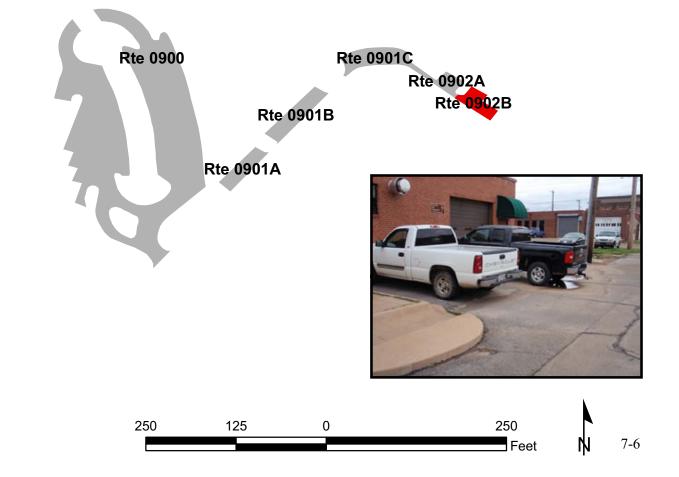
FORT SMITH NATIONAL HISTORIC SITE Route 0902B

EMPLOYEE STREET PARKING B ADJACENT TO PARKER AVENUE

| Route | Public / | | | | |
|---|---|---|---|---|---|
| 0902B | PUBLIC | 4/15/2011 | 894 | 0.02 | AS |
| 0 | 0 | 0 | AND GUTTER | CURB | FAIR/73 |
