Federal Lands Highway Road Inventory Program

Road Inventory and Condition Assessment

National Capital Parks – East Fort Washington Park FOWA

Cycle 5 Report

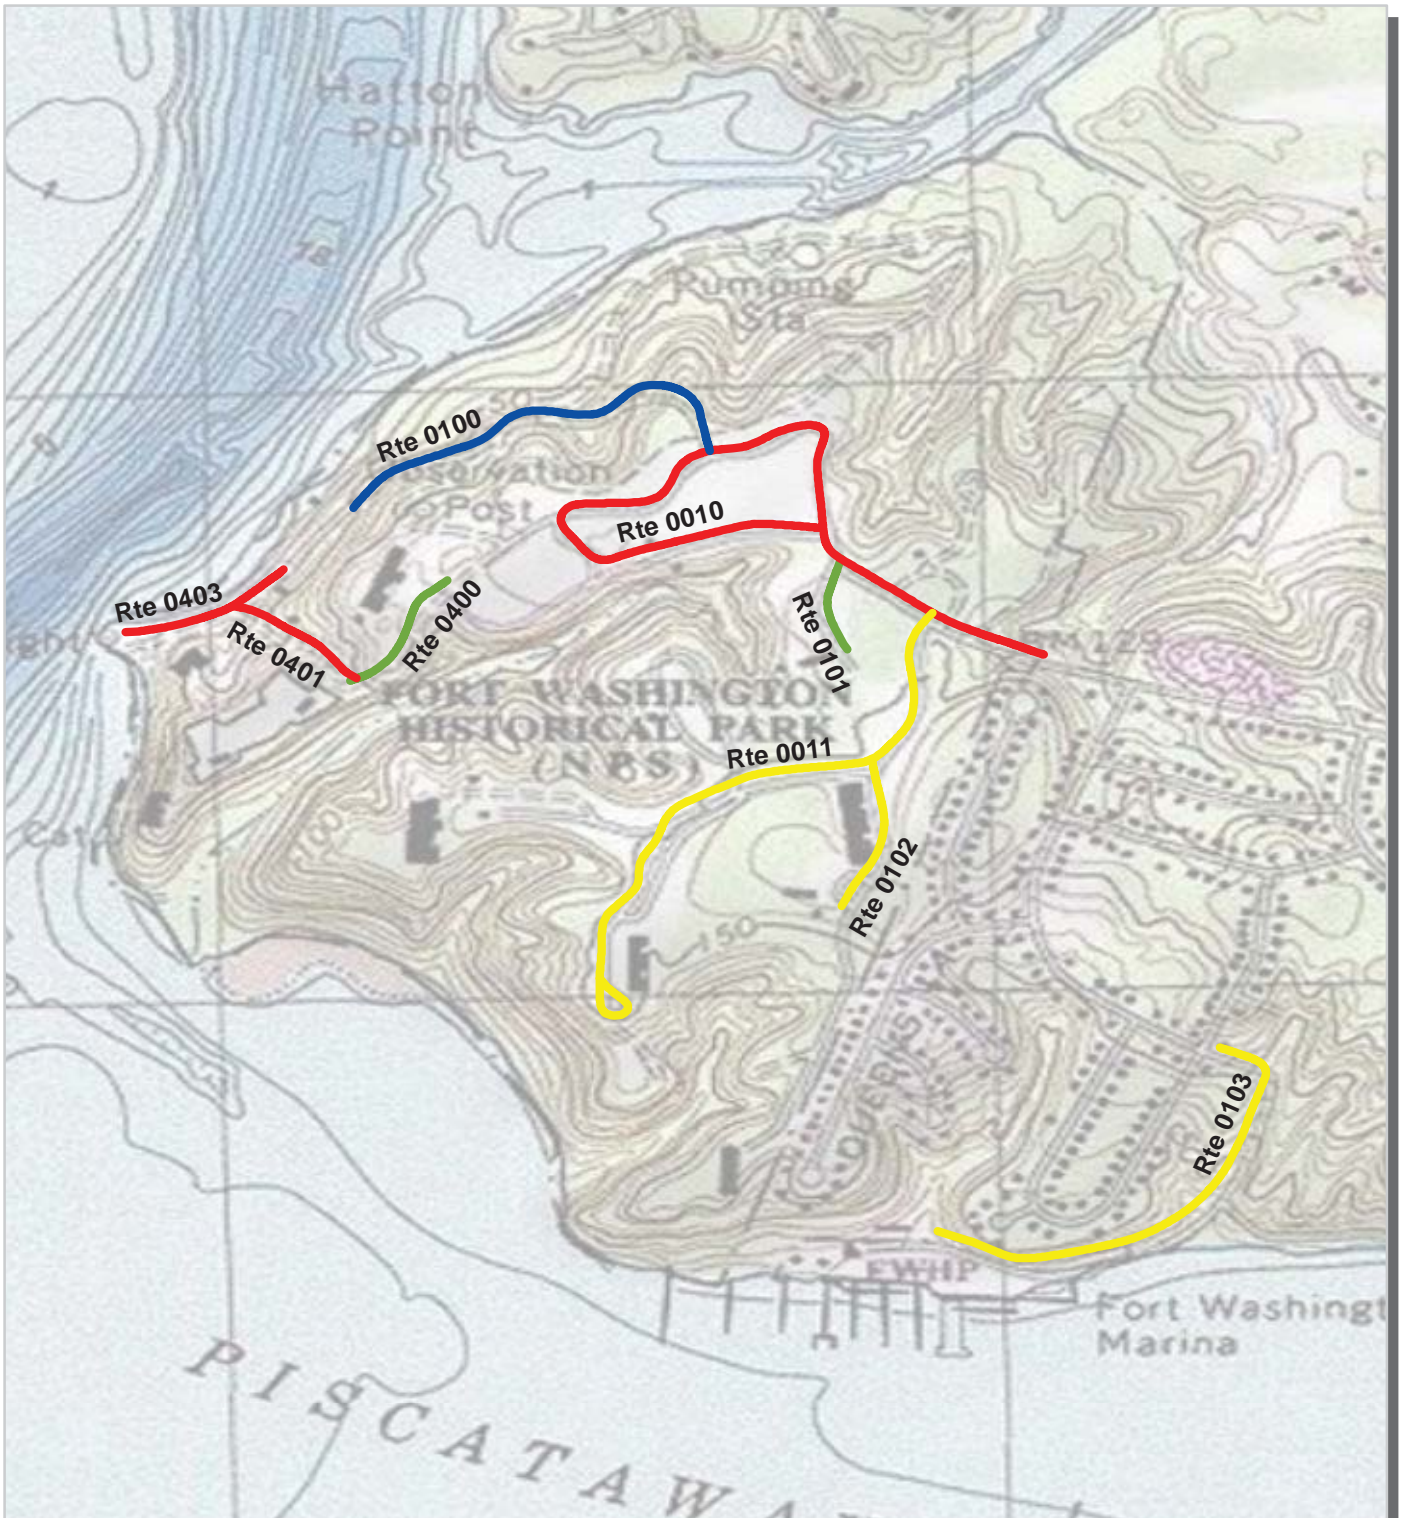
**Fort Washington Park
Route Condition Map
PCR - Mile by Mile
Area 1**

PCR	Poor	Fair	Good	Excellent	No Data
	(0 - 60)	(61 - 84)	(85 - 94)	(95 - 100)

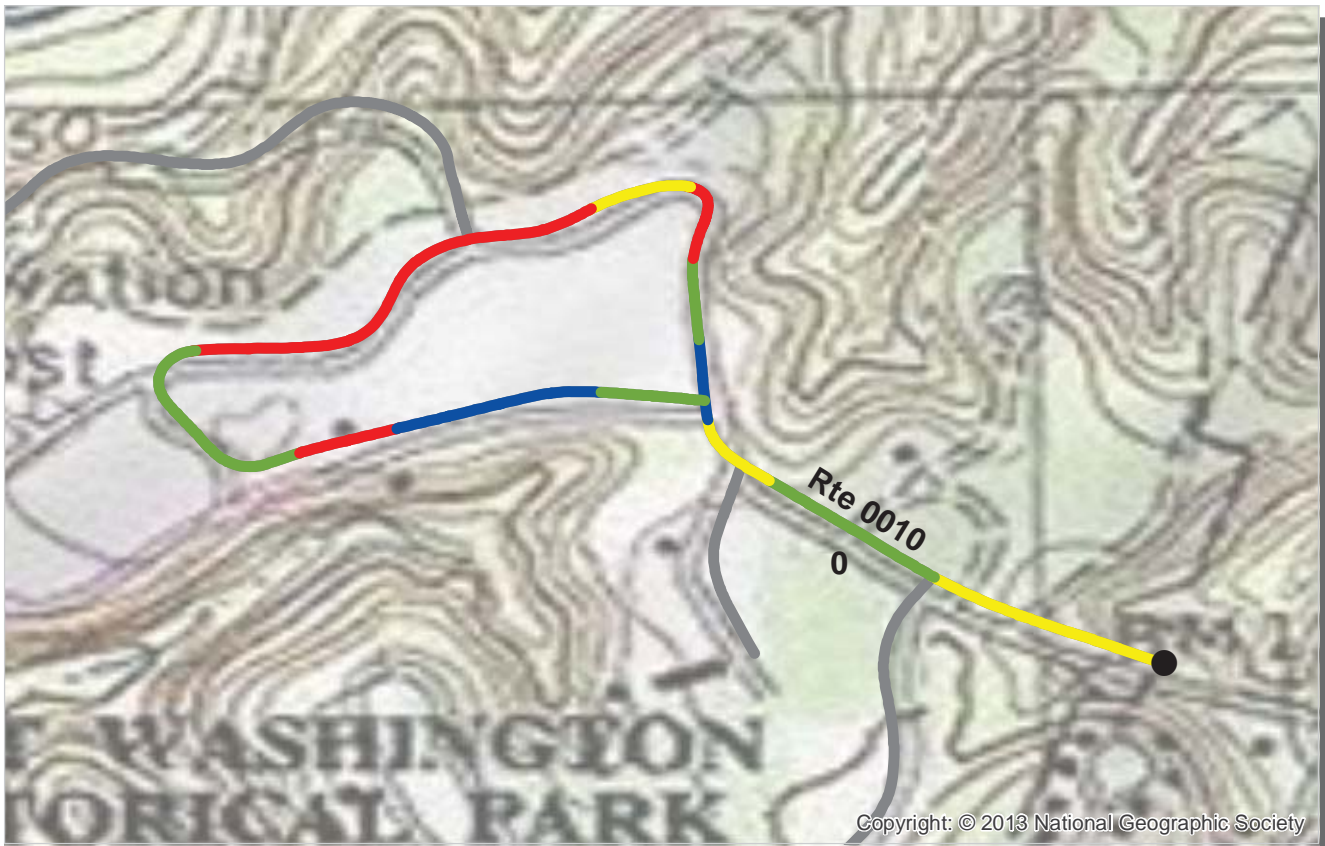
Section Number	0				
Section Length (mi)	0.82				
Cross Section Information					
Number of Lanes	1				
Paved Width (ft)	19				
Lane Width (ft)	10				
Roadway Condition Information					
SCR (Surface Condition Rating)	55				
PCR (Pavement Condition Rating)	55				
Distress Index Values					
Structural Crack Index	55				
Transverse Cracking Index	92				
Patching Index	100				
Rutting Index	97				
Roughness Condition Index (RCI)	NC

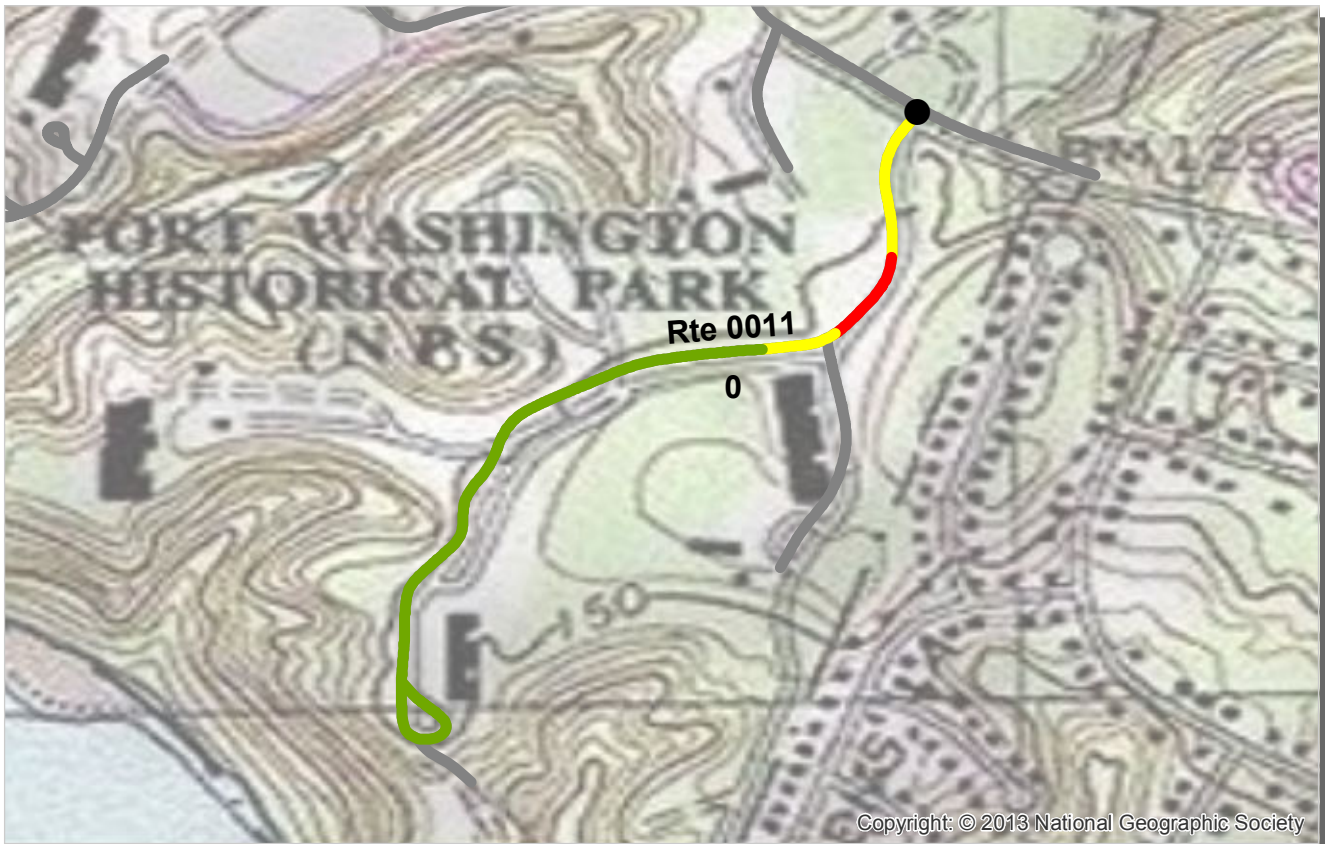
Section Number	0				
Section Length (mi)	0.61				
Cross Section Information					
Number of Lanes	2				
Paved Width (ft)	18				
Lane Width (ft)	10				
Roadway Condition Information					
SCR (Surface Condition Rating)	80				
PCR (Pavement Condition Rating)	80				
Distress Index Values					
Structural Crack Index	80				
Transverse Cracking Index	90				
Patching Index	100				
Rutting Index	99				
Roughness Condition Index (RCI)	NC

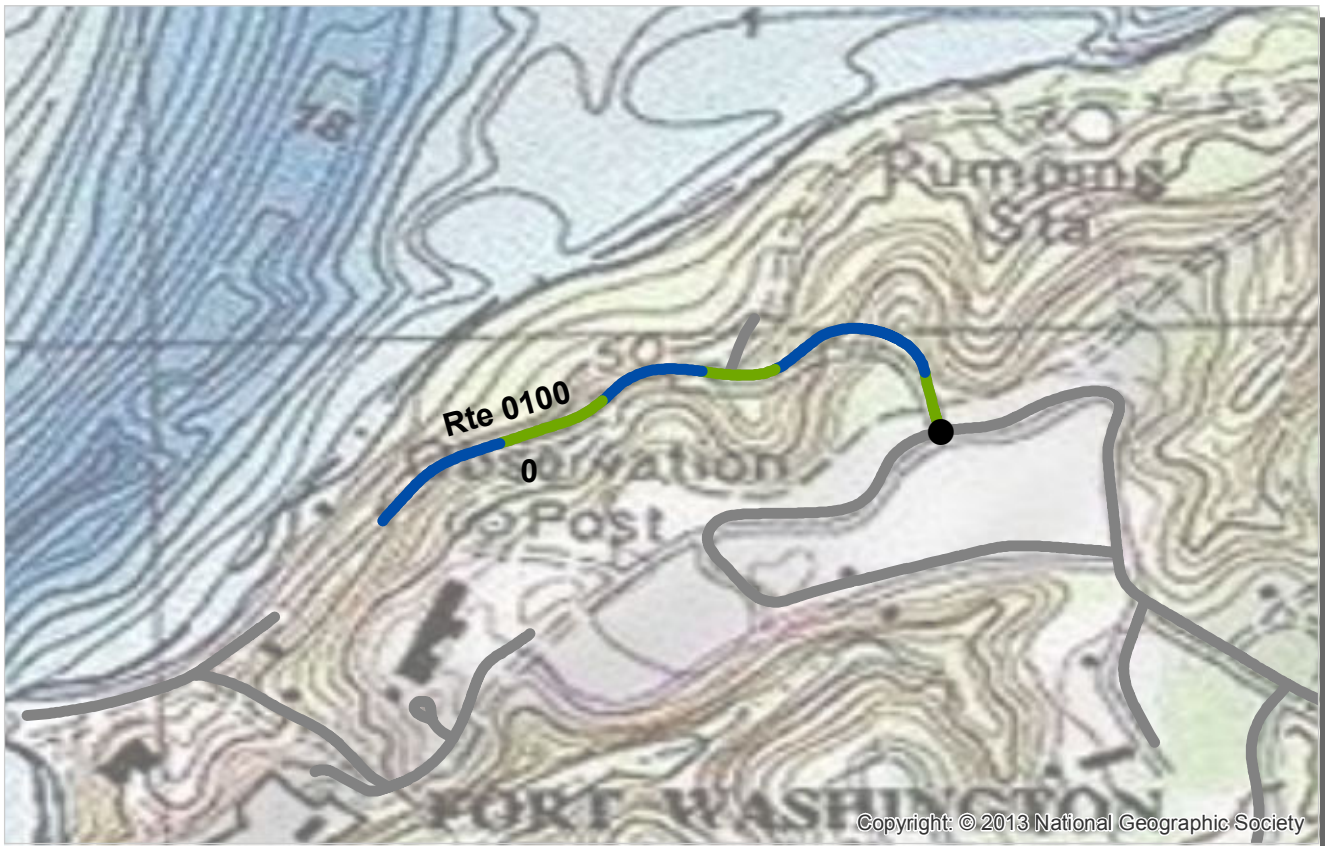
Section Number	0				
Section Length (mi)	0.38				
Cross Section Information					
Number of Lanes	2				
Paved Width (ft)	20				
Lane Width (ft)	10				
Roadway Condition Information					
SCR (Surface Condition Rating)	97				
PCR (Pavement Condition Rating)	97				
Distress Index Values					
Structural Crack Index	97				
Transverse Cracking Index	99				
Patching Index	100				
Rutting Index	98				
Roughness Condition Index (RCI)	NC

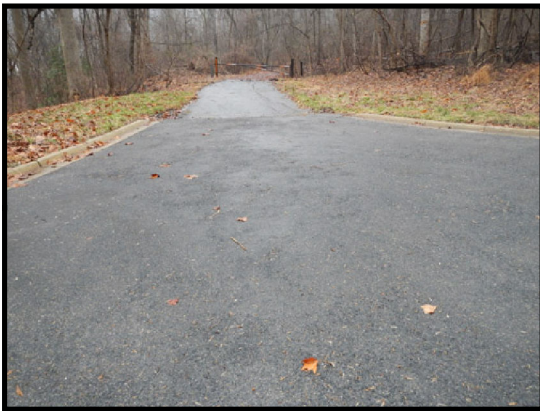
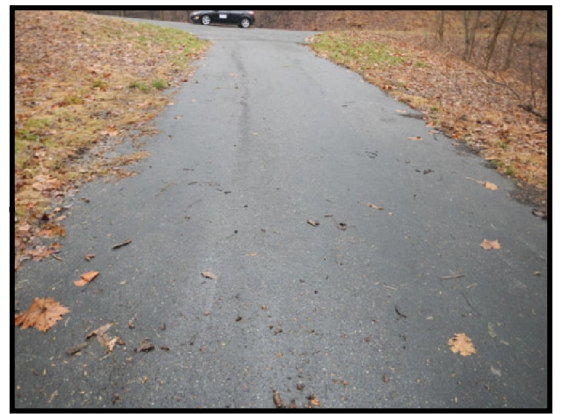
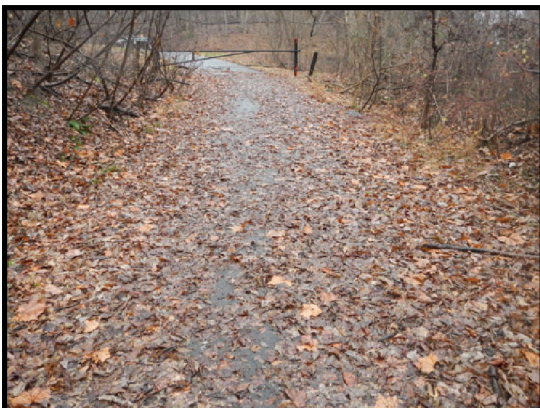
Route Number	Public / NonPublic	Date Visited	Area (sq ft)	Lane Miles *	Paved Length (mi)	Paved Width (ft)
0407	NONPUBLIC	1/15/2013	2,577	0.04	0.04	12.2
Culverts	Drop Inlets	Gates	Curb & Gutter	Curb	PCR	Surface Type
1	0	1	CONCRETE CURB AND GUTTER	NO CURB	FAIR/73	AS

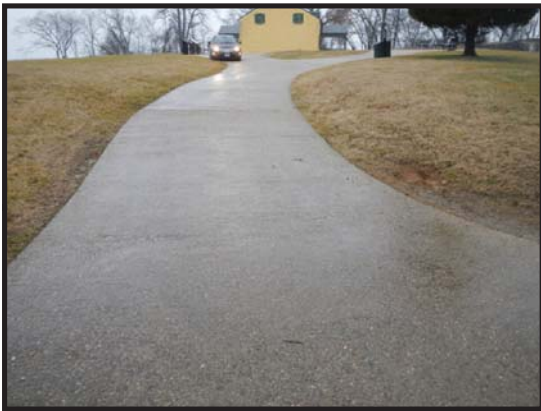
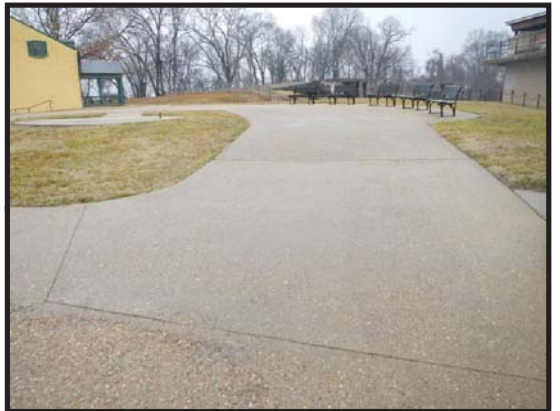
Route 0410

Route Number	Public / NonPublic	Date Visited	Area (sq ft)	Lane Miles *	Paved Length (mi)	Paved Width (ft)
0410	PUBLIC	1/15/2013	3,564	0.06	0.05	13.5
Culverts	Drop Inlets	Gates	Curb & Gutter	Curb	PCR	Surface Type
0	0	0	NO CURB AND GUTTER	NO CURB	GOOD/90	CO

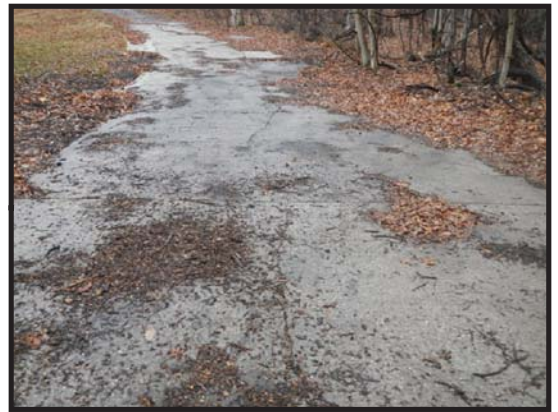
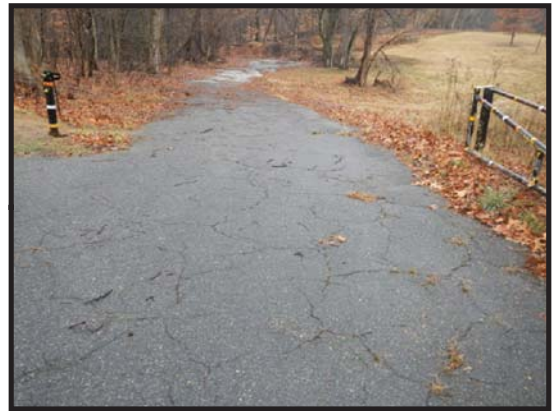
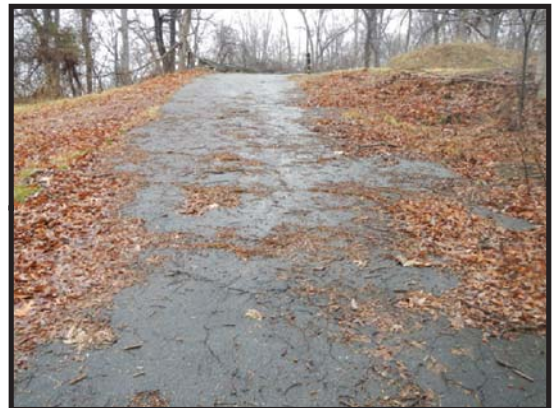
Route 0411

Route Number	Public / NonPublic	Date Visited	Area (sq ft)	Lane Miles *	Paved Length (mi)	Paved Width (ft)
0411	PUBLIC	1/15/2013	3,155	0.05	0.04	16.6
Culverts	Drop Inlets	Gates	Curb & Gutter	Curb	PCR	Surface Type
0	0	1	NO CURB AND GUTTER	NO CURB	POOR/45	AS

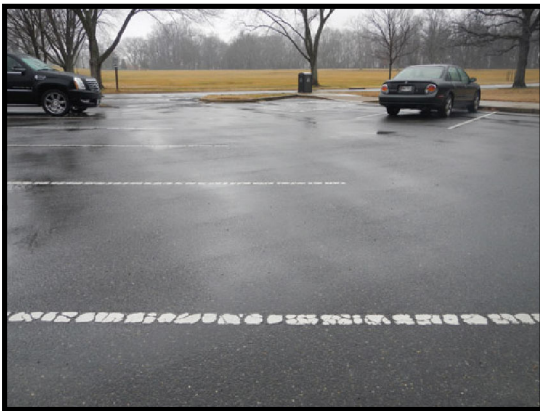
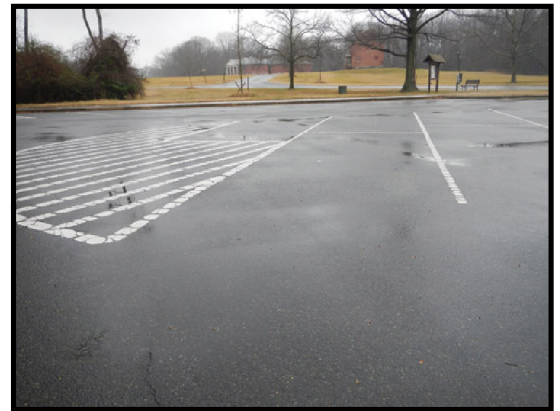
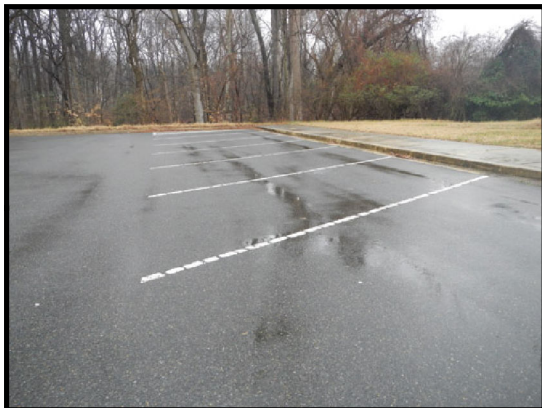
Route Number	Public / NonPublic	Date Visited	Area (sq ft)	Lane Miles *	Surface Type
0901	PUBLIC	1/15/2013	11,691	0.20	AS
Culverts	Drop Inlets	Gates	Curb & Gutter	Curb	PCR
0	0	0	CONCRETE CURB AND GUTTER	NO CURB	GOOD/90

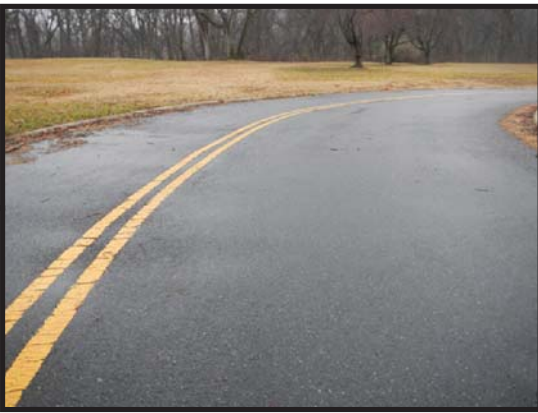
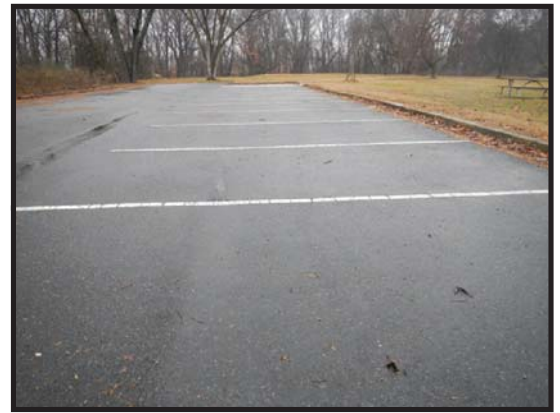
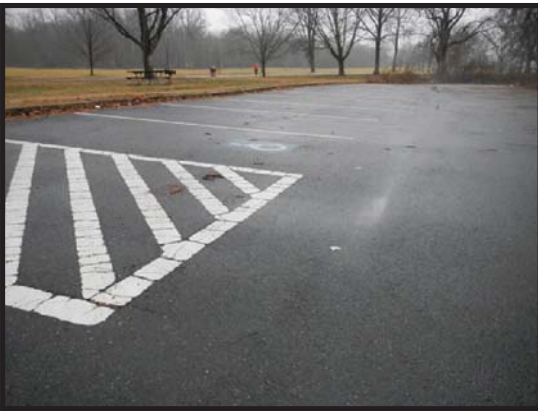
Route 0902

Route Number	Public / NonPublic	Date Visited	Area (sq ft)	Lane Miles *	Surface Type
0902	PUBLIC	1/15/2013	10,179	0.18	AS
Culverts	Drop Inlets	Gates	Curb & Gutter	Curb	PCR
0	0	0	CONCRETE CURB AND GUTTER	NO CURB	GOOD/90

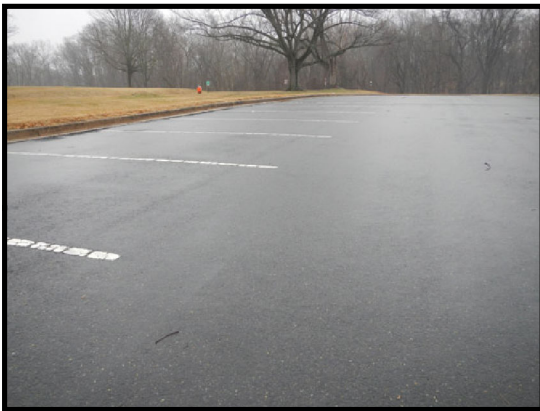
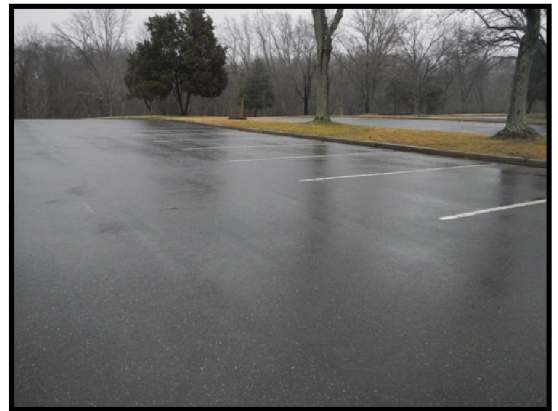
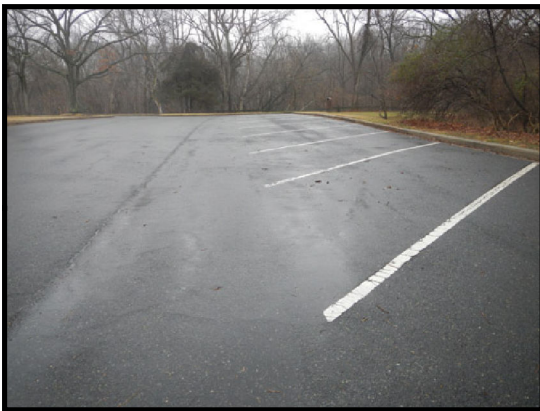
Route 0903

Route Number	Public / NonPublic	Date Visited	Area (sq ft)	Lane Miles *	Surface Type
0903	PUBLIC	1/15/2013	139,187	2.40	AS
Culverts	Drop Inlets	Gates	Curb & Gutter	Curb	PCR
0	22	0	CONCRETE CURB AND GUTTER	NO CURB	GOOD/90

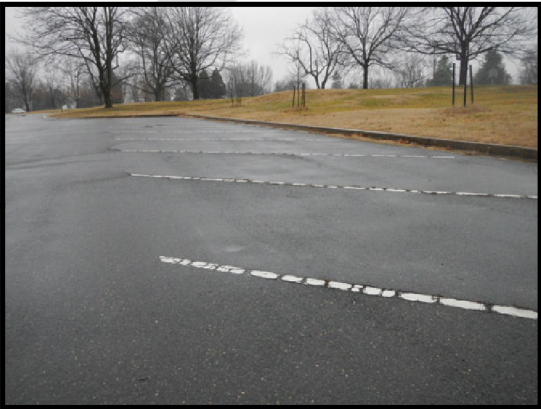
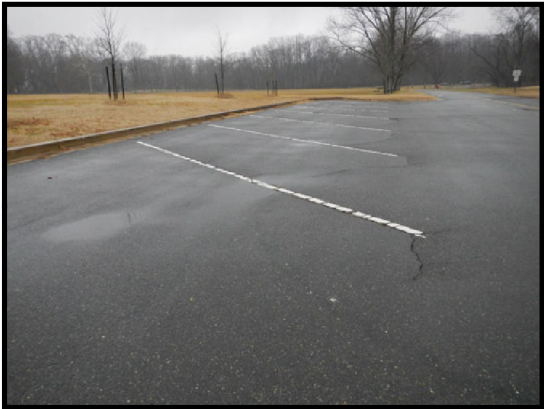
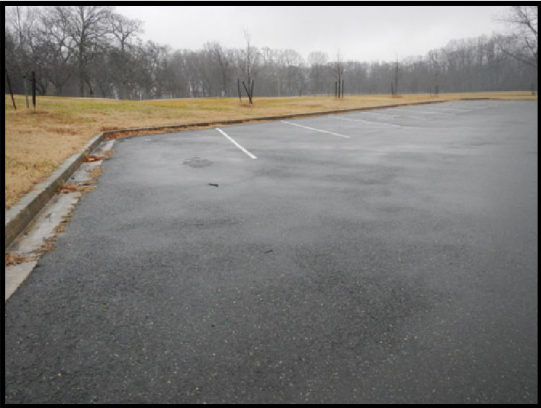
Route 0904

Route Number	Public / NonPublic	Date Visited	Area (sq ft)	Lane Miles *	Surface Type
0904	PUBLIC	1/15/2013	4,074	0.07	AS
Culverts	Drop Inlets	Gates	Curb & Gutter	Curb	PCR
0	0	0	CONCRETE CURB AND GUTTER	NO CURB	FAIR/73

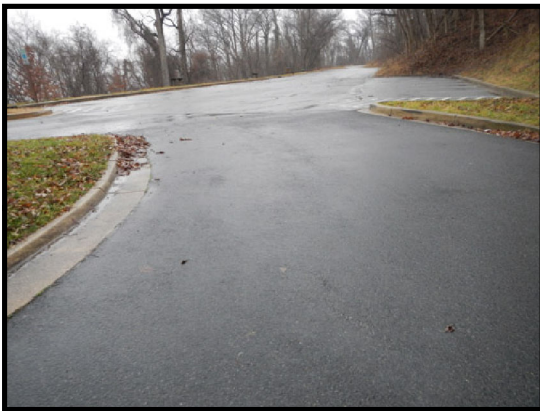
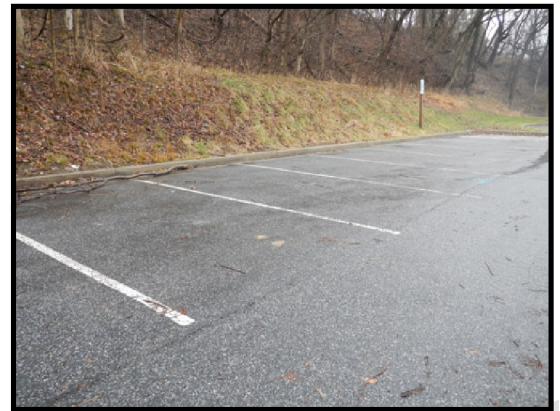
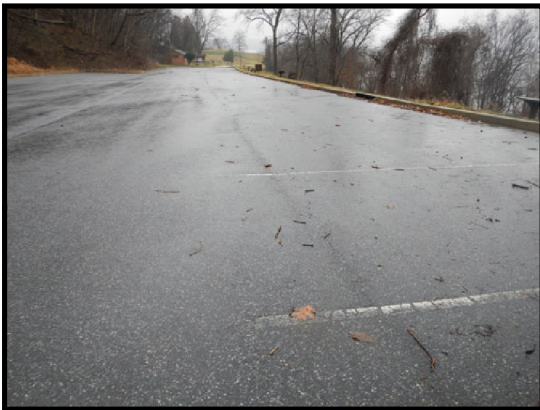
Route 0905

Route Number	Public / NonPublic	Date Visited	Area (sq ft)	Lane Miles *	Surface Type
0905	PUBLIC	1/15/2013	21,247	0.37	AS
Culverts	Drop Inlets	Gates	Curb & Gutter	Curb	PCR
0	4	0	CONCRETE CURB AND GUTTER	NO CURB	GOOD/90

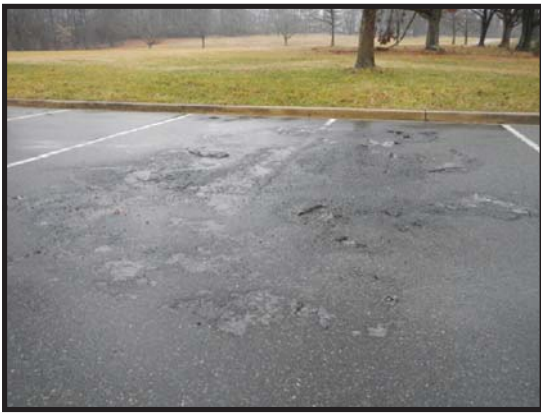
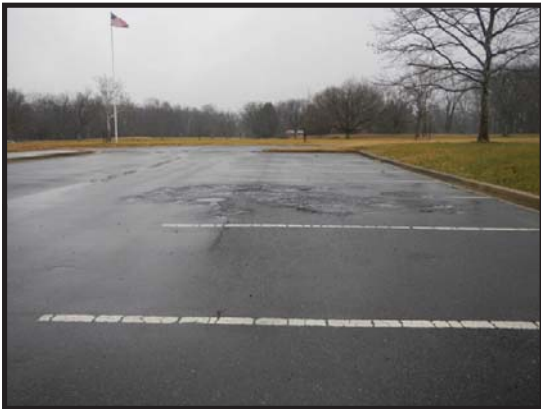
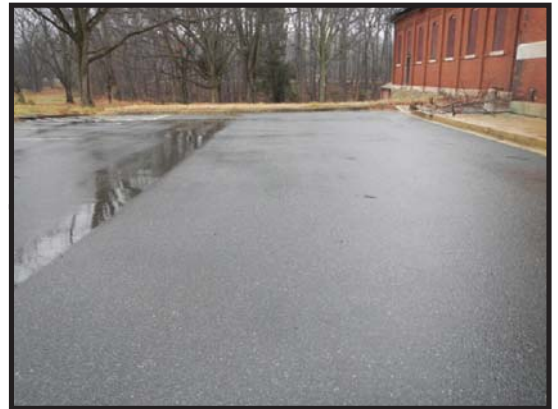
Route 0906

Route Number	Public / NonPublic	Date Visited	Area (sq ft)	Lane Miles *	Surface Type
0906	PUBLIC	1/15/2013	4,717	0.08	AS
Culverts	Drop Inlets	Gates	Curb & Gutter	Curb	PCR
0	0	0	CONCRETE CURB AND GUTTER	NO CURB	GOOD/90
