# Federal Lands Highway Road Inventory Program

Road Inventory and Condition Assessment

## Gloria Dei (Old Swedes') Church National Historic Site GLDE

### Cycle 5 Report

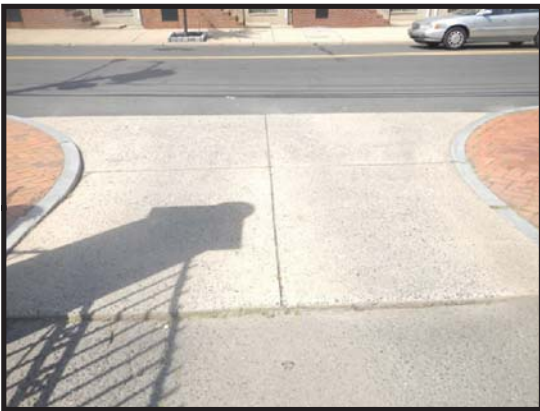
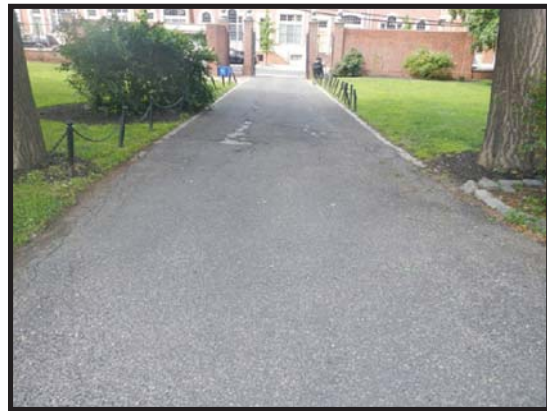
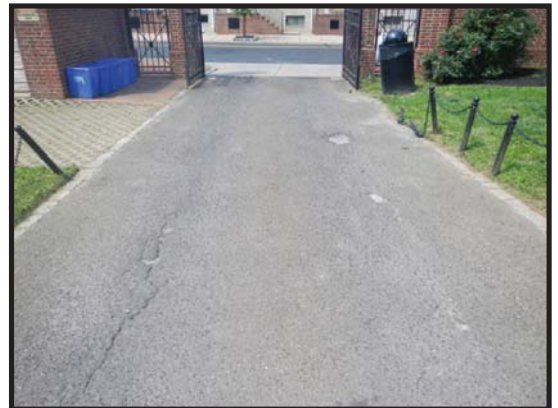
## Route 0900

### CHURCH PARKING ACCESS

FROM CHRISTIAN STREET

TO NON NPS GLORIA DEI CHURCH PARKING LOT

Route Number	Public / NonPublic	Date Visited	Area (sq ft)	Lane Miles *	Surface Type
0900	PUBLIC	6/19/2013	1,670	0.03	AS
Culverts	Drop Inlets	Gates	Curb & Gutter	Curb	PCR
0	0	1	NO CURB AND GUTTER	NO CURB	POOR/45

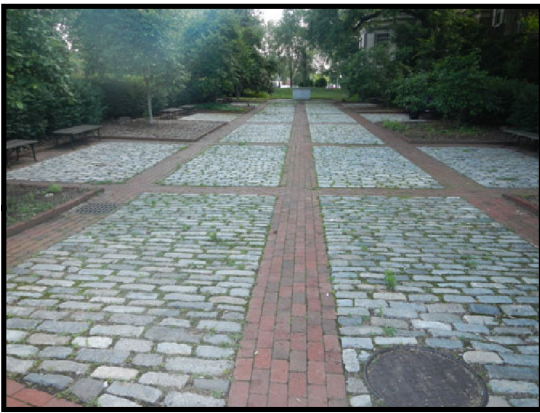
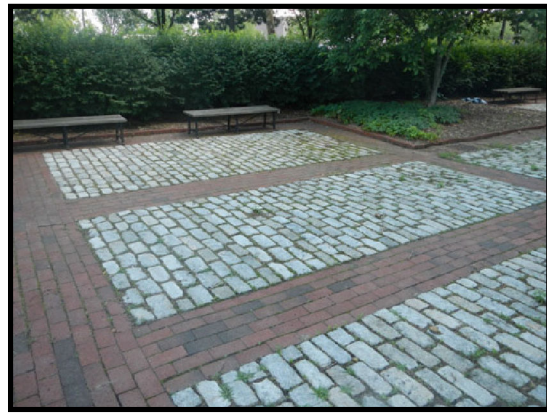
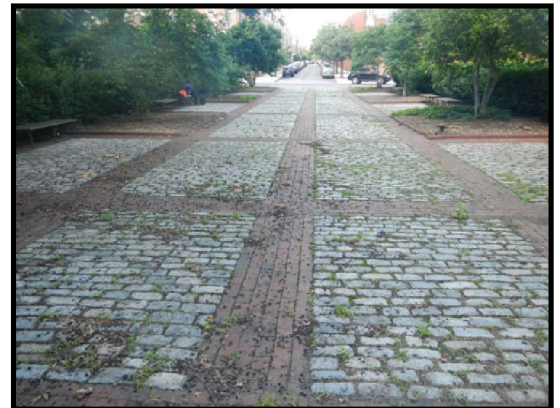
## Route 0901

SWANSON STREET  
FROM CHRISTIAN STREET  
TO END

Route Number	Public / NonPublic	Date Visited	Area (sq ft)	Lane Miles *	Surface Type
0901	NONPUBLIC	6/19/2013	4,162	0.07	GB
Culverts	Drop Inlets	Gates	Curb & Gutter	Curb	PCR
0	2	0	NO CURB AND GUTTER	BRICK CURB	FAIR/73
