# Federal Lands Highway Road Inventory Program

Road Inventory and Condition Assessment

## Horace M. Albright Training Center HOAL

### Cycle 5 Report

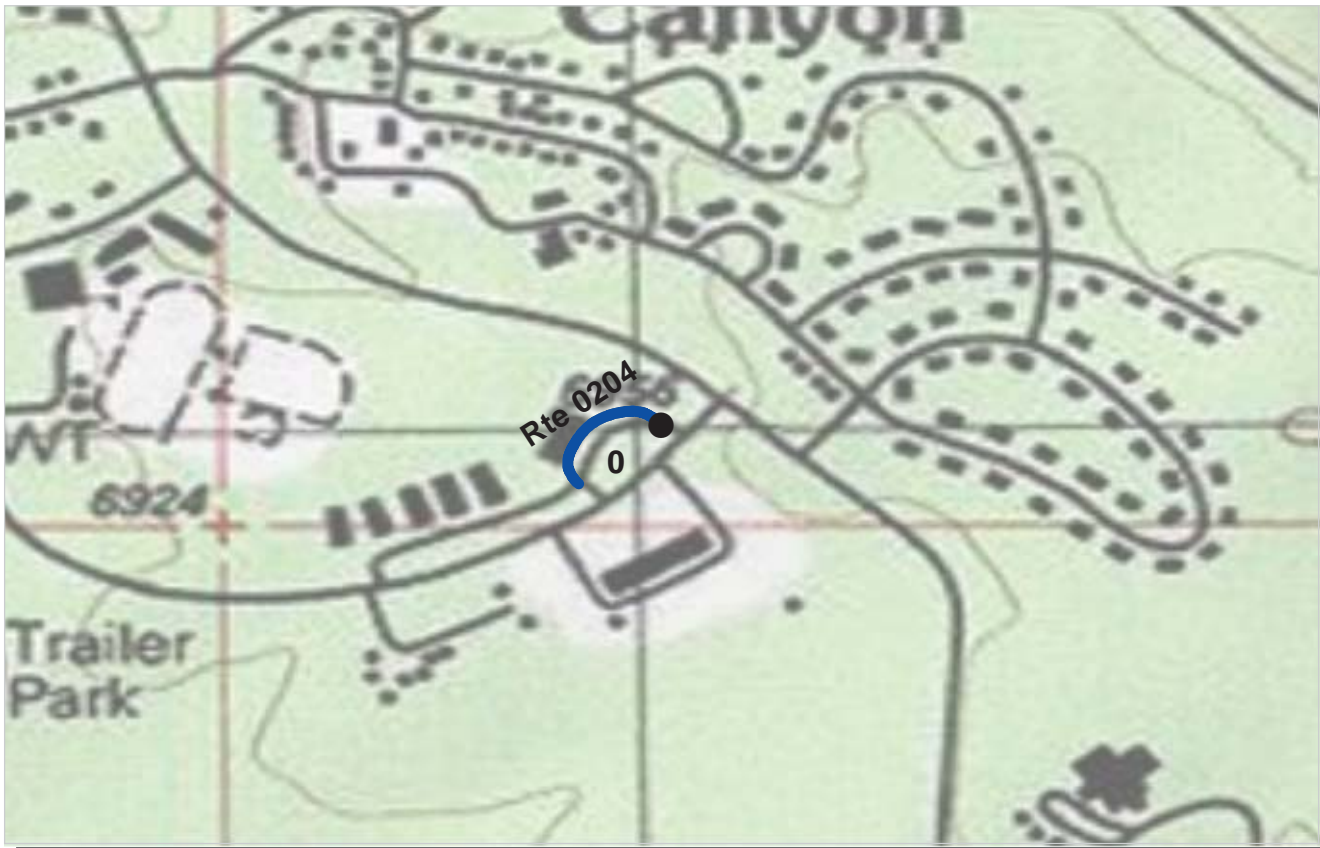
**ROUTE: 0204 NPS ACADEMY LOOP ROAD**

PCR    Poor ■    Fair ■    Good ■    Excellent ■    No Data ■  
           (0 - 60)           (61 - 84)           (85 - 94)           (95 - 100)

<b>Section Number</b>	0				
<b>Section Length (mi)</b>	0.09				
<b>Cross Section Information</b>					
Number of Lanes	2				
Paved Width (ft)	27				
Lane Width (ft)	13				
<b>Roadway Condition Information</b>					
SCR (Surface Condition Rating)	96				
PCR (Pavement Condition Rating)	96				
<b>Distress Index Values</b>					
Structural Crack Index	99				
Transverse Cracking Index	96				
Patching Index	100				
Rutting Index	99				
Roughness Condition Index (RCI)	NC

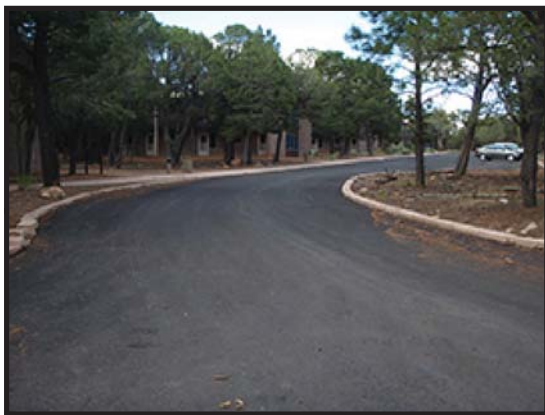
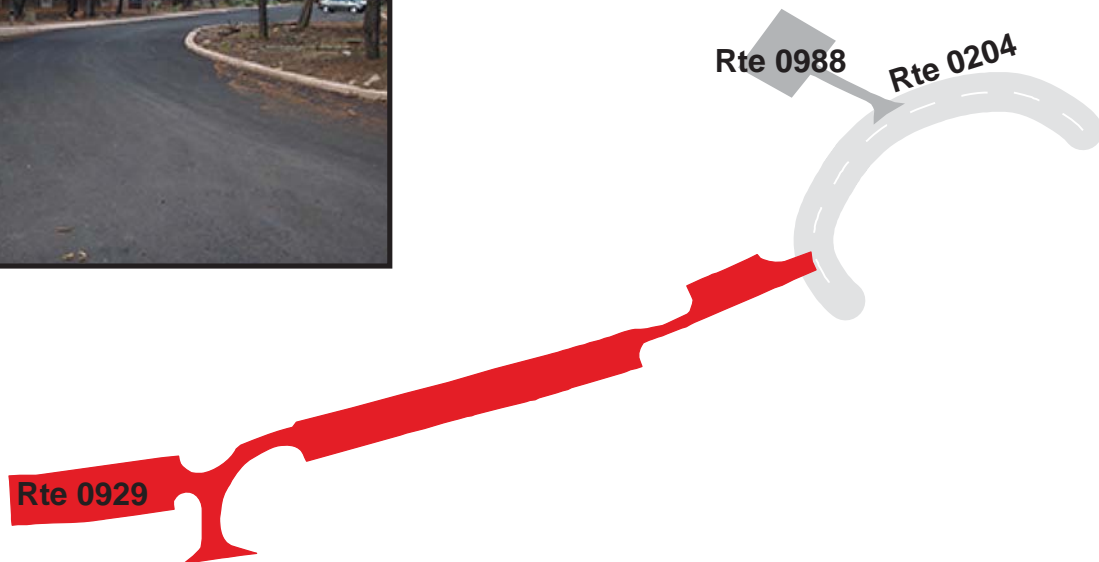
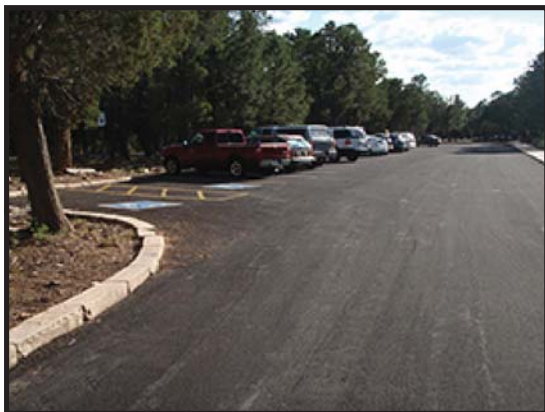
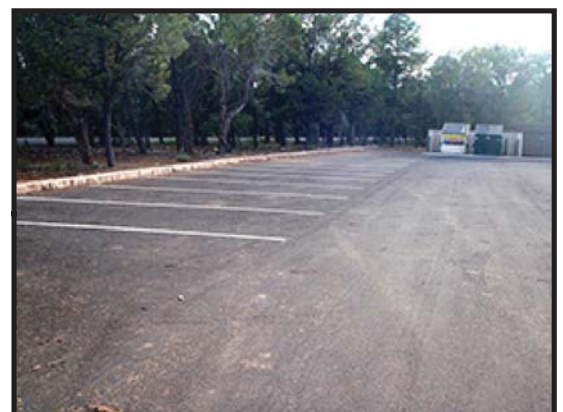
## Route 0929

Route Number	Public / NonPublic	Date Visited	Area (sq ft)	Lane Miles *	Surface Type
0929	PUBLIC	8/15/2011	36,807	0.63	AS
Culverts	Drop Inlets	Gates	Curb & Gutter	Curb	PCR
0	0	0	NO CURB AND GUTTER	STONE CURB	FAIR/73

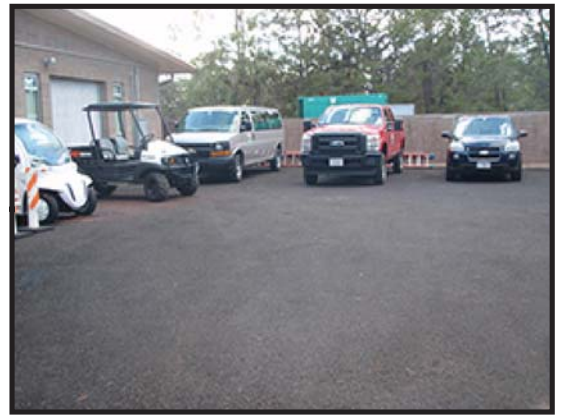
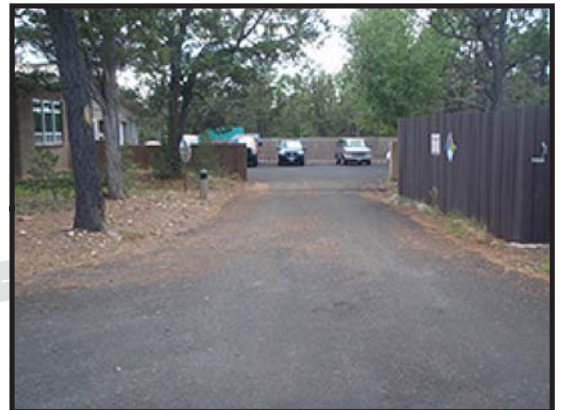
## Route 0988

Route Number	Public / NonPublic	Date Visited	Area (sq ft)	Lane Miles *	Surface Type
0988	PUBLIC	8/15/2011	6,649	0.11	AS
Culverts	Drop Inlets	Gates	Curb & Gutter	Curb	PCR
0	1	0	NO CURB AND GUTTER	NO CURB	GOOD/90
