Federal Lands Highway Road Inventory Program

Road Inventory and Condition Assessment

Keweenaw National Historical Park KEWE - 6410

Cycle 5 Report

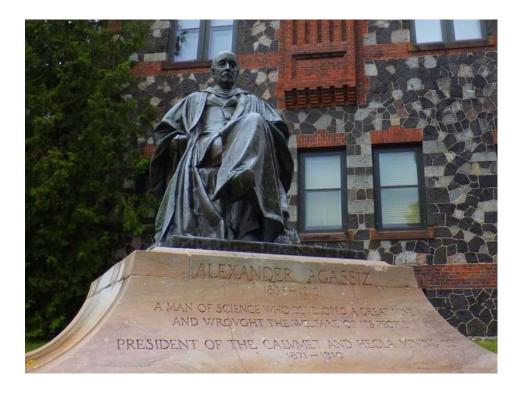
KNHP HEADQUARTERS FROM RED JACKET ROAD TO CALUMET AVENUE (U.S. HIGHWAY 41)

Route	Public /				
Number	NonPublic	Date Visited	Area (sq ft)	Lane Miles *	Surface Type
0900	NONPUBLIC	8/9/2012	26,404	0.46	AS
Culverts	Drop Inlets	Gates	Curb & Gutter	Curb	PCR
			NO CURB AND	ASPHALT	
0	7	0	GUTTER	CURB	POOR/45
