Federal Lands Highway Road Inventory Program

Road Inventory and Condition Assessment

Moore's Creek National Battlefield MOCR

Cycle 5 Report

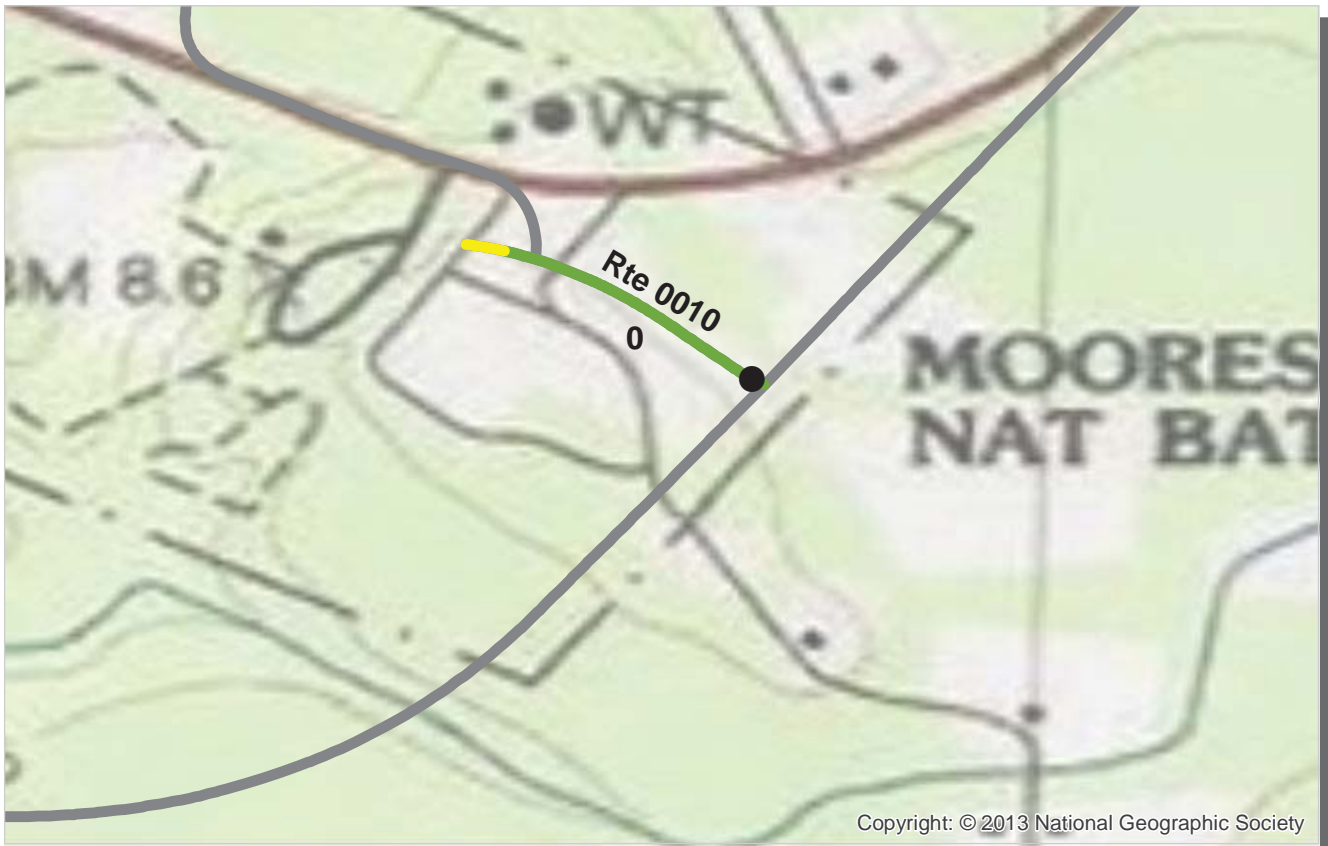
ROUTE: 0010 MOORES CREEK DRIVE

Section Number	0				
Section Length (mi)	0.14				
Cross Section Information					
Number of Lanes	2				
Paved Width (ft)	20				
Lane Width (ft)	9				
Roadway Condition Information					
SCR (Surface Condition Rating)	85				
PCR (Pavement Condition Rating)	85				
Distress Index Values					
Structural Crack Index	98				
Transverse Cracking Index	98				
Patching Index	99				
Rutting Index	85				
Roughness Condition Index (RCI)	NC

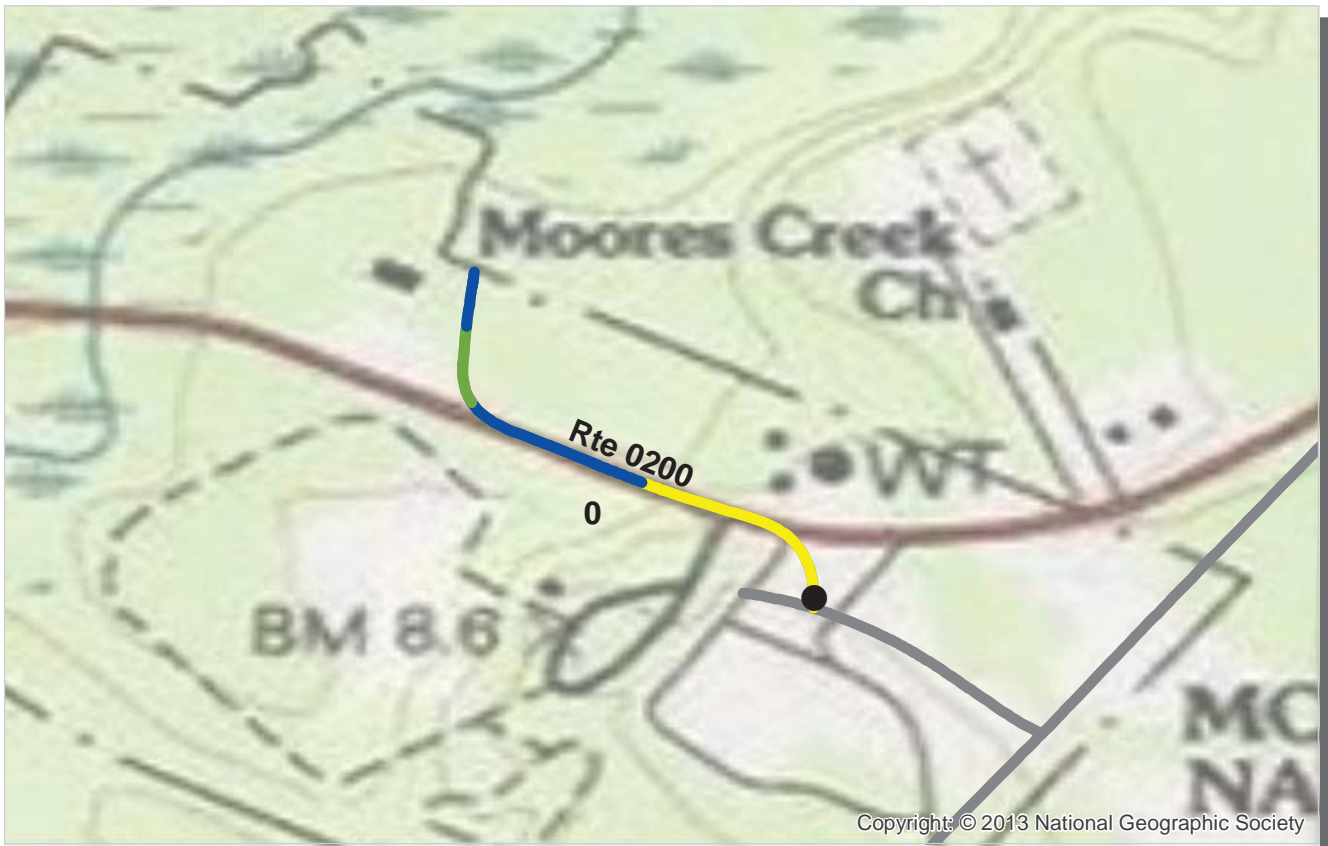
ROUTE: 0200 PATRIOTS HALL DRIVE

Section Number	0				
Section Length (mi)	0.25				
Cross Section Information					
Number of Lanes	2				
Paved Width (ft)	19				
Lane Width (ft)	10				
Roadway Condition Information					
SCR (Surface Condition Rating)	87				
PCR (Pavement Condition Rating)	87				
Distress Index Values					
Structural Crack Index	100				
Transverse Cracking Index	100				
Patching Index	100				
Rutting Index	87				
Roughness Condition Index (RCI)	NC

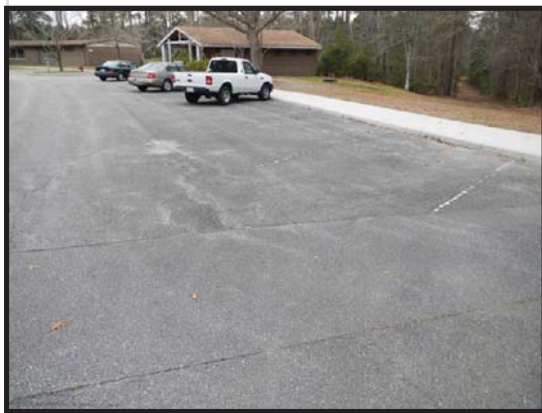
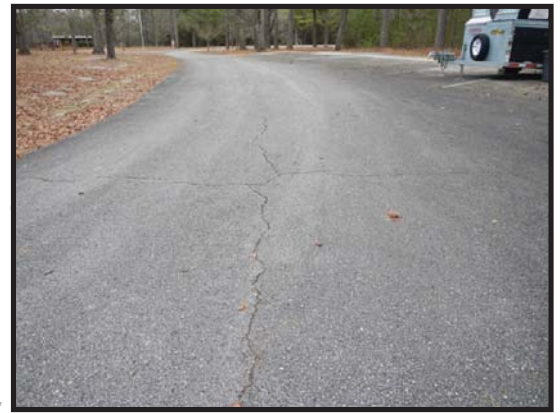
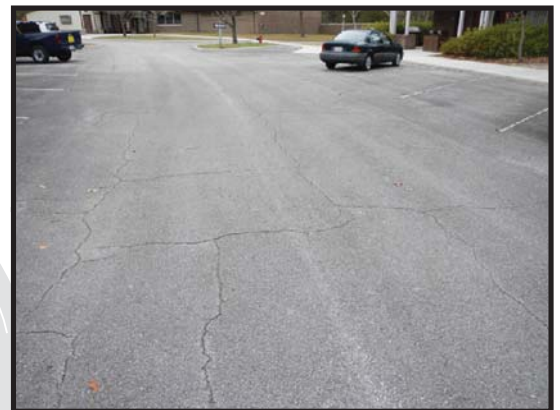
Route 0901

Route Number	Public / NonPublic	Date Visited	Area (sq ft)	Lane Miles *	Surface Type
0900	PUBLIC	2/4/2013	28,889	0.50	AS
Culverts	Drop Inlets	Gates	Curb & Gutter	Curb	PCR
0	5	0	NO CURB AND GUTTER	CONCRETE CURB	POOR/45

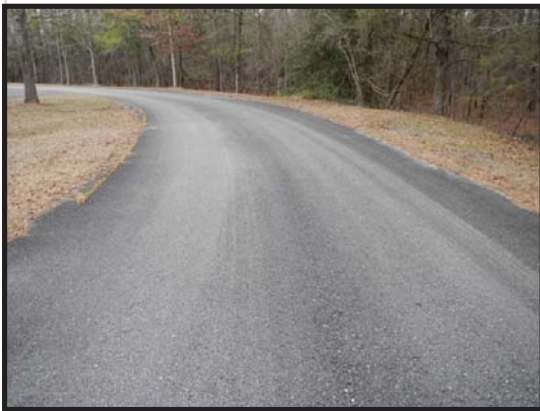
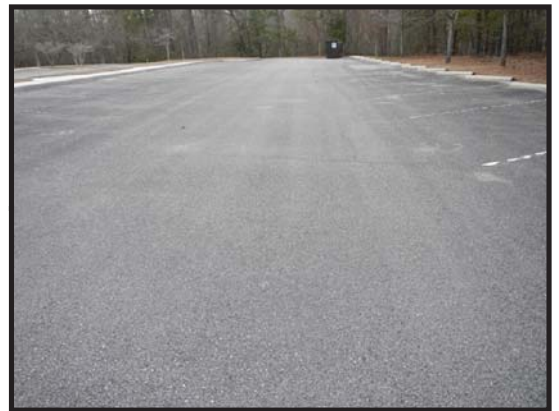
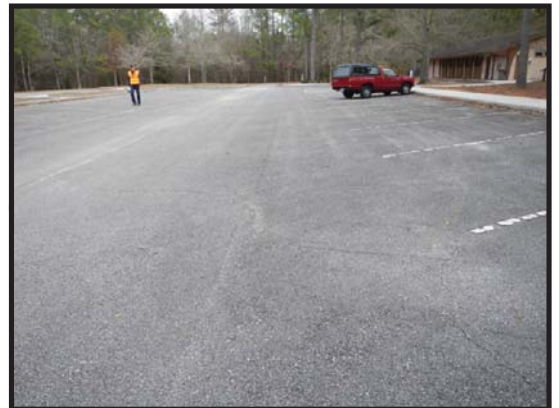
Route 0902

Route Number	Public / NonPublic	Date Visited	Area (sq ft)	Lane Miles *	Surface Type
0901	PUBLIC	2/4/2013	33,977	0.59	AS
Culverts	Drop Inlets	Gates	Curb & Gutter	Curb	PCR
1	0	0	NO CURB AND GUTTER	CONCRETE CURB	POOR/45

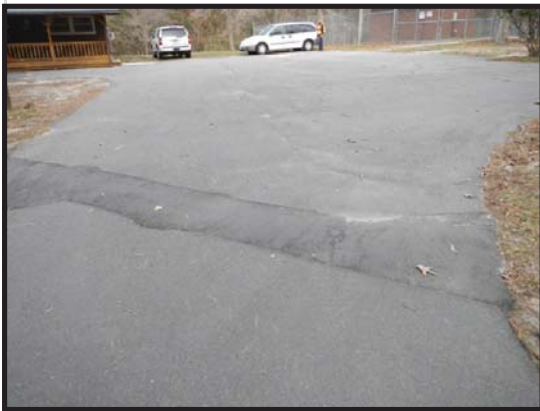
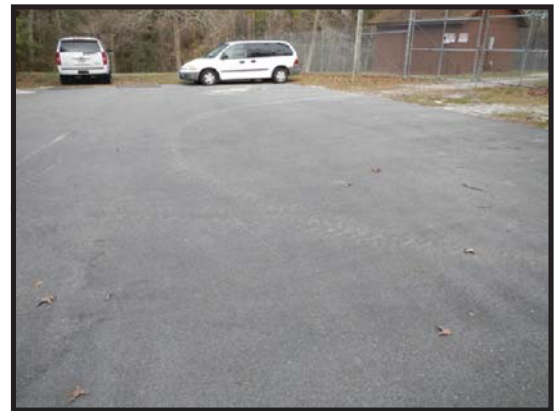
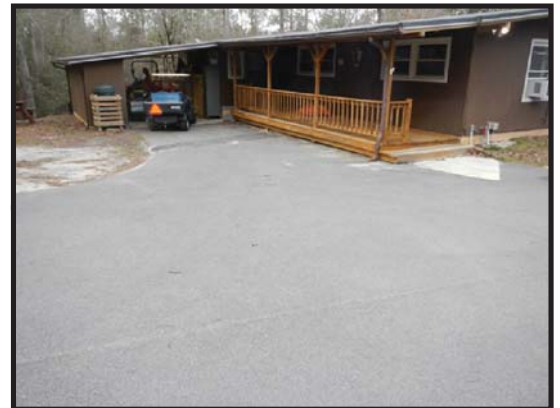
Route 0903

Route Number	Public / NonPublic	Date Visited	Area (sq ft)	Lane Miles *	Surface Type
0902	NONPUBLIC	2/4/2013	5,125	0.09	AS
Culverts	Drop Inlets	Gates	Curb & Gutter	Curb	PCR
0	3	1	NO CURB AND GUTTER	NO CURB	FAIR/73

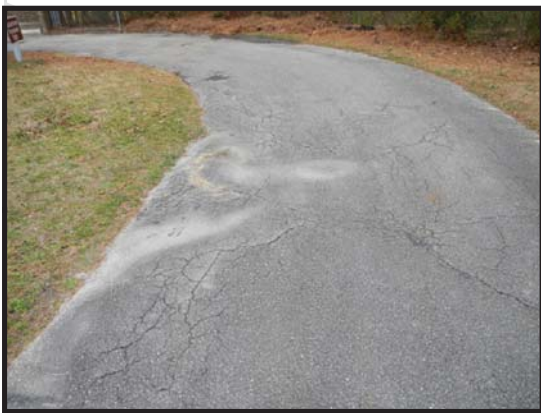
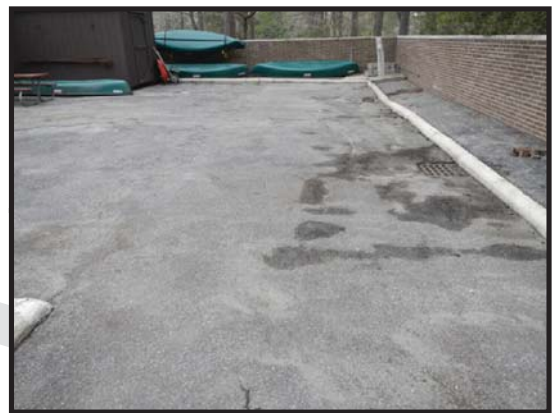
Route Number	Public / NonPublic	Date Visited	Area (sq ft)	Lane Miles *	Surface Type
0903	NONPUBLIC	2/4/2013	3,393	0.06	AS
Culverts	Drop Inlets	Gates	Curb & Gutter	Curb	PCR
0	2	1	NO CURB AND GUTTER	CONCRETE CURB	POOR/45
