Federal Lands Highway Road Inventory Program

Road Inventory and Condition Assessment

Muir Woods National Monument
MUWO - 8180

Cycle 5 Report

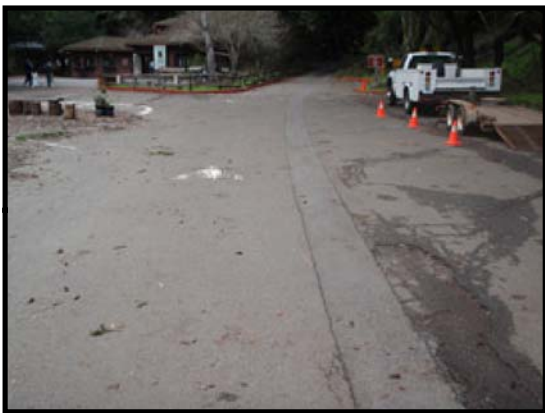
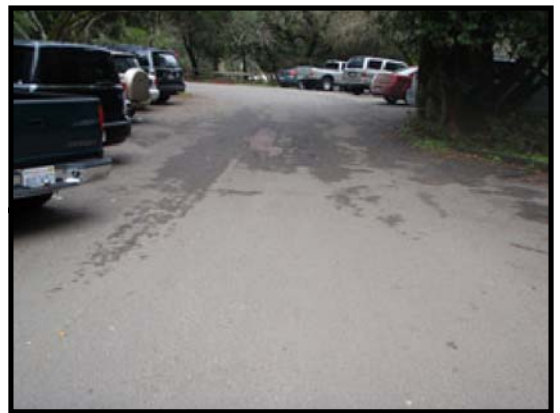
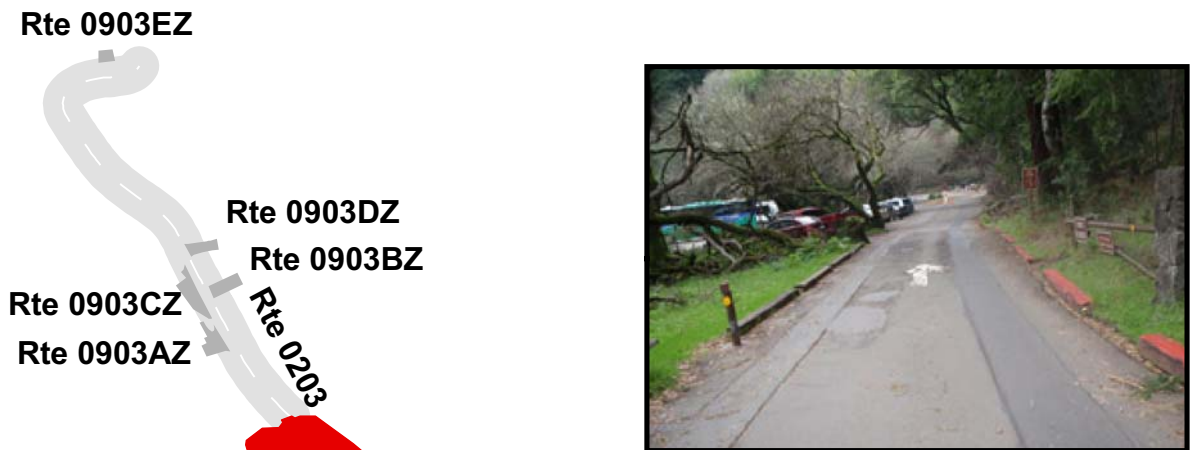
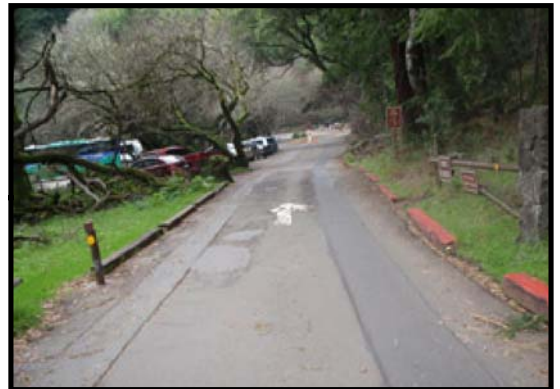
Route 0901

Route Number	Public / NonPublic	Date Visited	Area (sq ft)	Lane Miles *	Surface Type
0901	NONPUBLIC	1/28/2010	13,790	0.24	AS
Culverts	Drop Inlets	Gates	Curb & Gutter	Curb	PCR
0	0	0	NO CURB AND GUTTER	CONCRETE & WOOD CURB	POOR/45

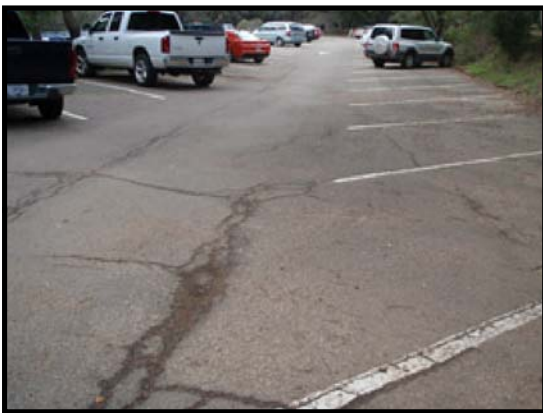
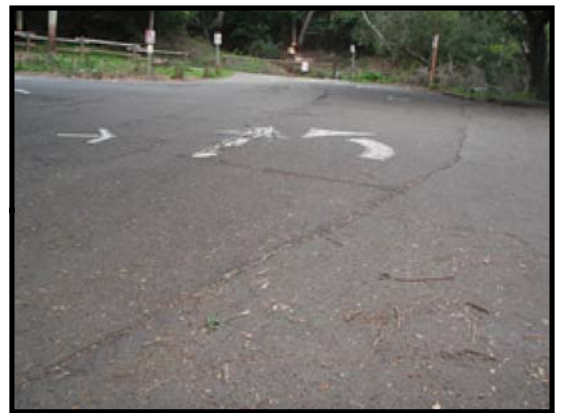
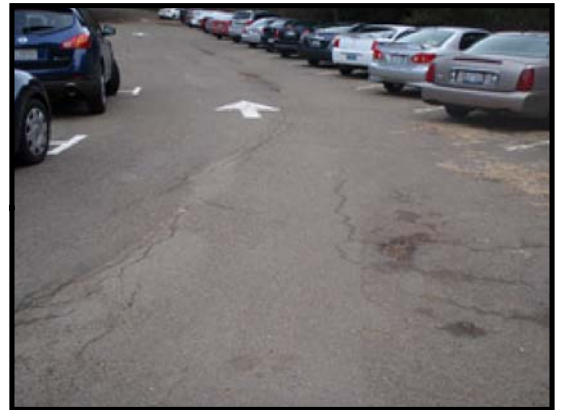
Route 0902

Route Number	Public / NonPublic	Date Visited	Area (sq ft)	Lane Miles *	Surface Type
0902	PUBLIC	1/28/2010	33,860	0.58	AS
Culverts	Drop Inlets	Gates	Curb & Gutter	Curb	PCR
0	0	2	NO CURB AND GUTTER	WOOD CURB	POOR/45

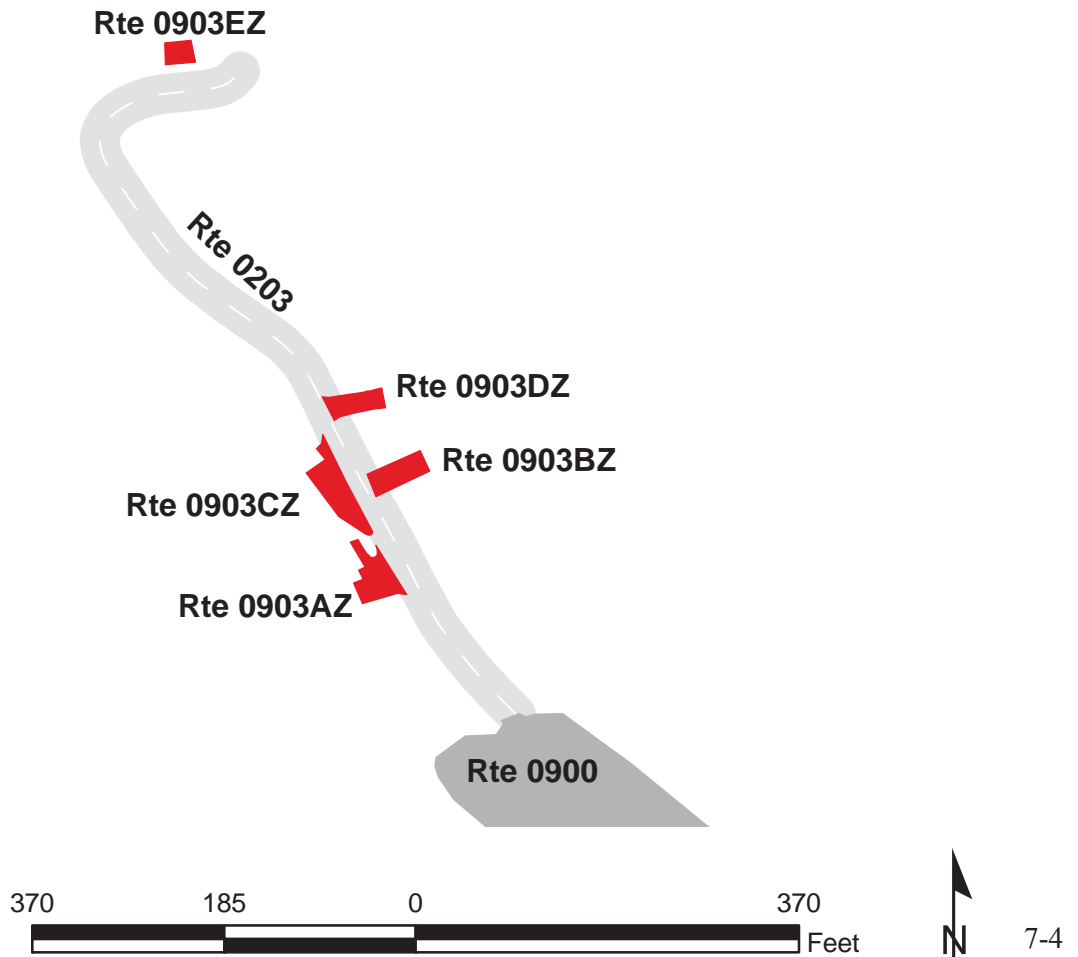
Route 0903ZZ

Route Number	Public / NonPublic	Date Visited	Area (sq ft)	Lane Miles *	Surface Type
0903ZZ	NONPUBLIC	1/28/2010	5,100	0.09	AS
Culverts	Drop Inlets	Gates	Curb & Gutter	Curb	PCR
0	1	0	NO CURB AND GUTTER	ASPHALT, CONCRETE, & WOOD CURB	SUMMARY/48

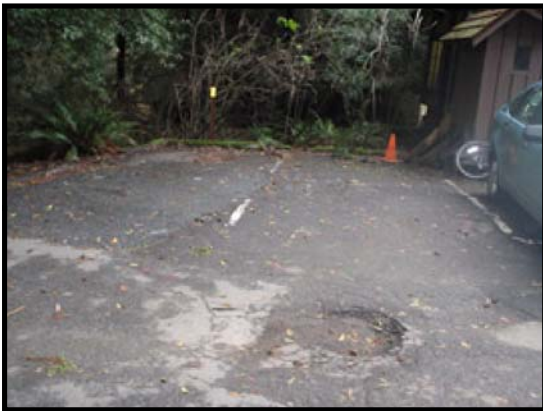
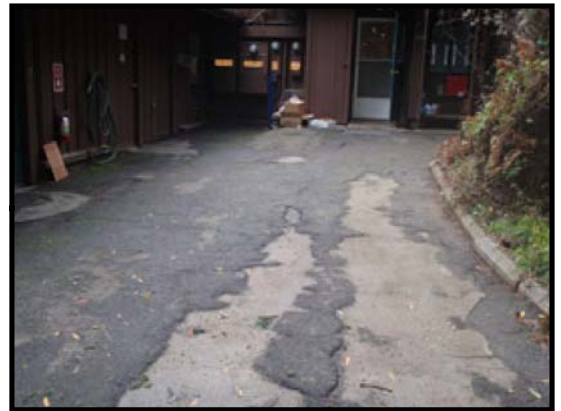
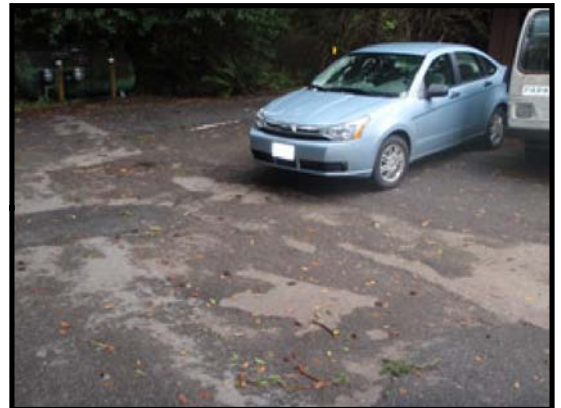
Route 0903AZ

Route Number	Public / NonPublic	Date Visited	Area (sq ft)	Lane Miles *	Surface Type
0903AZ	NONPUBLIC	1/28/2010	1,221	0.02	AS
Culverts	Drop Inlets	Gates	Curb & Gutter	Curb	PCR
0	0	0	NO CURB AND GUTTER	CONCRETE & WOOD CURB	POOR/45

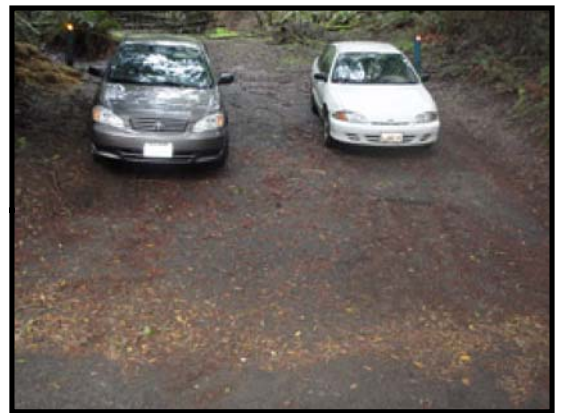
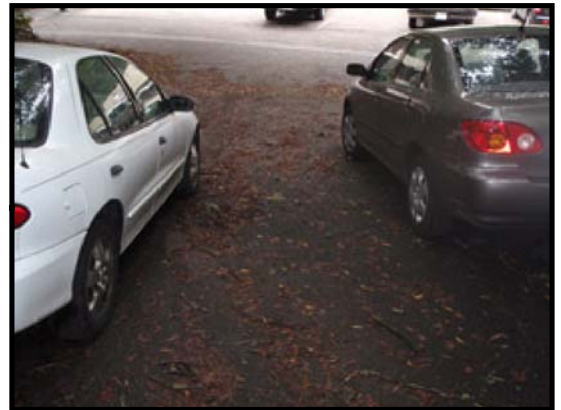
Route 0903BZ

Route Number	Public / NonPublic	Date Visited	Area (sq ft)	Lane Miles *	Surface Type
0903BZ	NONPUBLIC	1/28/2010	1,016	0.02	AS
Culverts	Drop Inlets	Gates	Curb & Gutter	Curb	PCR
0	0	0	NO CURB AND GUTTER	NO CURB	POOR/45

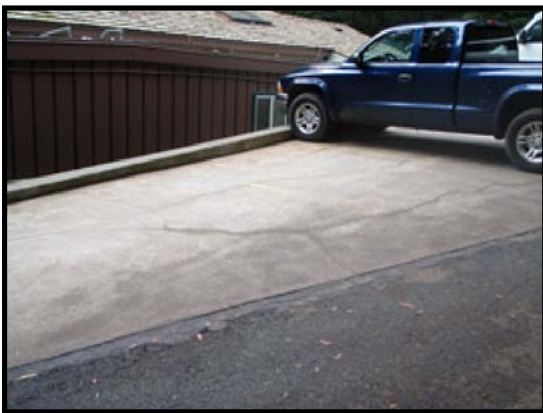
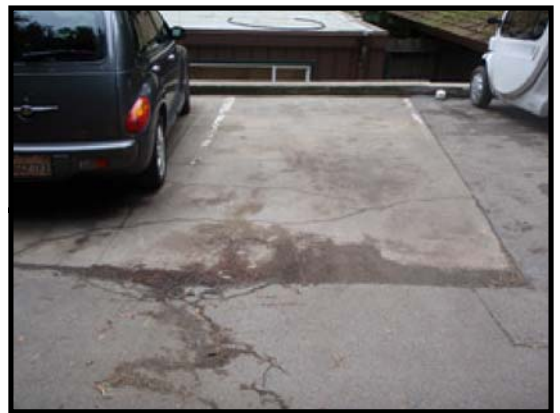
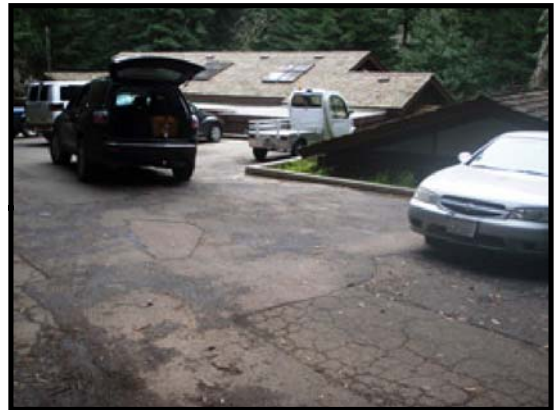
Route 0903CZ

Route Number	Public / NonPublic	Date Visited	Area (sq ft)	Lane Miles *	Surface Type
0903CZ	NONPUBLIC	1/28/2010	1,576	0.03	AS
Culverts	Drop Inlets	Gates	Curb & Gutter	Curb	PCR
0	1	0	NO CURB AND GUTTER	CONCRETE CURB	POOR/45

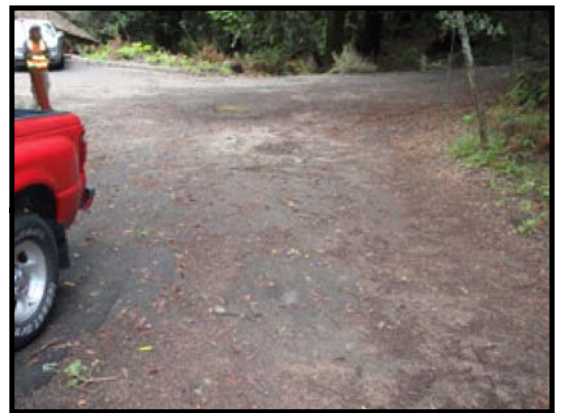
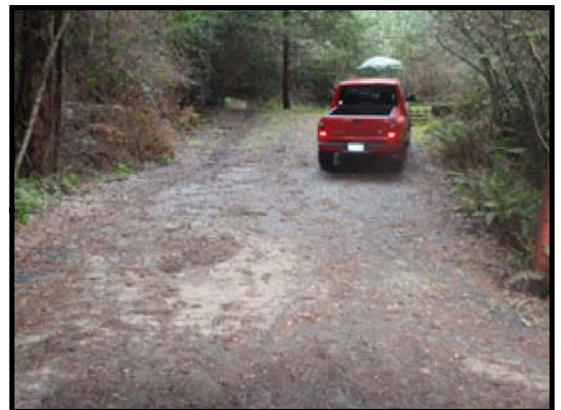
Route 0903DZ

Route Number	Public / NonPublic	Date Visited	Area (sq ft)	Lane Miles *	Surface Type
0903DZ	NONPUBLIC	1/28/2010	836	0.01	AS
Culverts	Drop Inlets	Gates	Curb & Gutter	Curb	PCR
0	0	0	NO CURB AND GUTTER	NO CURB	POOR/45

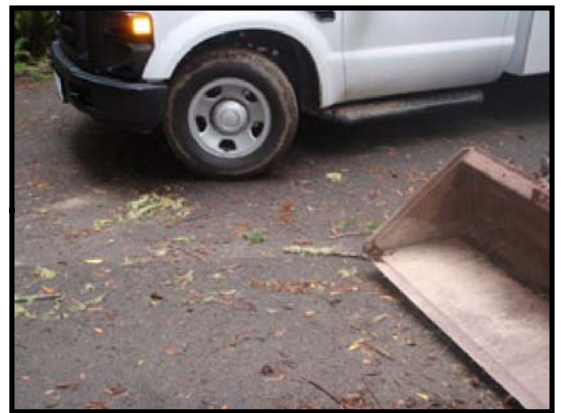
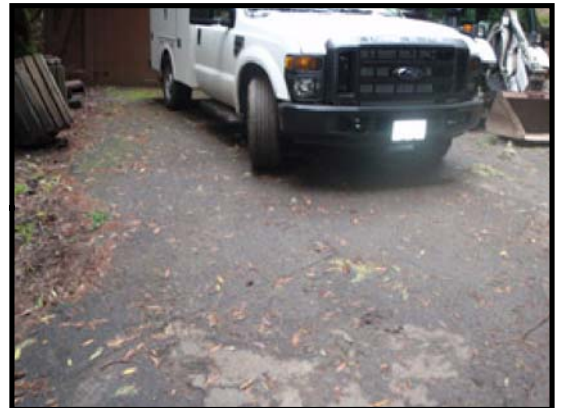
Route 0903EZ

Route Number	Public / NonPublic	Date Visited	Area (sq ft)	Lane Miles *	Surface Type
0903EZ	NONPUBLIC	1/28/2010	451	0.01	AS
Culverts	Drop Inlets	Gates	Curb & Gutter	Curb	PCR
0	0	0	NO CURB AND GUTTER	ASPHALT CURB	FAIR/73
