Road Inventory and Condition Assessment

Natchez National Historical Park NATC - 5565

Cycle 5 Report

Prepared By: Federal Highway Administration

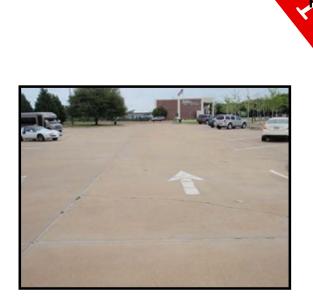
Route 0902

NATCHEZ VISITOR CENTER PARKING

FROM JOHN R. JUNKIN DRIVE (U.S. HIGHWAY 84) AND SOUTH CANAL STREET TO PARKING

| Route | Public / | | | | |
|---|---|---|---|---|---|
| 0902 | PUBLIC | 4/18/2011 | 171,669 | 2.96 | AS |
| 0 | 29 | 0 | AND GUTTER | CURB | FAIR/73 |
