Federal Lands Highway Road Inventory Program

Road Inventory and Condition Assessment

Old Santa Fe Trail Building
OSTB - 7700

Cycle 5 Report

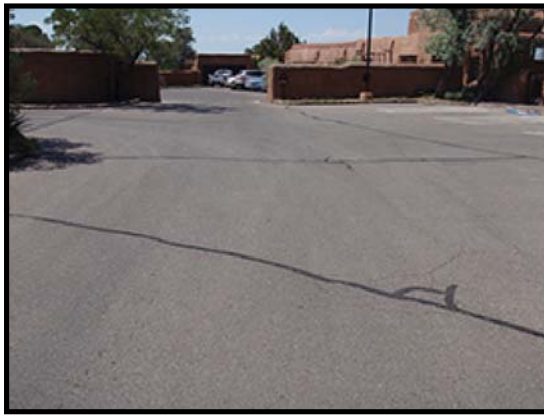
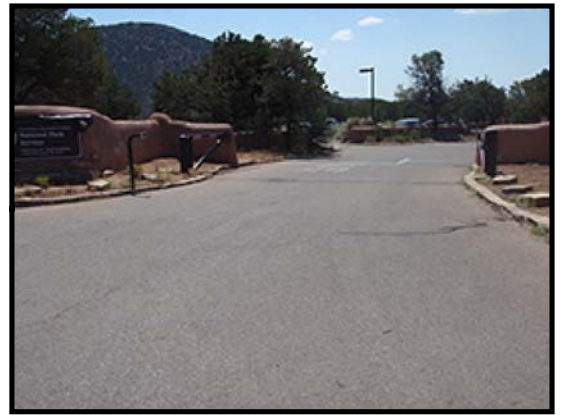
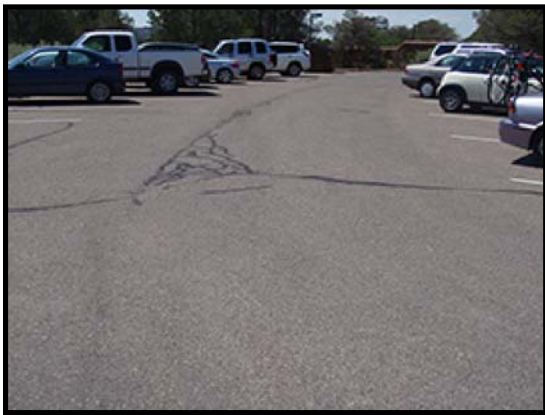
Route 0900

VISITOR PARKING

FROM OLD SANTA FE TRAIL
TO ROUTE 0901 (ADMINISTRATIVE PARKING)

Route Number	Public / NonPublic	Date Visited	Area (sq ft)	Lane Miles *	Surface Type
0900	PUBLIC	8/15/2012	18,271	0.32	AS
Culverts	Drop Inlets	Gates	Curb & Gutter	Curb	PCR
0	0	1	NO CURB AND GUTTER	STONE CURB	FAIR/73

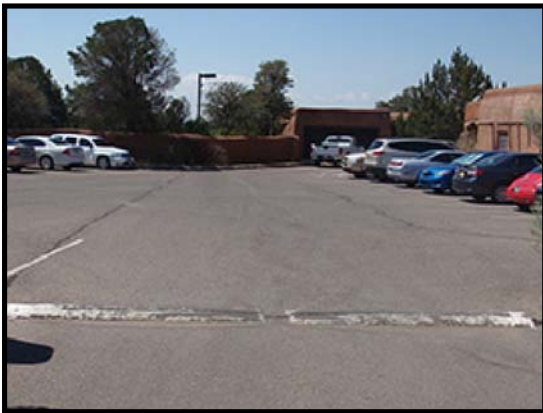
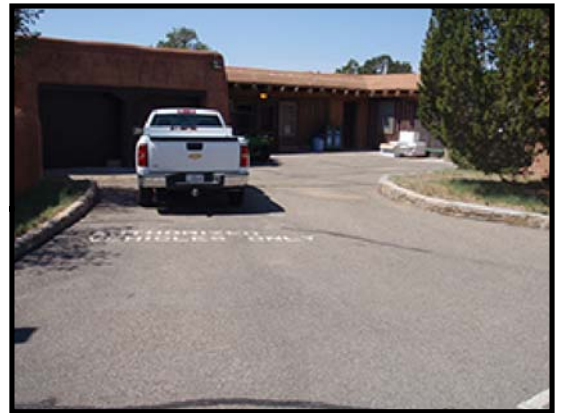
Route 0901

ADMINISTRATIVE PARKING
FROM ROUTE 0900 (VISITOR PARKING)
TO PARKING

Route Number	Public / NonPublic	Date Visited	Area (sq ft)	Lane Miles *	Surface Type
0901	NONPUBLIC	8/15/2012	12,175	0.21	AS
Culverts	Drop Inlets	Gates	Curb & Gutter	Curb	PCR
0	2	0	NO CURB AND GUTTER	STONE CURB	FAIR/73

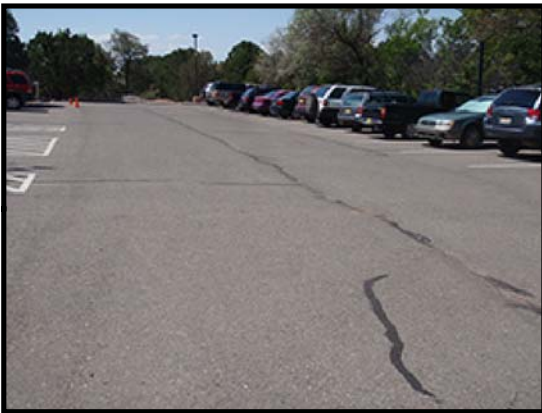
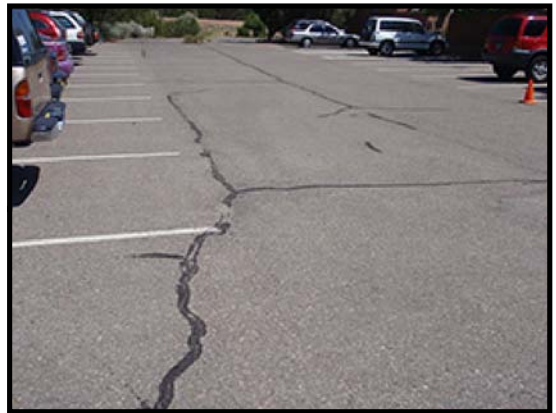
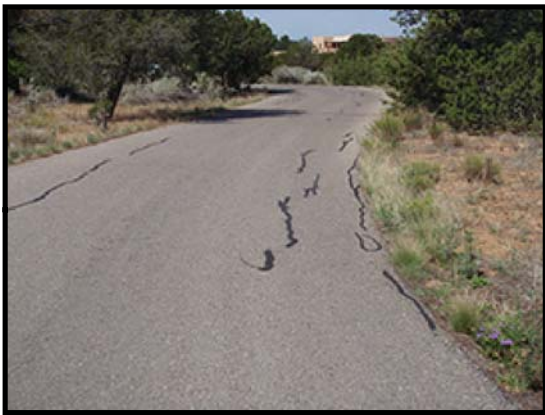
Route 0902

REAR ADMINISTRATIVE PARKING
FROM ROUTE 0900 (VISITOR PARKING)
TO PARKING

Route Number	Public / NonPublic	Date Visited	Area (sq ft)	Lane Miles *	Surface Type
0902	NONPUBLIC	8/15/2012	16,871	0.29	AS
Culverts	Drop Inlets	Gates	Curb & Gutter	Curb	PCR
1	0	0	NO CURB AND GUTTER	NO CURB	FAIR/73
