Road Inventory and Condition Assessment

Pu'uhonua o Honaunau National Historical Park PUHO

Updated Cycle 5 Report

Prepared By: Federal Highway Administration
Road Inventory Program (RIP)
Data Collected: 04/2014
Report Date: 09/2014

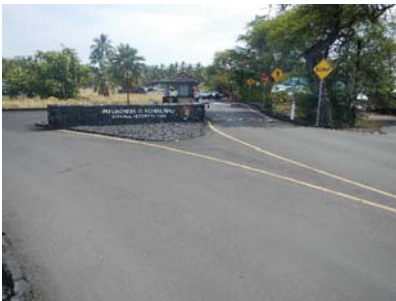
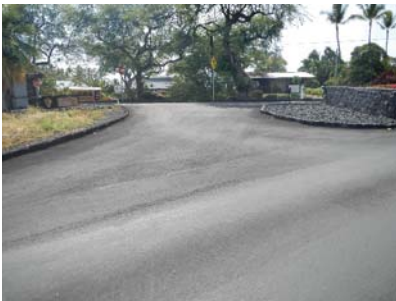
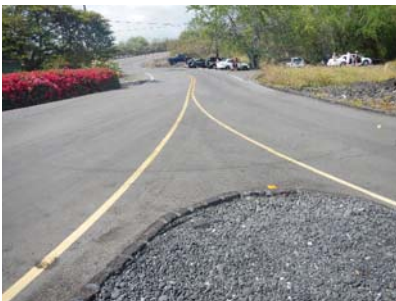
Inspection Date	FMSS Number	User Access
4/7/2014	50243	PUBLIC
Surface Type	Area (Sq. Ft.)	Lane Miles (11' Widths)
ASPHALT	8,017	0.138
Culverts	Drop Inlets	Gates
0	0	2
Pavement Recommendation		Condition Rating / PCR
PREVENTIVE MAINTENANCE		GOOD / 90
Route Condition Legend – Pavement Condition Rating (PCR) Poor (0 - 60) Fair (61 - 84) Good (85 - 94) Excellent (95 - 100) Not Rated		
See Appendix for definitions and formulas

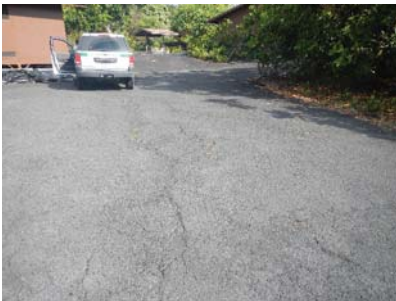
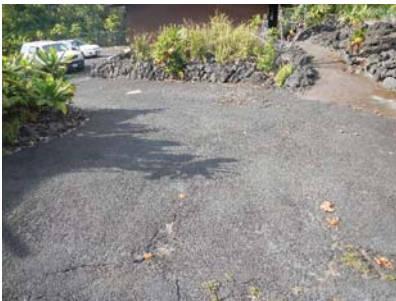
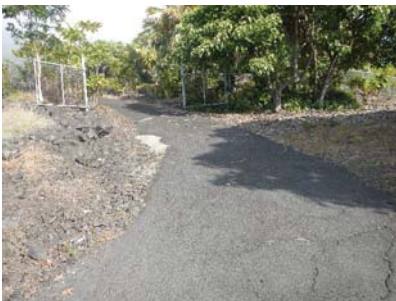
ROUTE 0401: UPLAND GARDEN ROAD

Inspection Date	FMSS Number	User Access
4/7/2014	50222	NONPUBLIC
Surface Type	Area (Sq. Ft.)	Lane Miles (11' Widths)
ASPHALT	7,218	0.124
Culverts	Drop Inlets	Gates
0	0	1
Pavement Recommendation		Condition Rating / PCR
RECONSTRUCTION		POOR / 30
Route Condition Legend – Pavement Condition Rating (PCR) Poor (0 - 60) Fair (61 - 84) Good (85 - 94) Excellent (95 - 100) Not Rated		
See Appendix for definitions and formulas

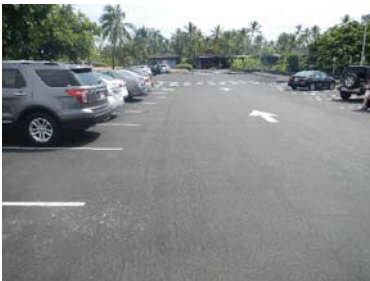
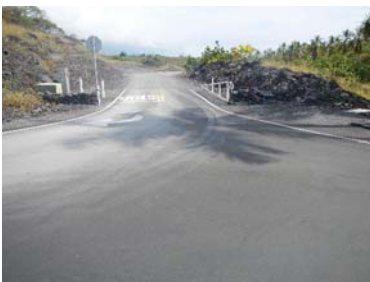
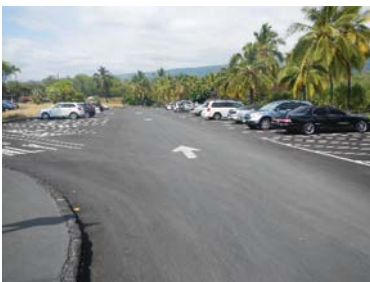
Inspection Date	FMSS Number	User Access	Surface Type
4/7/2014	50236	PUBLIC	ASPHALT
Area (Sq. Ft.)	Lane Miles (11' Widths)	Curb Reveal (Inches)	Curb Recommendation
42,506	0.732	3	LIGHT REPAIR
Curb Type		Curb & Gutter Type	
STONE		NO CURB AND GUTTER	
Culverts	Drop Inlets	Gates	
0	4	1	
Pavement Recommendation		Condition Rating / PCR	
PREVENTIVE MAINTENANCE		GOOD / 90
