Federal Lands Highway Road Inventory Program

Road Inventory and Condition Assessment

Richmond National Battlefield Park RICH

Cycle 5 Report

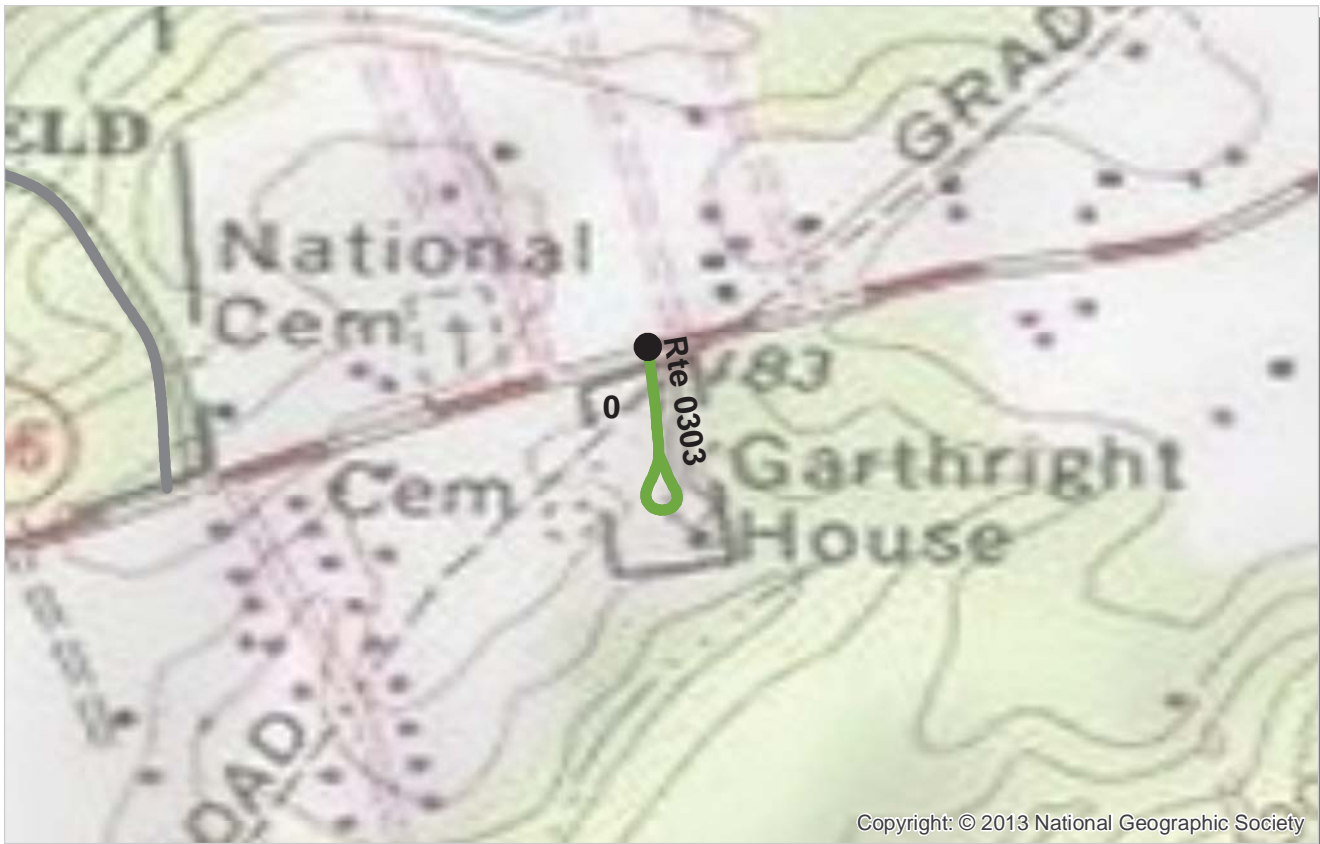
ROUTE: 0303 GARTHRIGHT HOUSE ROAD

Section Number	0				
Section Length (mi)	0.11				
Cross Section Information					
Number of Lanes	1				
Paved Width (ft)	12				
Lane Width (ft)	12				
Roadway Condition Information					
SCR (Surface Condition Rating)	86				
PCR (Pavement Condition Rating)	86				
Distress Index Values					
Structural Crack Index	100				
Transverse Cracking Index	100				
Patching Index	100				
Rutting Index	86				
Roughness Condition Index (RCI)	NC

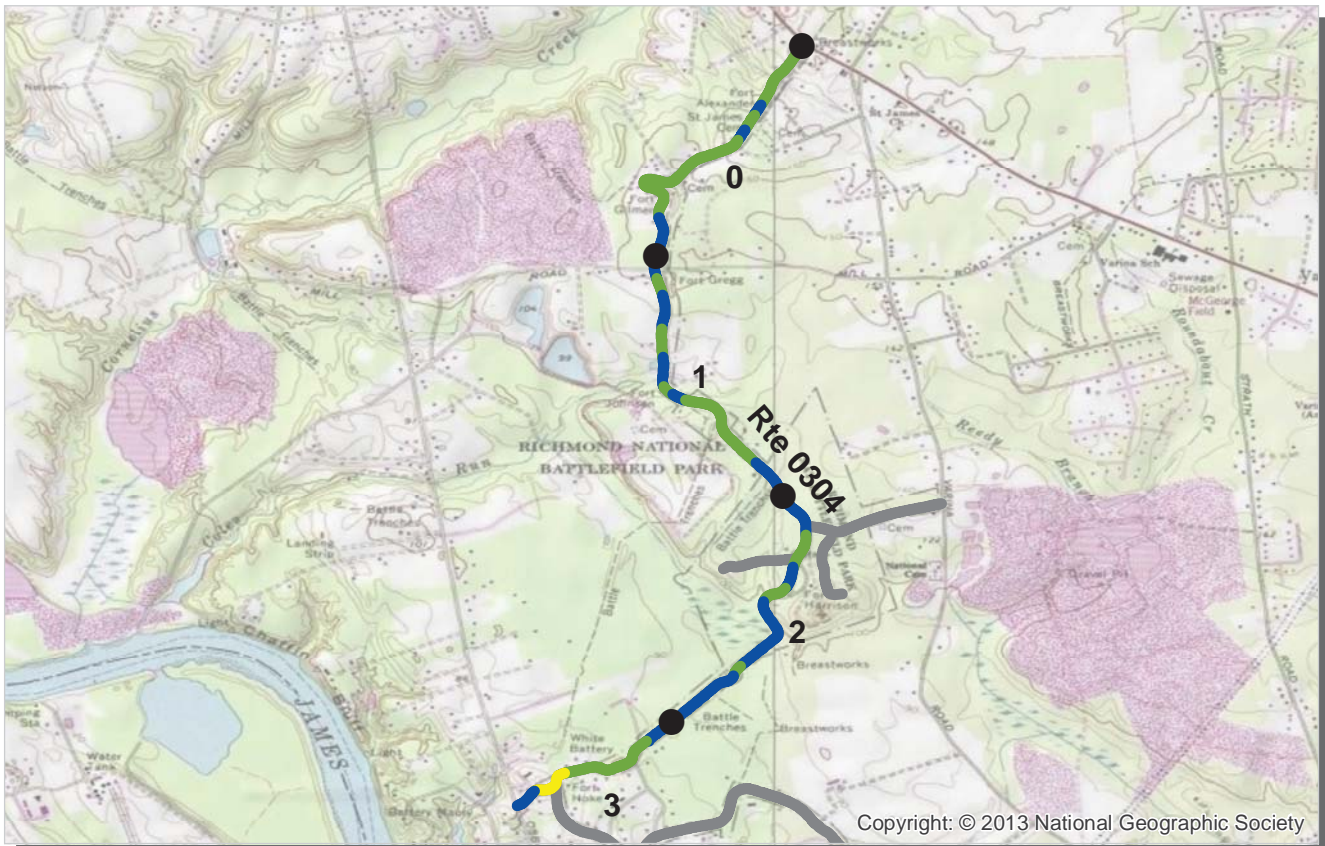
ROUTE: 0304 BATTLEFIELD PARK ROAD

<i>Section Number</i>	0	1	2	3	
<i>Section Length (mi)</i>	1.00	1.00	1.00	0.57	
<i>Cross Section Information</i>					
Number of Lanes	2	2	2	2	
Paved Width (ft)	18	18	19	18	
Lane Width (ft)	9	9	9	9	
<i>Roadway Condition Information</i>					
SCR (Surface Condition Rating)	97	97	99	96	
PCR (Pavement Condition Rating)	91	93	97	89	
<i>Distress Index Values</i>					
Structural Crack Index	100	100	100	100	
Transverse Cracking Index	100	100	100	100	
Patching Index	100	100	100	100	
Rutting Index	97	97	99	96	
Roughness Condition Index (RCI)	82	88	95	78

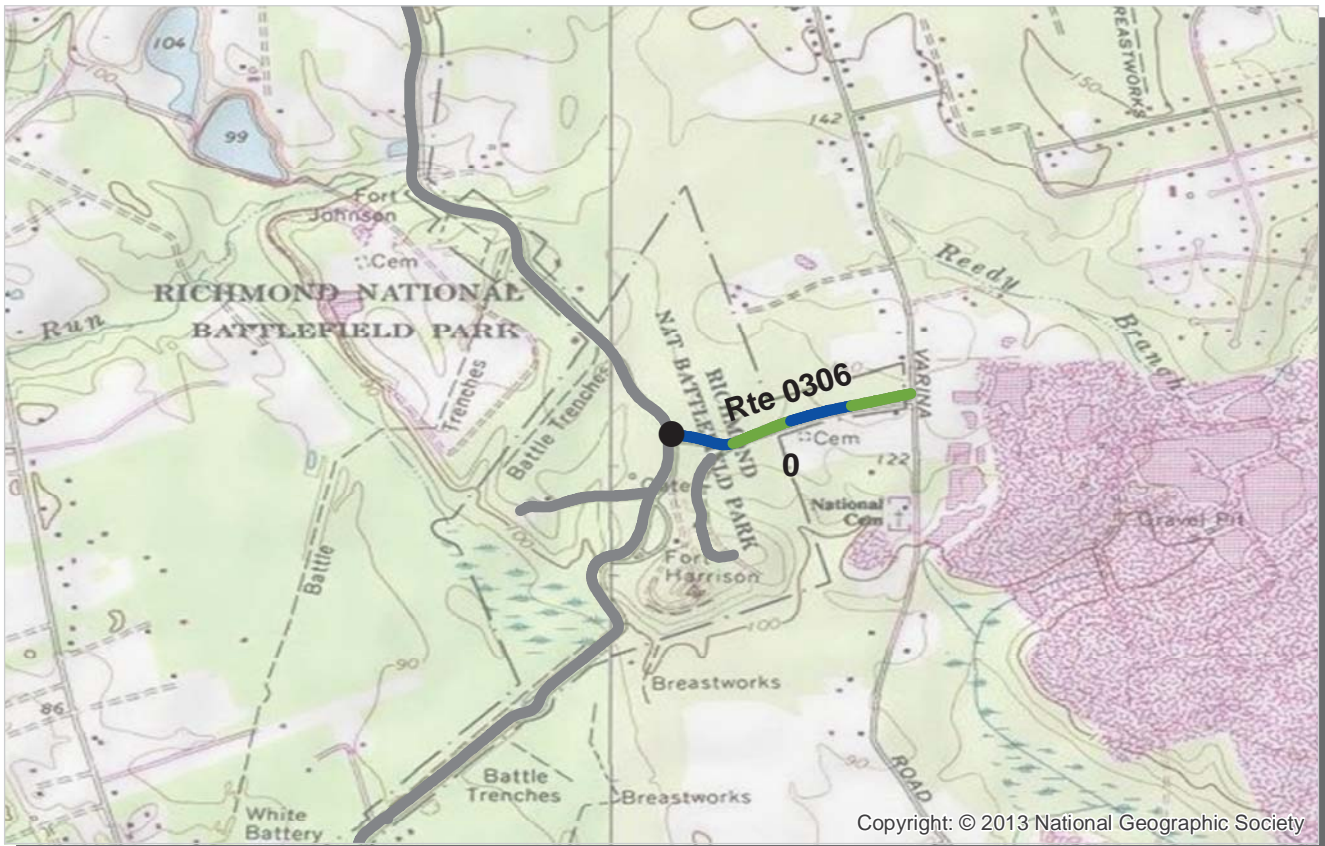
ROUTE: 0306 PICNIC ROAD

Section Number	0				
Section Length (mi)	0.39				
Cross Section Information					
Number of Lanes	2				
Paved Width (ft)	18				
Lane Width (ft)	9				
Roadway Condition Information					
SCR (Surface Condition Rating)	96				
PCR (Pavement Condition Rating)	96				
Distress Index Values					
Structural Crack Index	100				
Transverse Cracking Index	100				
Patching Index	100				
Rutting Index	96				
Roughness Condition Index (RCI)	NC

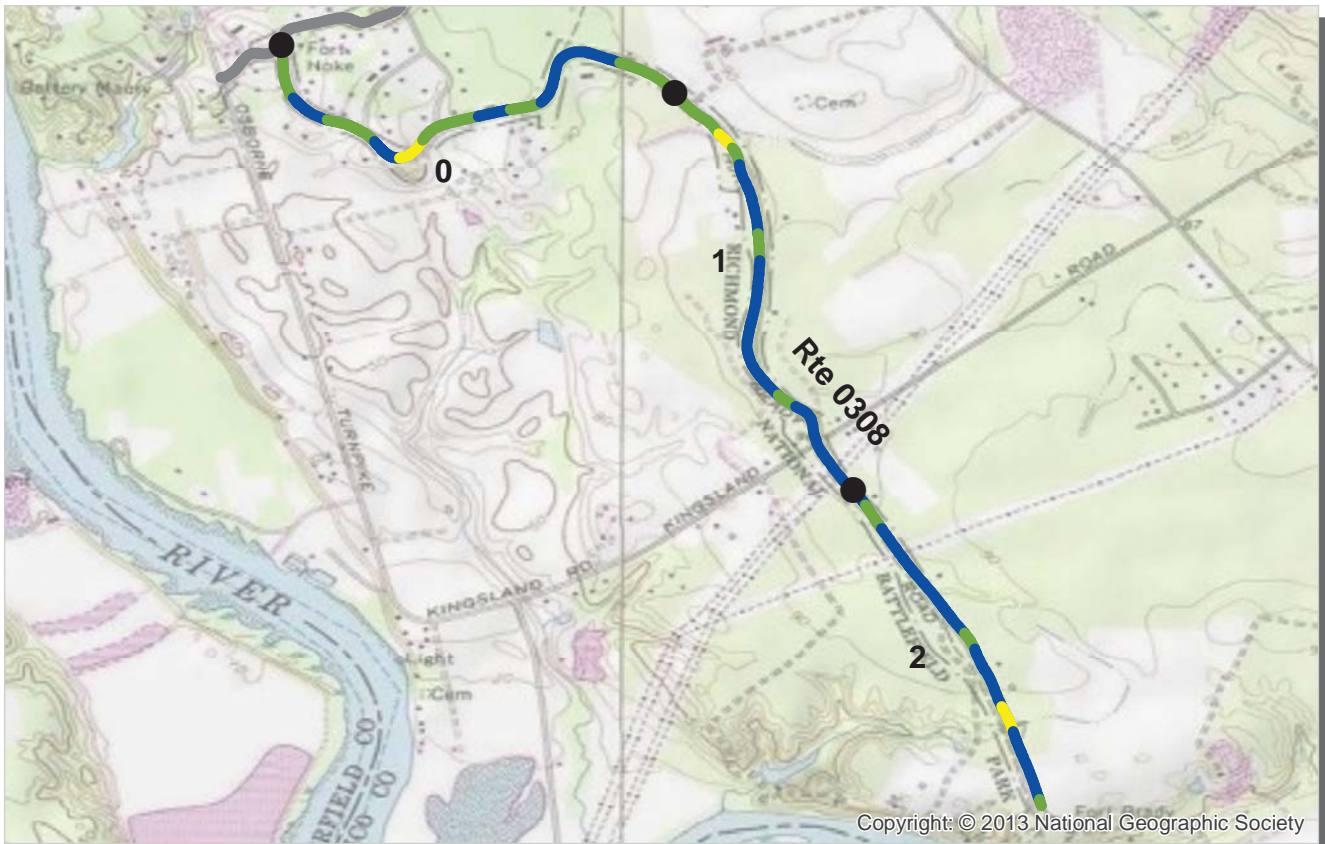
ROUTE: 0308 HOKE BRADY ROAD

Section Number	0	1	2		
Section Length (mi)	1.00	1.00	0.79		
Cross Section Information					
Number of Lanes	2	2	2		
Paved Width (ft)	17	18	18		
Lane Width (ft)	9	9	9		
Roadway Condition Information					
SCR (Surface Condition Rating)	96	97	97		
PCR (Pavement Condition Rating)	92	93	95		
Distress Index Values					
Structural Crack Index	100	100	100		
Transverse Cracking Index	100	100	100		
Patching Index	100	100	100		
Rutting Index	96	97	97		
Roughness Condition Index (RCI)	87	87	93

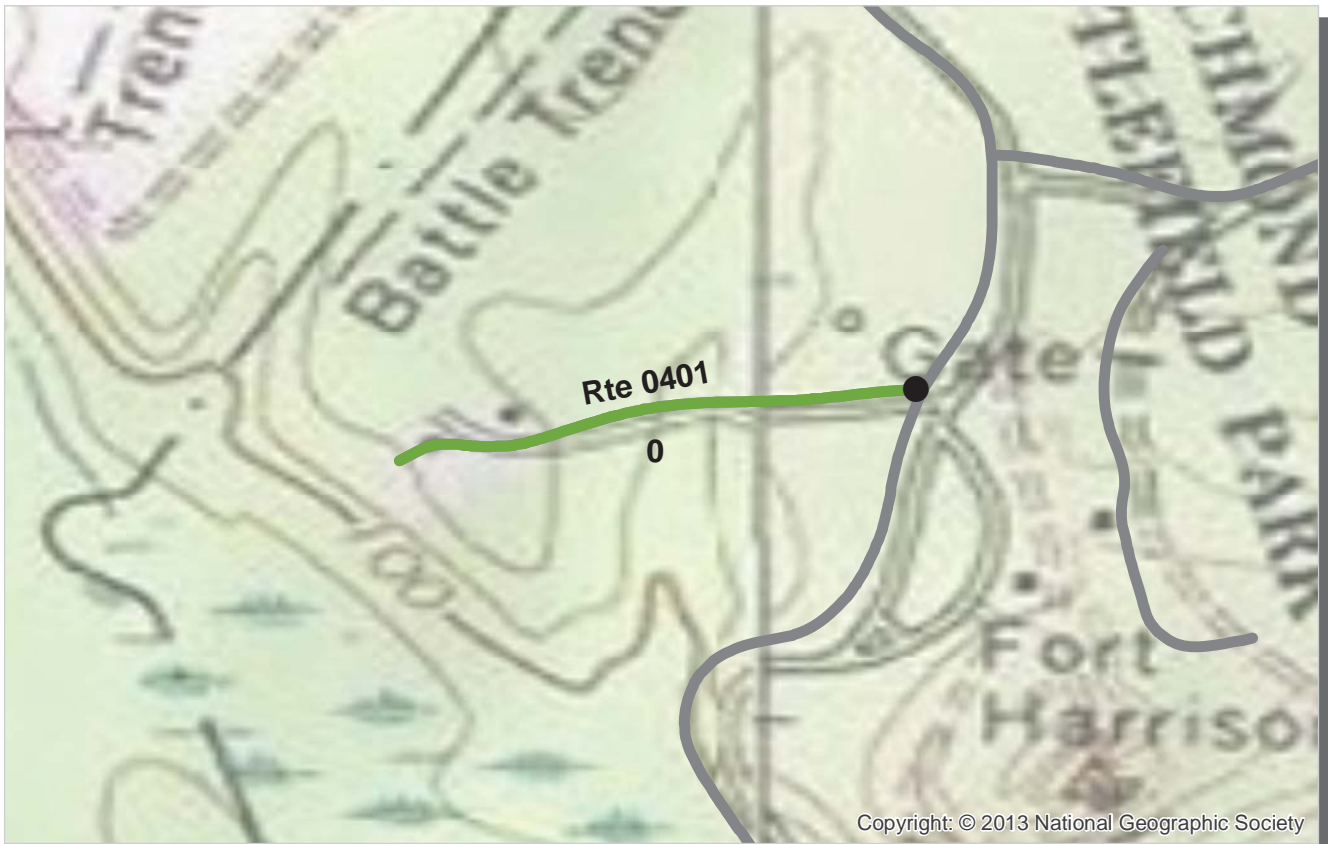
ROUTE: 0401 MAINTENANCE WAY

Section Number	0				
Section Length (mi)	0.21				
Cross Section Information					
Number of Lanes	2				
Paved Width (ft)	16				
Lane Width (ft)	8				
Roadway Condition Information					
SCR (Surface Condition Rating)	89				
PCR (Pavement Condition Rating)	89				
Distress Index Values					
Structural Crack Index	100				
Transverse Cracking Index	100				
Patching Index	100				
Rutting Index	89				
Roughness Condition Index (RCI)	NC

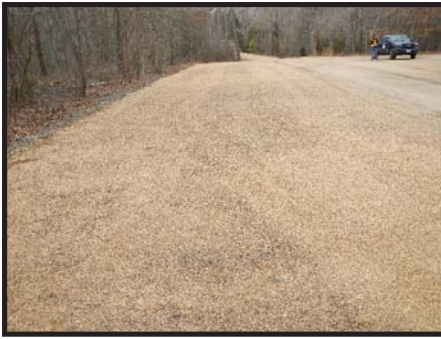
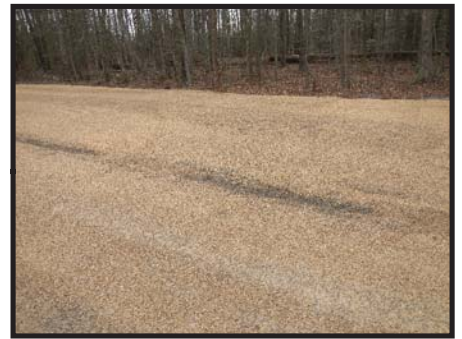
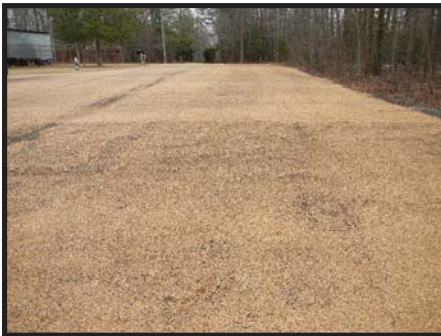
Route 0915

NOTE: Pavement condition unable to be assessed due to gravel covering the paved surface.

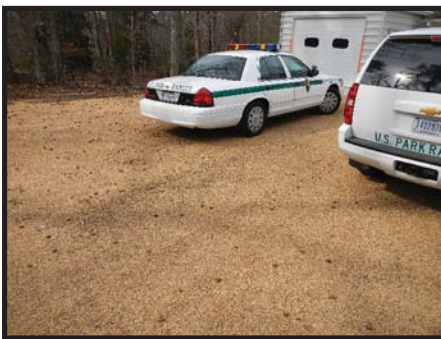
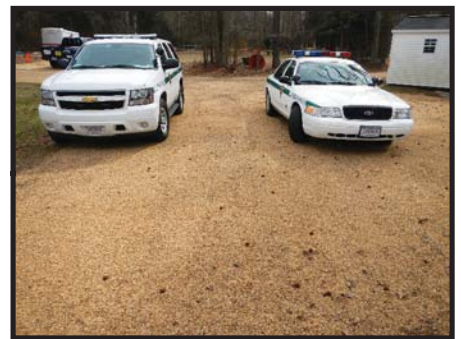
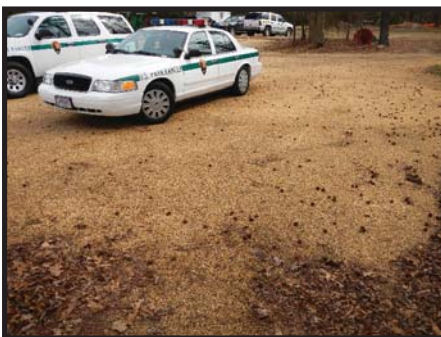
Route 0917

NOTE: Pavement condition unable to be assessed due to gravel covering the paved surface.

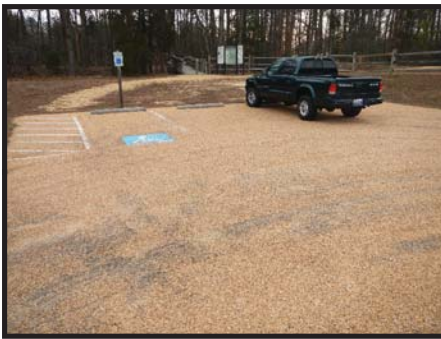
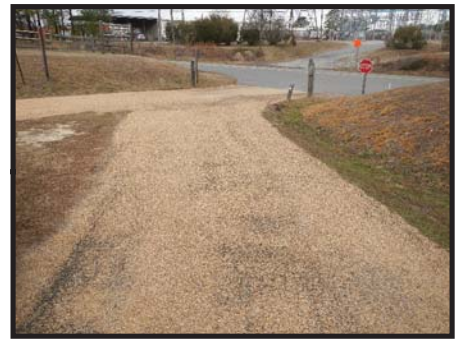
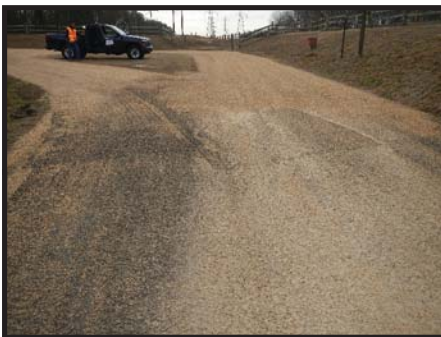
Route 0920

NOTE: Pavement condition unable to be assessed due to gravel covering the paved surface.

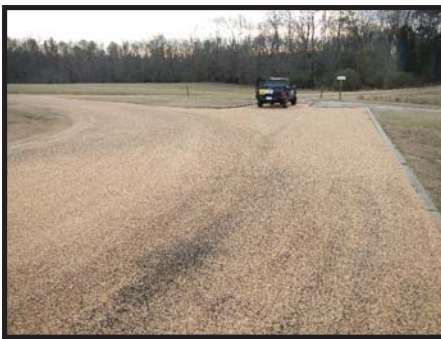
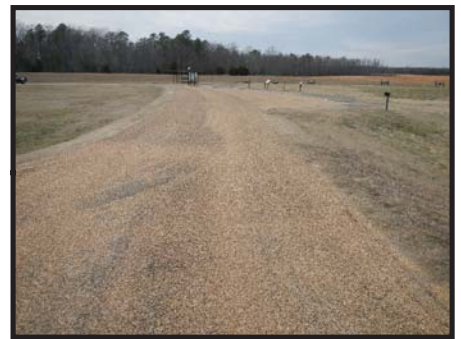
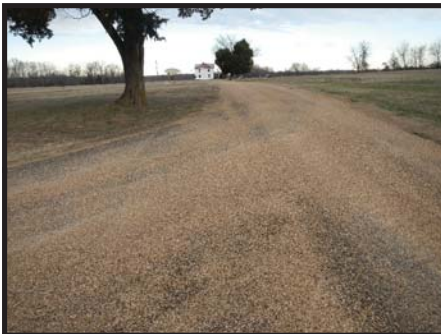
Route 0922

NOTE: Pavement condition unable to be assessed due to gravel covering the paved surface.

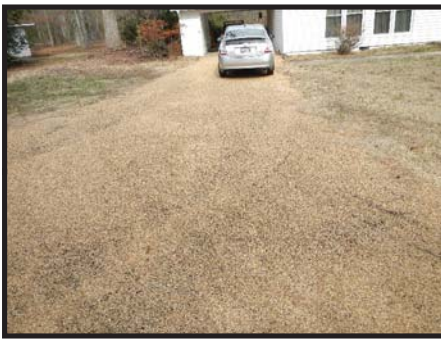
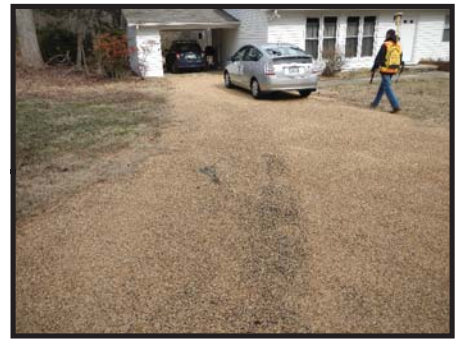
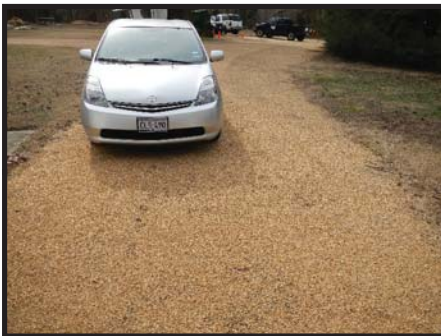
NOTE: Pavement condition unable to be assessed due to gravel covering the paved surface.
