Federal Lands Highway Road Inventory Program

Road Inventory and Condition Assessment

Saint Croix Island International Historic Site SACR

Cycle 5 Report

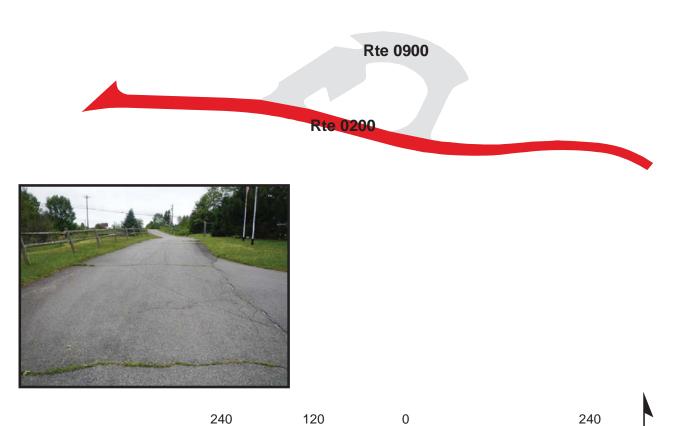
SAINT CROIX ISLAND INTERNATIONAL HISTORIC SITE Route 0200

SAINT CROIX ISLAND IHS ACCESS ROAD FROM ST CROIX DRIVE TO END OF PAVEMENT

Route	Public /				
Number	NonPublic	Date Visited	Area (sq ft)	Lane Miles *	Surface Type
0200	PUBLIC	6/26/2013	8,433	0.15	AS
Culverts	Drop Inlets	Gates	Curb & Gutter	Curb	PCR
			NO CURB AND		
1	0	1	GUTTER	NO CURB	POOR/45
