Federal Lands Highway Road Inventory Program

Road Inventory and Condition Assessment

San Juan National Historic Site SAJU

Cycle 5 Report

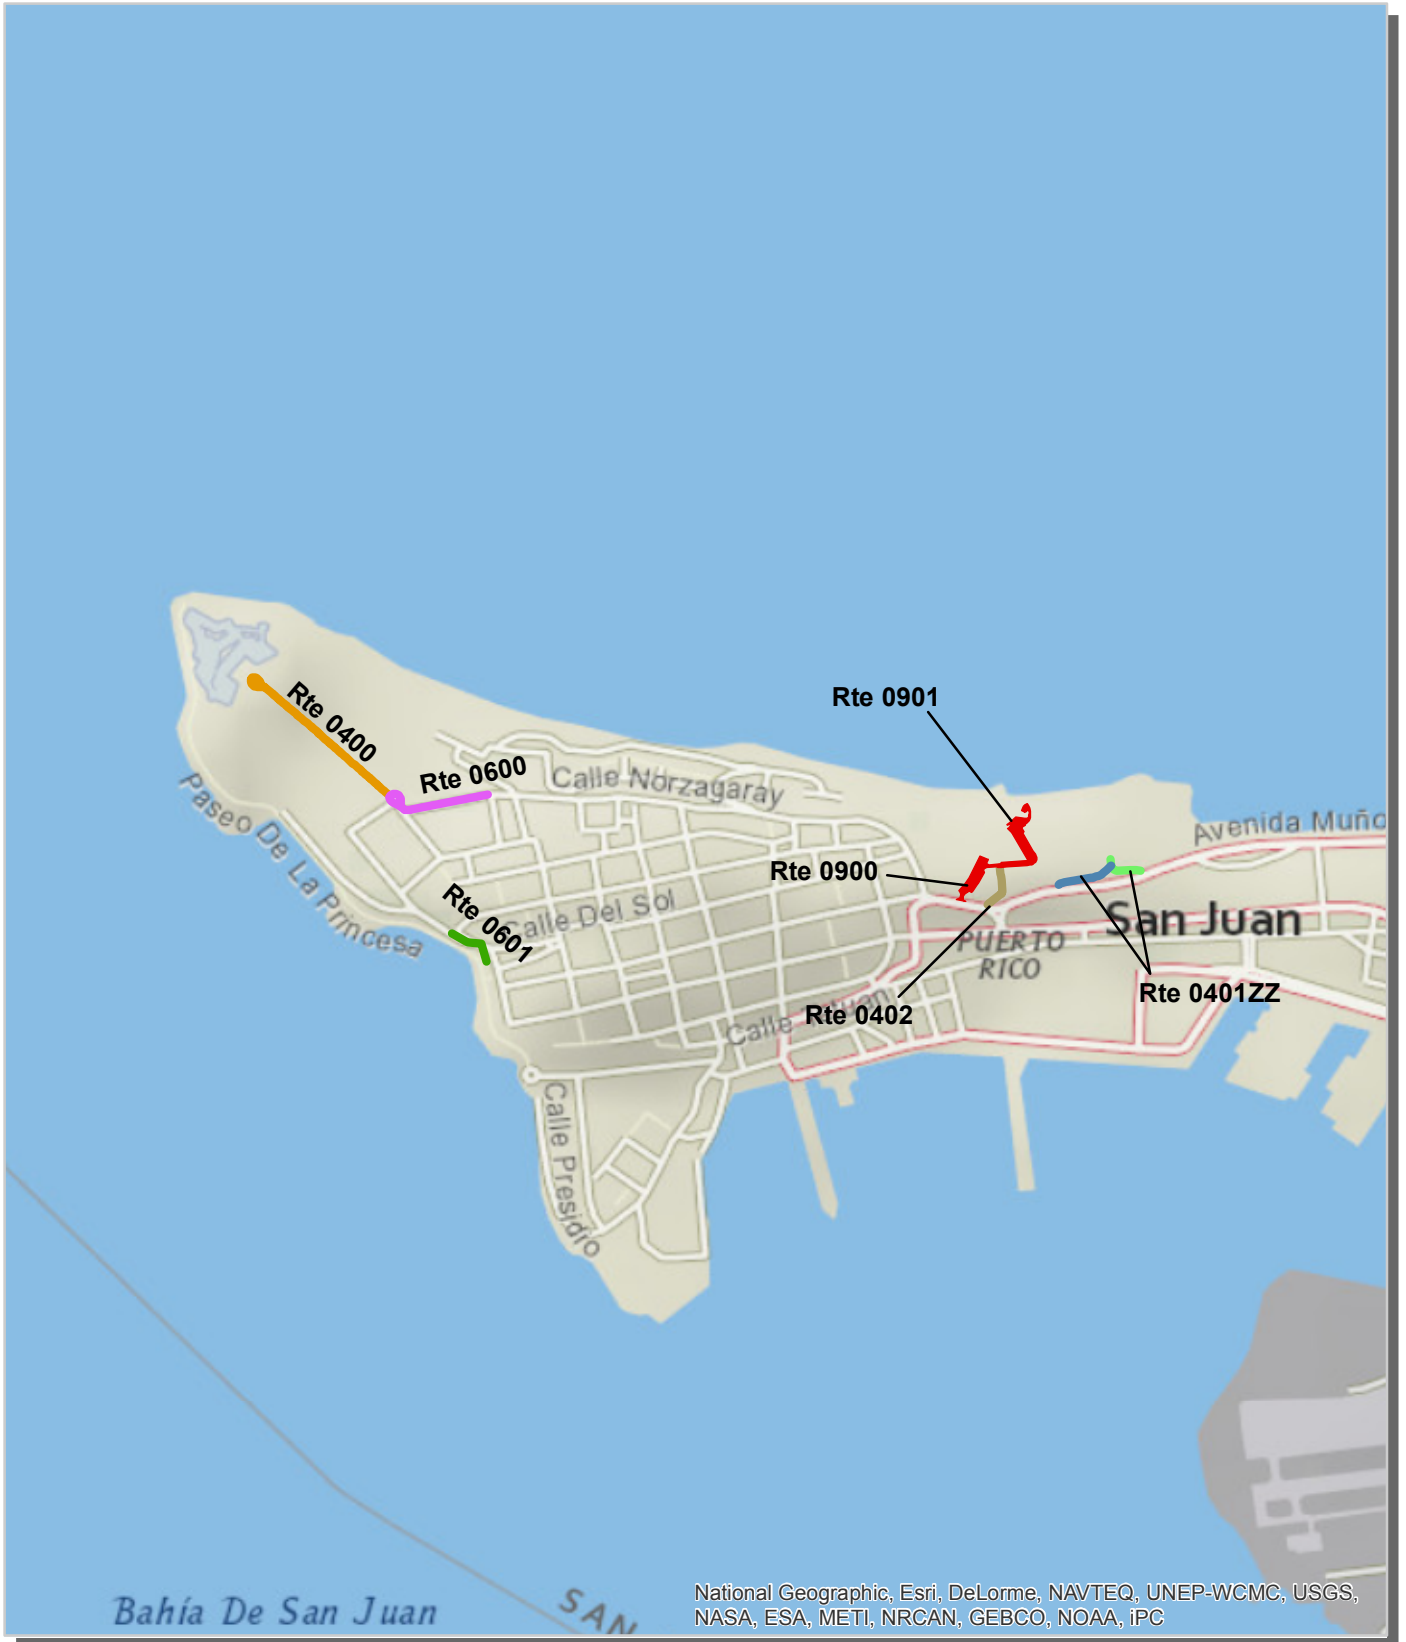
San Juan National Historic Site Route Location Map Area 1

Unique colors used to differentiate routes

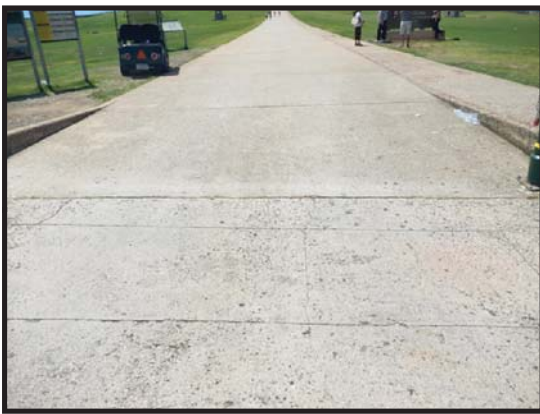
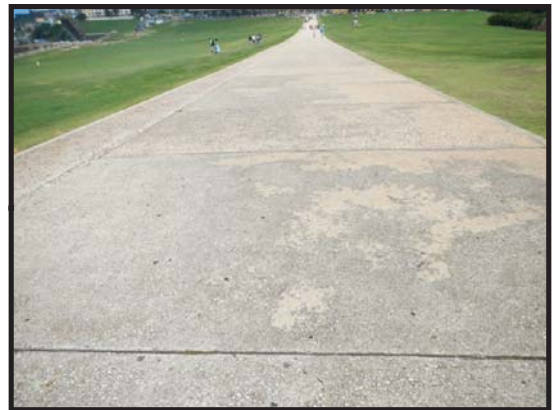
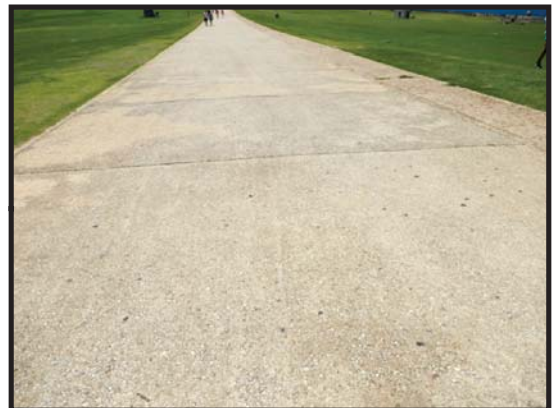
Route 0400

EL MORRO ADMINISTRATIVE ROAD

Route Number	Public / NonPublic	Date Visited	Area (sq ft)	Lane Miles *	Paved Length (mi)	Paved Width (ft)
0400	NONPUBLIC	5/17/2013	30,920	0.53	0.24	24
Culverts	Drop Inlets	Gates	Curb & Gutter	Curb	PCR	Surface Type
0	0	1	NO CURB AND GUTTER	NO CURB	FAIR/73	CO

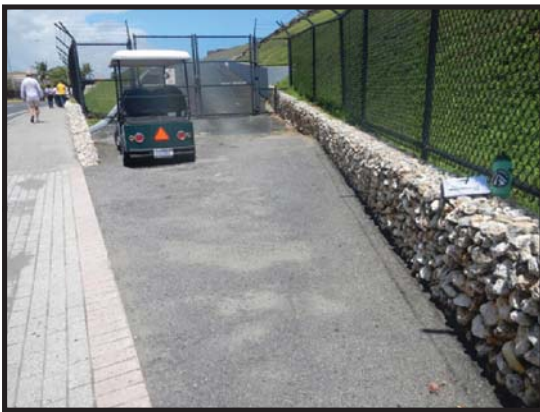
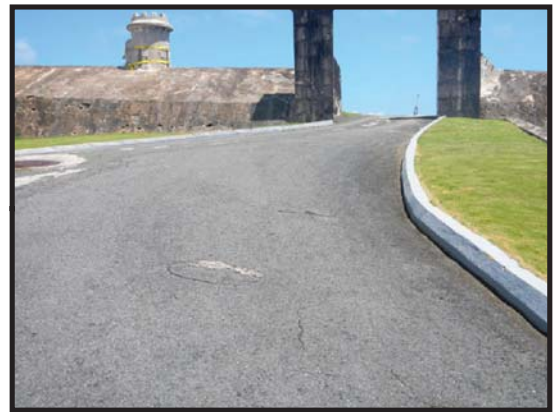
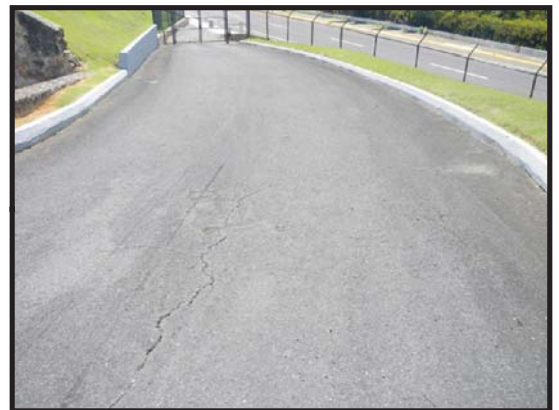
Route 0401AZ

ADMINISTRATIVE ACCESS ROAD A

Route Number	Public / NonPublic	Date Visited	Area (sq ft)	Lane Miles *	Paved Length (mi)	Paved Width (ft)
0401AZ	NONPUBLIC	5/17/2013	4,129	0.07	0.05	17
Culverts	Drop Inlets	Gates	Curb & Gutter	Curb	PCR	Surface Type
0	0	1	NO CURB AND GUTTER	CONCRETE CURB	POOR/45	AS

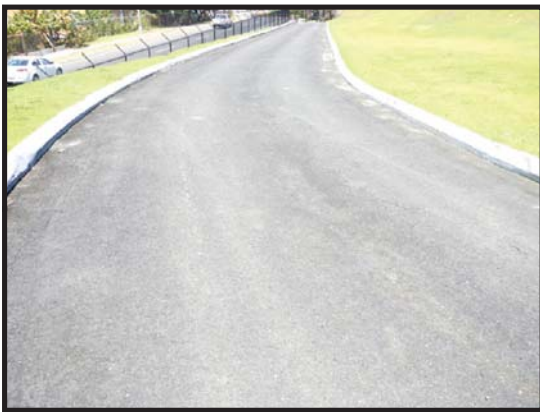
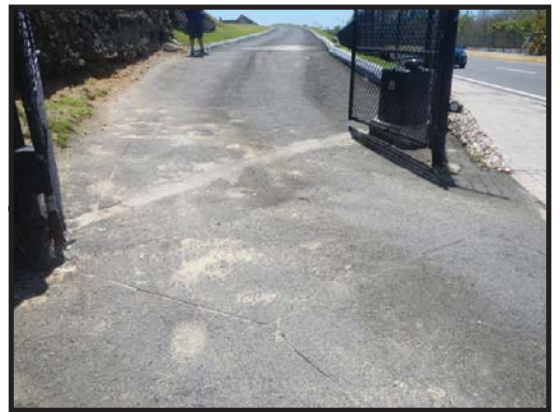
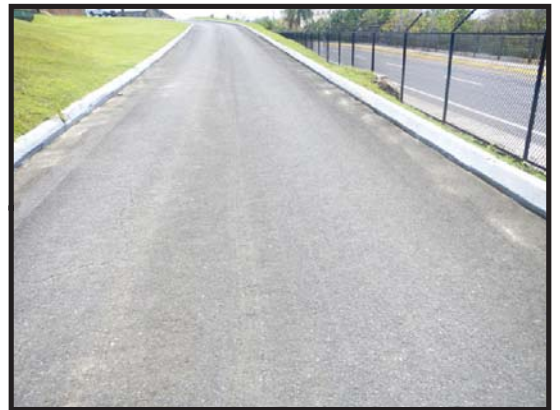
Route 0401BZ

ADMINISTRATIVE ACCESS ROAD B
 FROM ROUTE 0401AZ (ADMINISTRATIVE ACCESS ROAD A)
 TO MUNOZ RIVERA

Route Number	Public / NonPublic	Date Visited	Area (sq ft)	Lane Miles *	Paved Length (mi)	Paved Width (ft)
0401BZ	NONPUBLIC	5/17/2013	4,308	0.07	0.07	12
Culverts	Drop Inlets	Gates	Curb & Gutter	Curb	PCR	Surface Type
0	0	1	NO CURB AND GUTTER	CONCRETE CURB	FAIR/73	AS

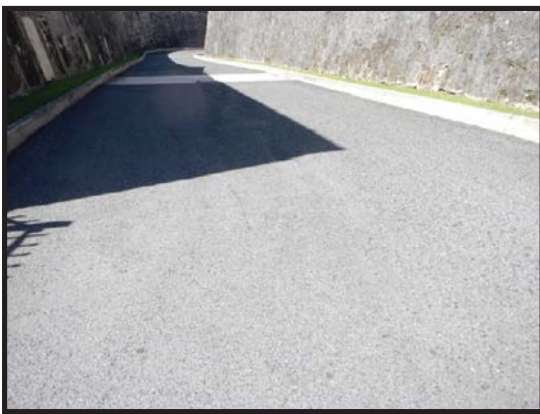
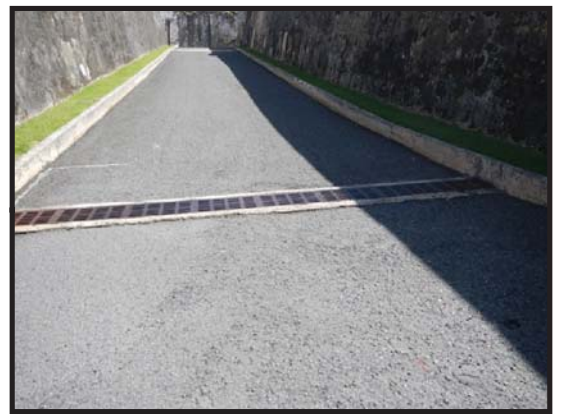
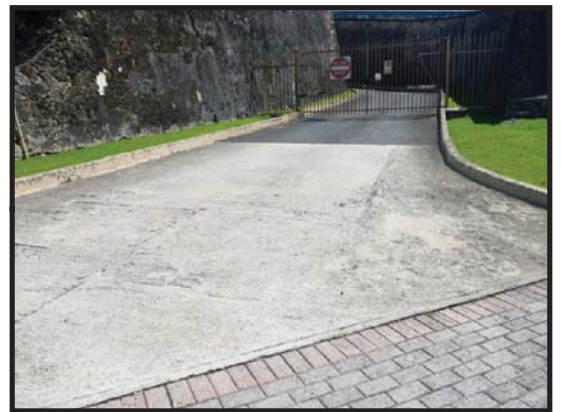
Route 0402

VISITOR CENTER ADMINISTRATIVE ROAD
FROM NORZAGARAY
TO ROUTE 0900 (VISITOR CENTER PARKING)

Route Number	Public / NonPublic	Date Visited	Area (sq ft)	Lane Miles *	Paved Length (mi)	Paved Width (ft)
0402	NONPUBLIC	5/17/2013	4,847	0.08	0.05	17
Culverts	Drop Inlets	Gates	Curb & Gutter	Curb	PCR	Surface Type
0	3	2	NO CURB AND GUTTER	CONCRETE CURB	FAIR/73	AS

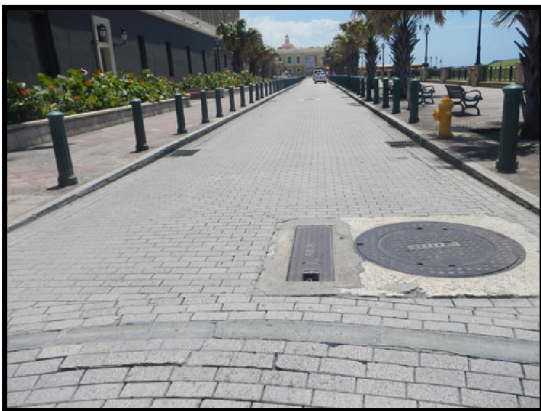
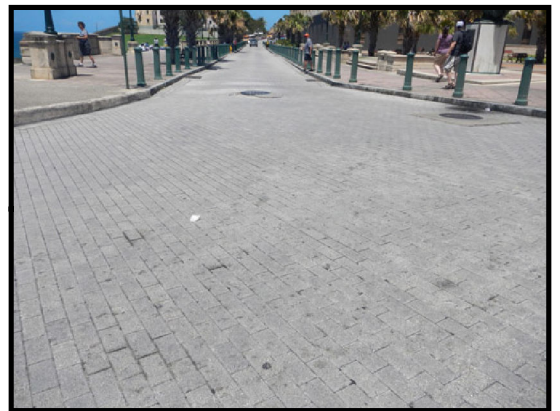
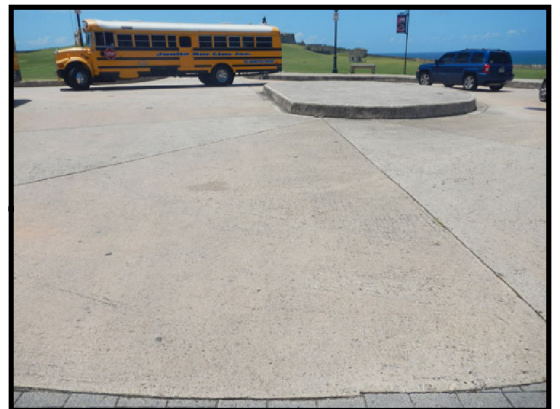
Route 0600

NORZAGARAY
FROM PARK BOUNDARY
TO END OF LOOP

Route Number	Public / NonPublic	Date Visited	Area (sq ft)	Lane Miles *	Paved Length (mi)	Paved Width (ft)
0600	PUBLIC	5/17/2013	16,051	0.28	0.15	20
Culverts	Drop Inlets	Gates	Curb & Gutter	Curb	PCR	Surface Type
0	19	0	CONCRETE CURB AND GUTTER	STONE CURB	GOOD/90	CO

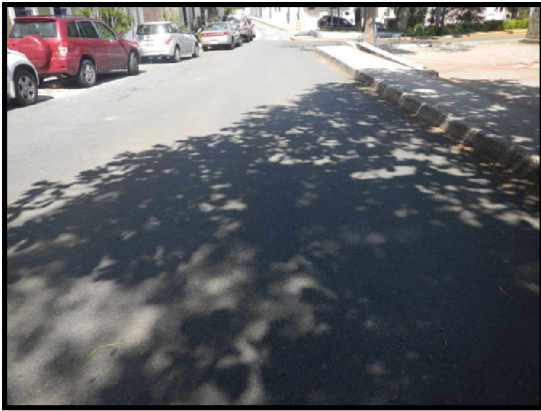
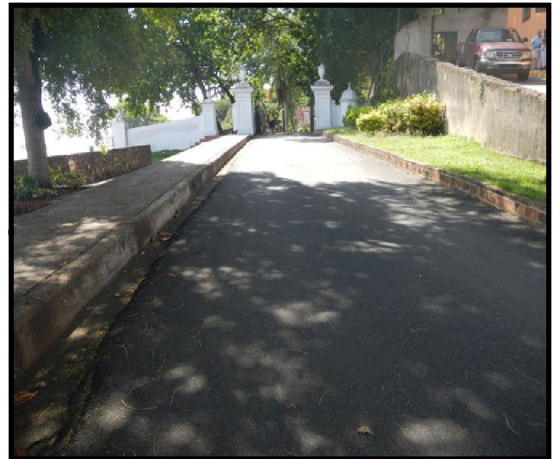
Route 0601

RECINTO OCESTE

Route Number	Public / NonPublic	Date Visited	Area (sq ft)	Lane Miles *	Paved Length (mi)	Paved Width (ft)
0601	PUBLIC	5/17/2013	9,504	0.16	0.06	30
Culverts	Drop Inlets	Gates	Curb & Gutter	Curb	PCR	Surface Type
0	0	0	CONCRETE CURB AND GUTTER	CONCRETE CURB	FAIR/73	AS

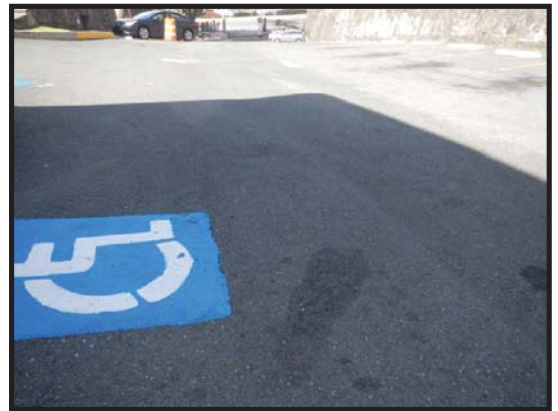
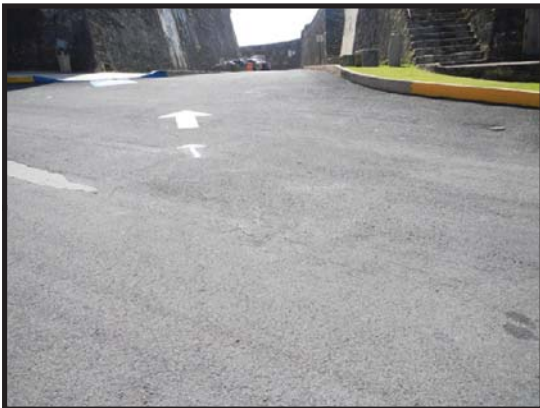
Route 0900

VISITOR CENTER PARKING

Route Number	Public / NonPublic	Date Visited	Area (sq ft)	Lane Miles *	Surface Type
0900	PUBLIC	5/17/2013	20,242	0.35	AS
Culverts	Drop Inlets	Gates	Curb & Gutter	Curb	PCR
0	1	3	NO CURB AND GUTTER	CONCRETE CURB	FAIR/73

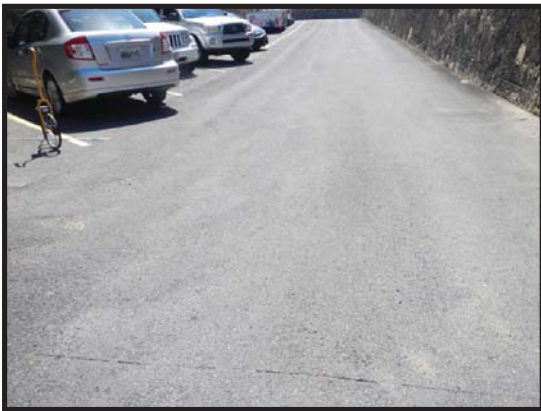
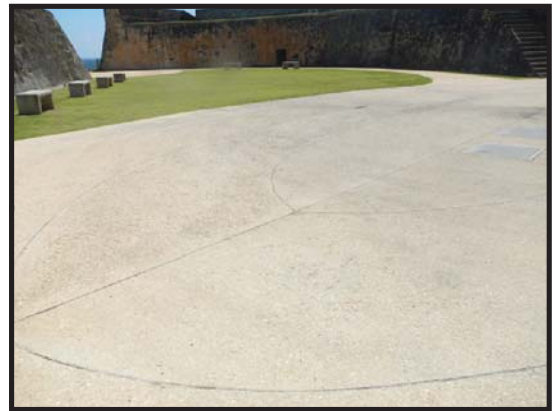
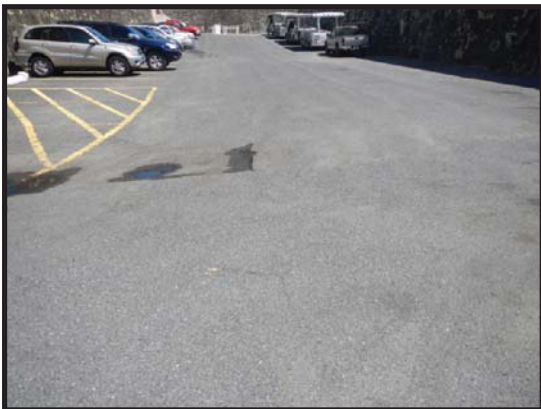
Route 0901

VISITOR CENTER ADMINISTRATIVE PARKING
FROM ROUTE 0900 (VISITOR CENTER PARKING)
TO PARKING

Route Number	Public / NonPublic	Date Visited	Area (sq ft)	Lane Miles *	Surface Type
0901	NONPUBLIC	5/17/2013	29,998	0.52	AS
Culverts	Drop Inlets	Gates	Curb & Gutter	Curb	PCR
0	0	1	NO CURB AND GUTTER	NO CURB	FAIR/73
