Federal Lands Highway Road Inventory Program

Road Inventory and Condition Assessment

Scotts Bluff National Monument SCBL - 6700

Cycle 5 Report

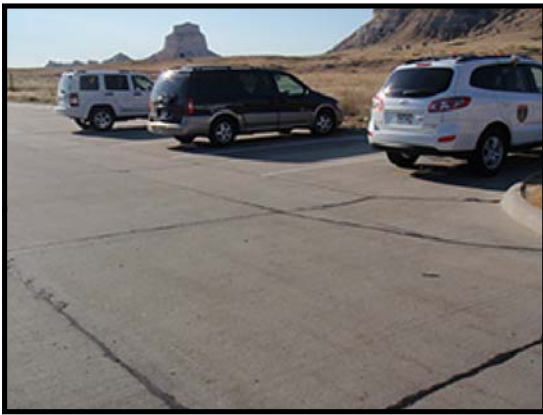
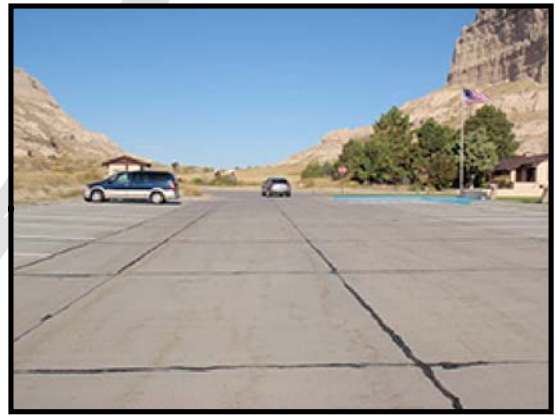
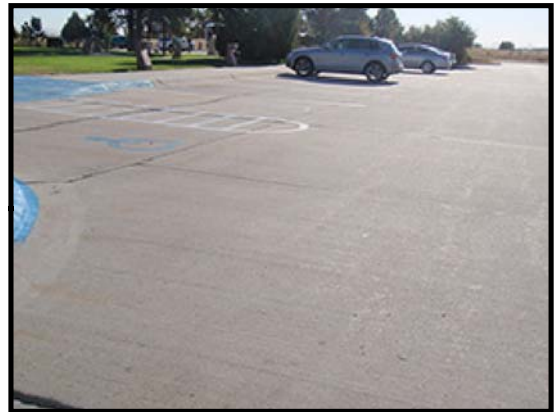
Route 0900

Route Number	Public / NonPublic	Date Visited	Area (sq ft)	Lane Miles *	Surface Type
0900	PUBLIC	10/1/2010	11,639	0.20	CO
Culverts	Drop Inlets	Gates	Curb & Gutter	Curb	PCR
0	0	0	NO CURB AND GUTTER	CONCRETE CURB	FAIR/73

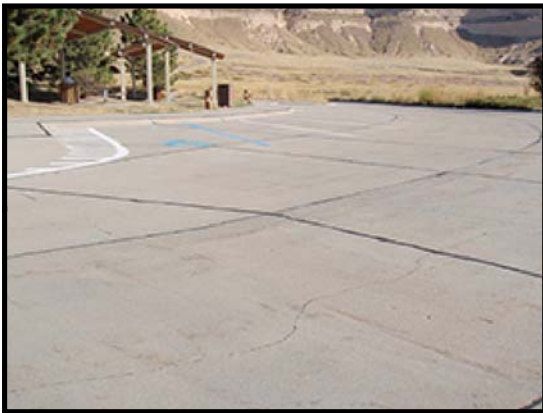
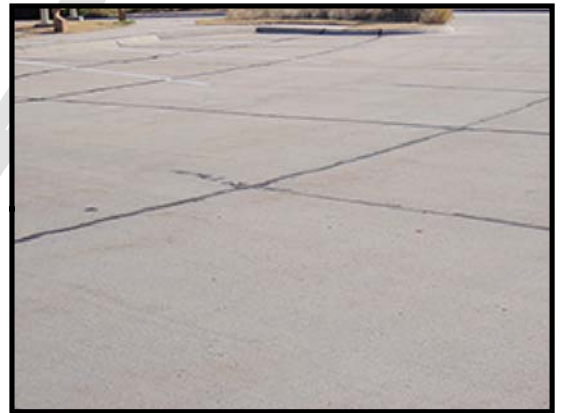
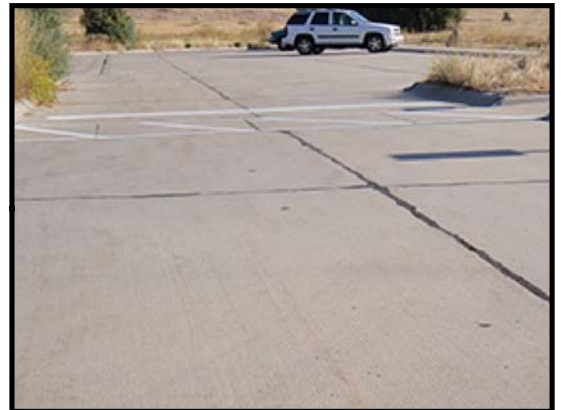
Route 0901

Route Number	Public / NonPublic	Date Visited	Area (sq ft)	Lane Miles *	Surface Type
0901	PUBLIC	10/1/2010	26,465	0.46	CO
Culverts	Drop Inlets	Gates	Curb & Gutter	Curb	PCR
0	0	0	NO CURB AND GUTTER	CONCRETE CURB	FAIR/73

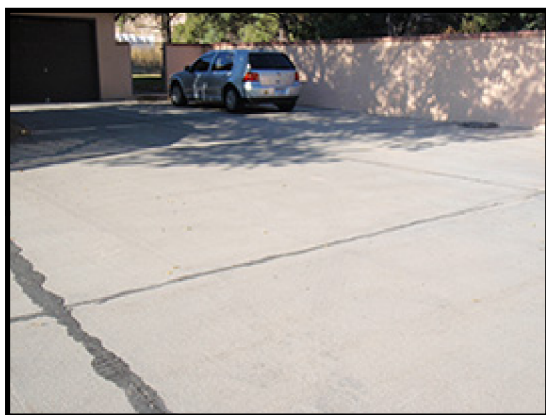
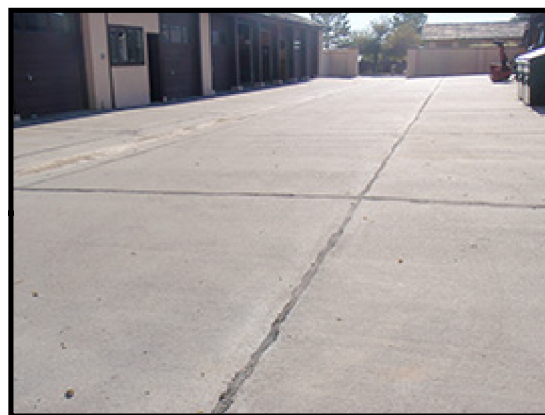
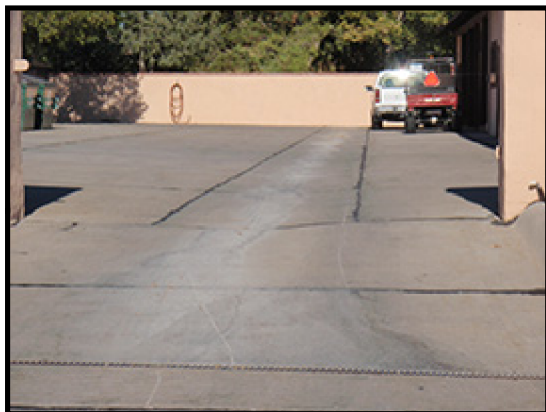
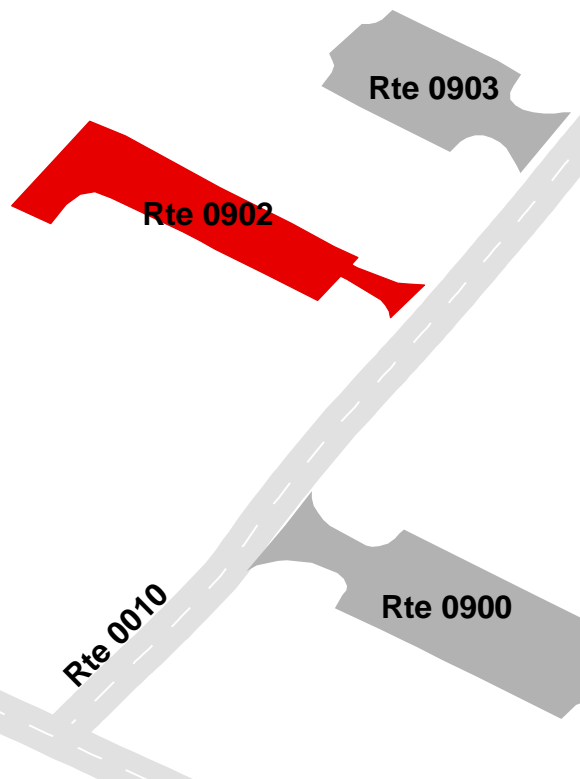
Route 0902

Route Number	Public / NonPublic	Date Visited	Area (sq ft)	Lane Miles *	Surface Type
0902	NONPUBLIC	10/1/2010	7,405	0.13	CO
Culverts	Drop Inlets	Gates	Curb & Gutter	Curb	PCR
0	1	1	NO CURB AND GUTTER	CONCRETE CURB	GOOD/90

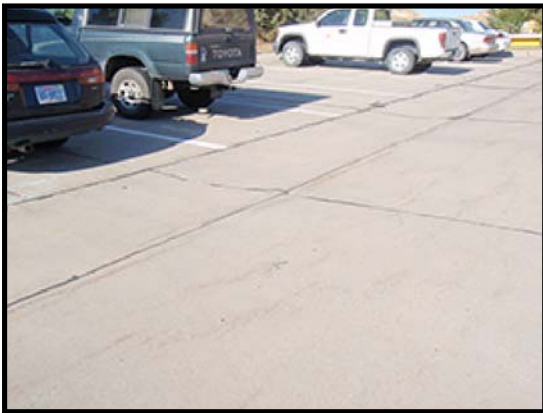
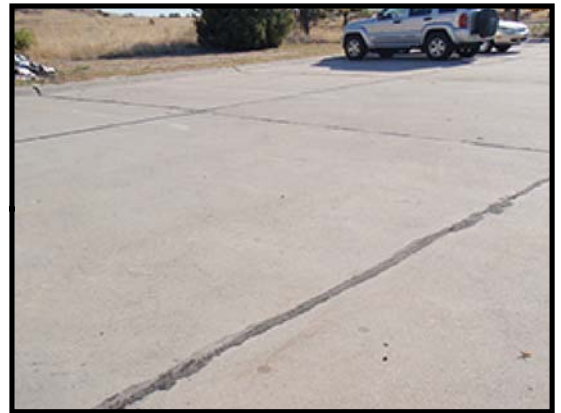
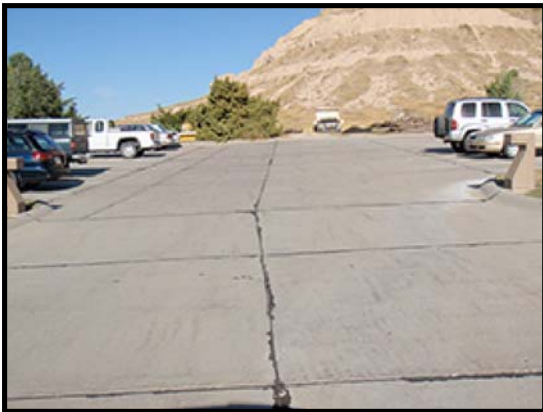
Route Number	Public / NonPublic	Date Visited	Area (sq ft)	Lane Miles *	Surface Type
0903	NONPUBLIC	10/1/2010	6,634	0.11	CO
Culverts	Drop Inlets	Gates	Curb & Gutter	Curb	PCR
0	0	0	NO CURB AND GUTTER	CONCRETE CURB	GOOD/90

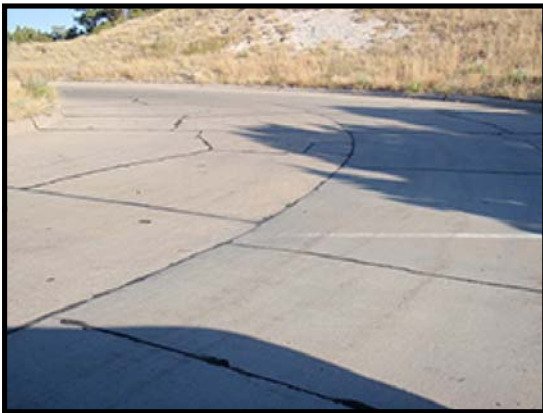
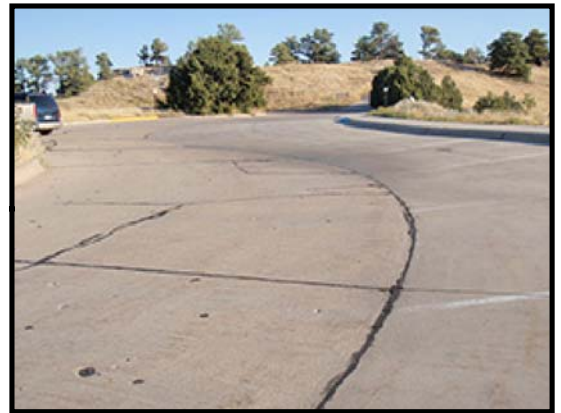
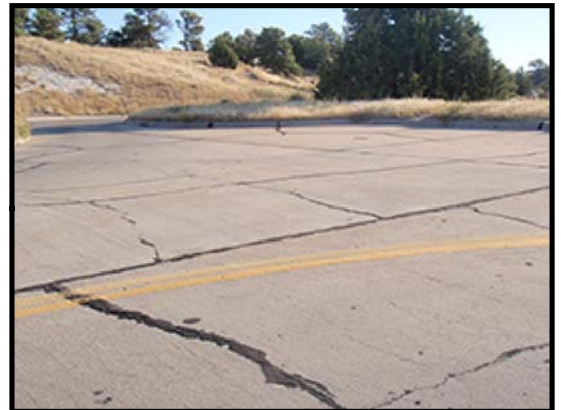
Route 0904

Route Number	Public / NonPublic	Date Visited	Area (sq ft)	Lane Miles *	Surface Type
0904	PUBLIC	10/1/2010	27,296	0.47	CO
Culverts	Drop Inlets	Gates	Curb & Gutter	Curb	PCR
0	2	0	NO CURB AND GUTTER	CONCRETE CURB	FAIR/73
