# Federal Lands Highway Road Inventory Program

Road Inventory and Condition Assessment

## Sleeping Bear Dunes National Lakeshore SLBE

### Cycle 5 Report

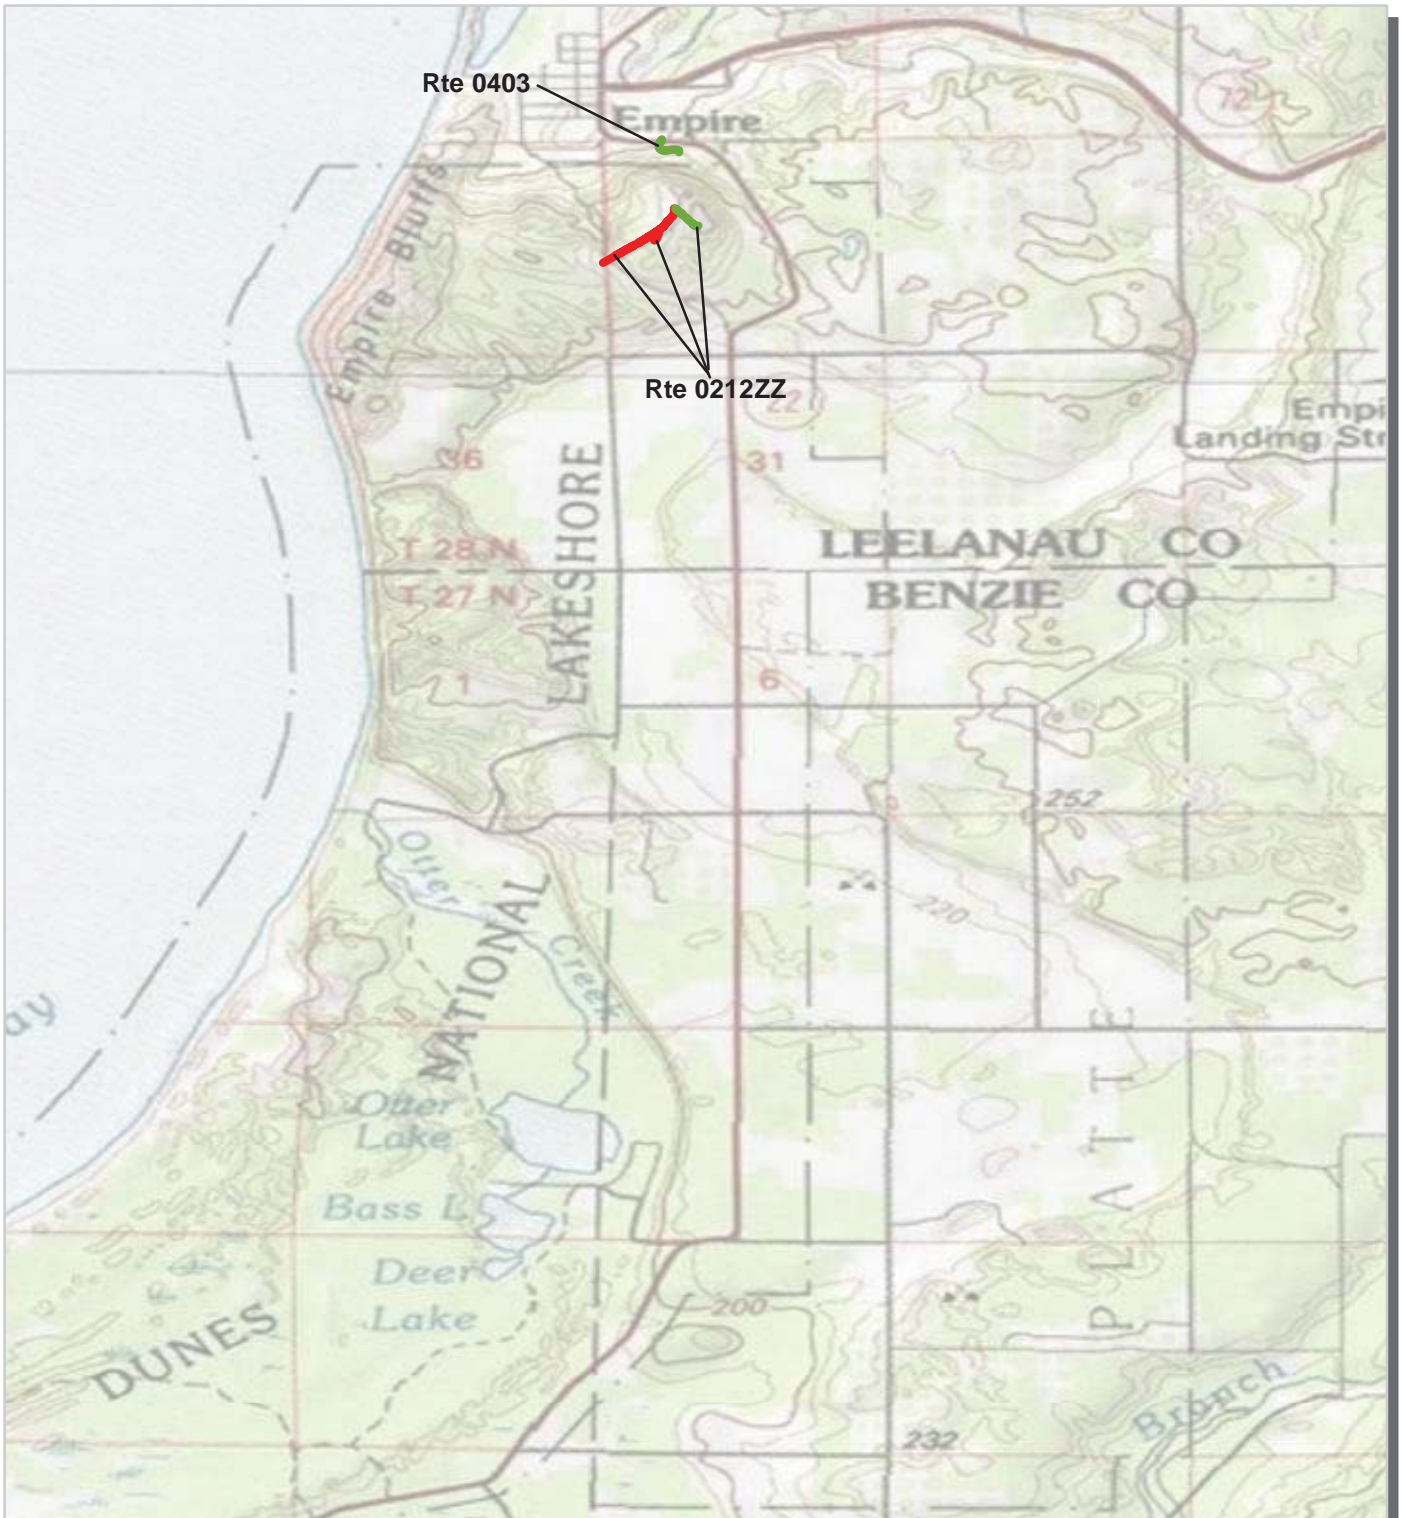
# Sleeping Bear Dunes National Lakeshore Route Condition Map PCR - Mile by Mile Area 2

| PCR | Poor | Fair | Good | Excellent | No Data |
| | (0 - 60) | (61 - 84) | (85 - 94) | (95 - 100) | |

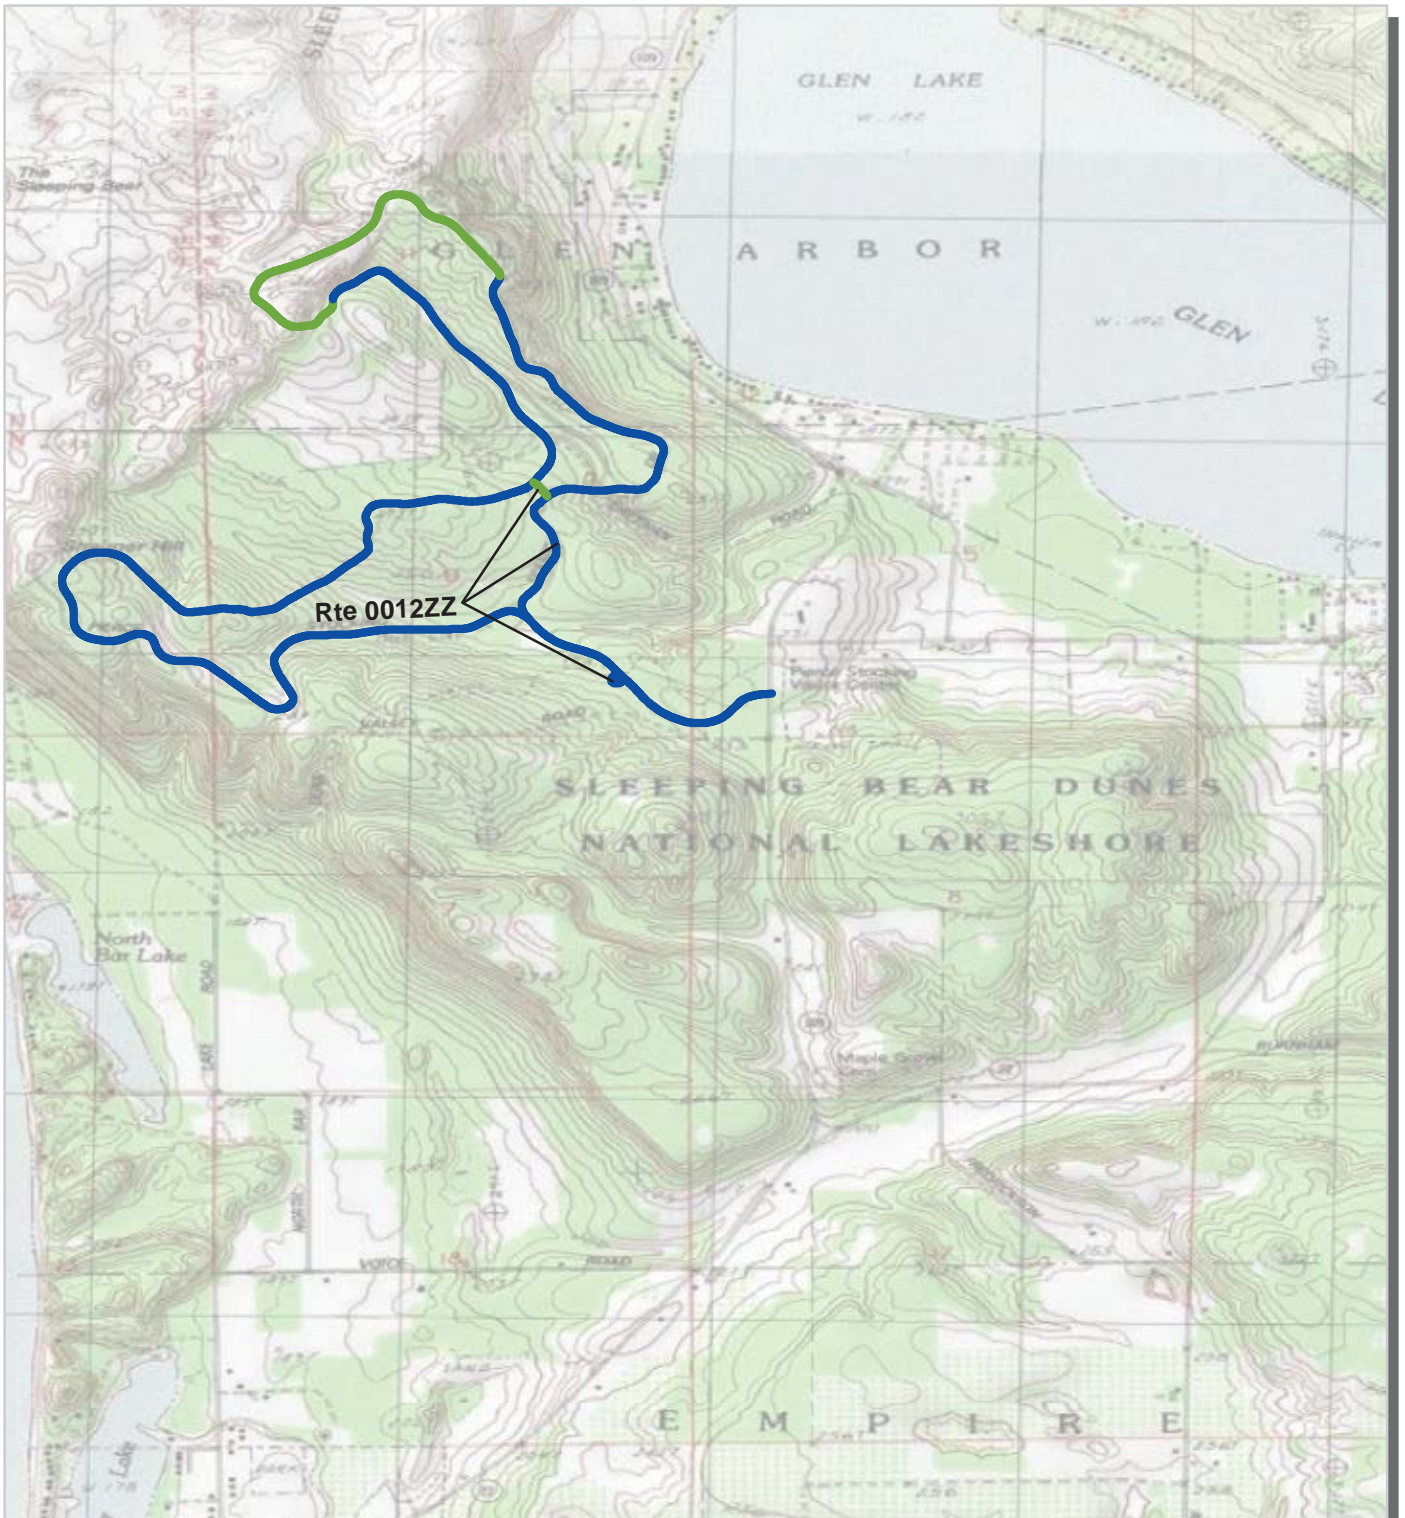
**Sleeping Bear Dunes National Lakeshore  
Route Condition Map  
PCR - Mile by Mile  
Area 3**

| PCR | Poor | <span style="display: inline-block; width: 20px; height: 10px; background-color: red; border: 1px solid black;"></span> | Fair | <span style="display: inline-block; width: 20px; height: 10px; background-color: yellow; border: 1px solid black;"></span> | Good | <span style="display: inline-block; width: 20px; height: 10px; background-color: green; border: 1px solid black;"></span> | Excellent | <span style="display: inline-block; width: 20px; height: 10px; background-color: blue; border: 1px solid black;"></span> | No Data | <span style="display: inline-block; width: 20px; height: 10px; background-color: black; border: 1px solid black;"></span> |
| | (0 - 60) | | (61 - 84) | (85 - 94) | | (95 - 100) | | | | |

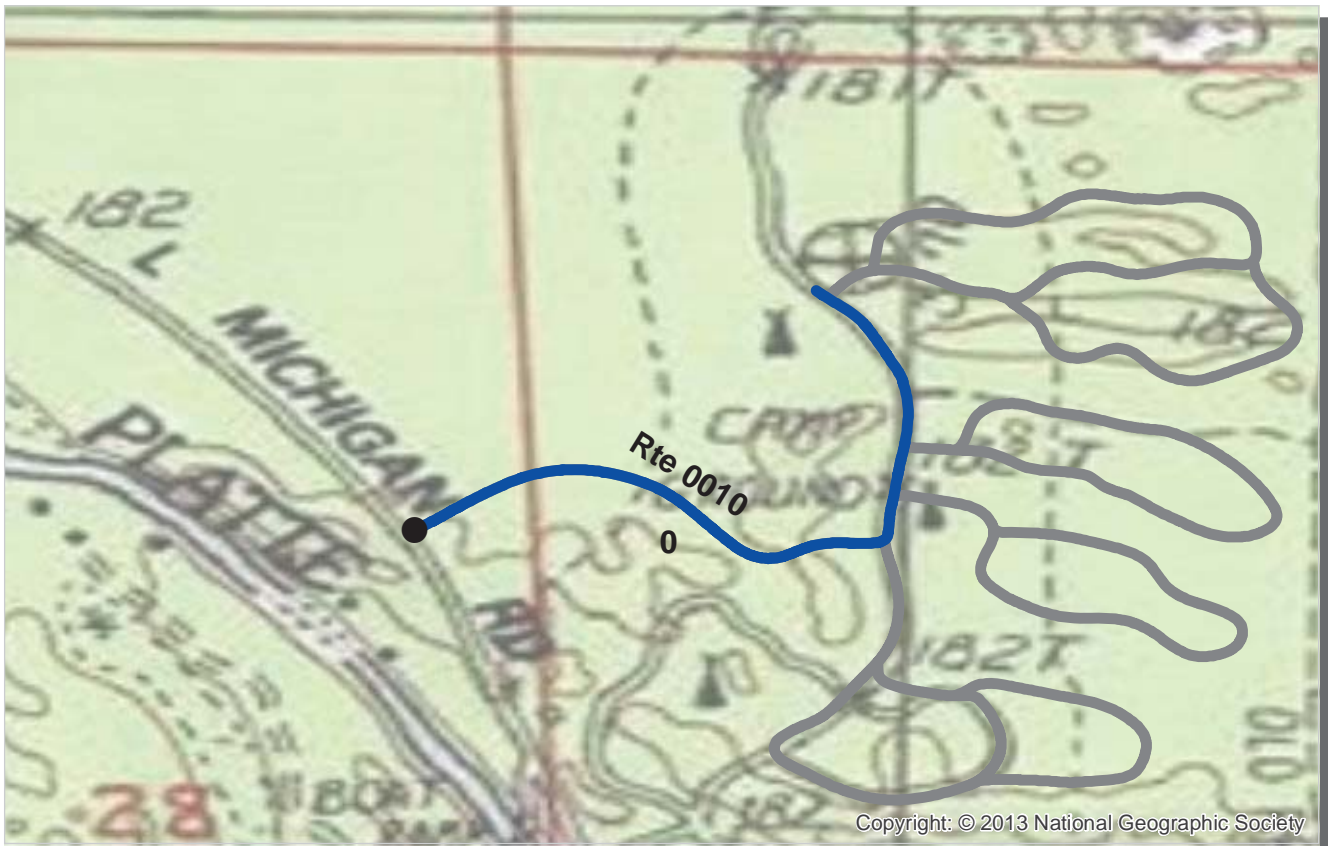
**ROUTE: 0010 PRCG ENTRANCE ROAD**

| SCR (Surface Condition Rating) | 100 | | | | |
| PCR (Pavement Condition Rating) | 100 | | | | |
| Structural Crack Index | 100 | | | | |
| Transverse Cracking Index | 100 | | | | |

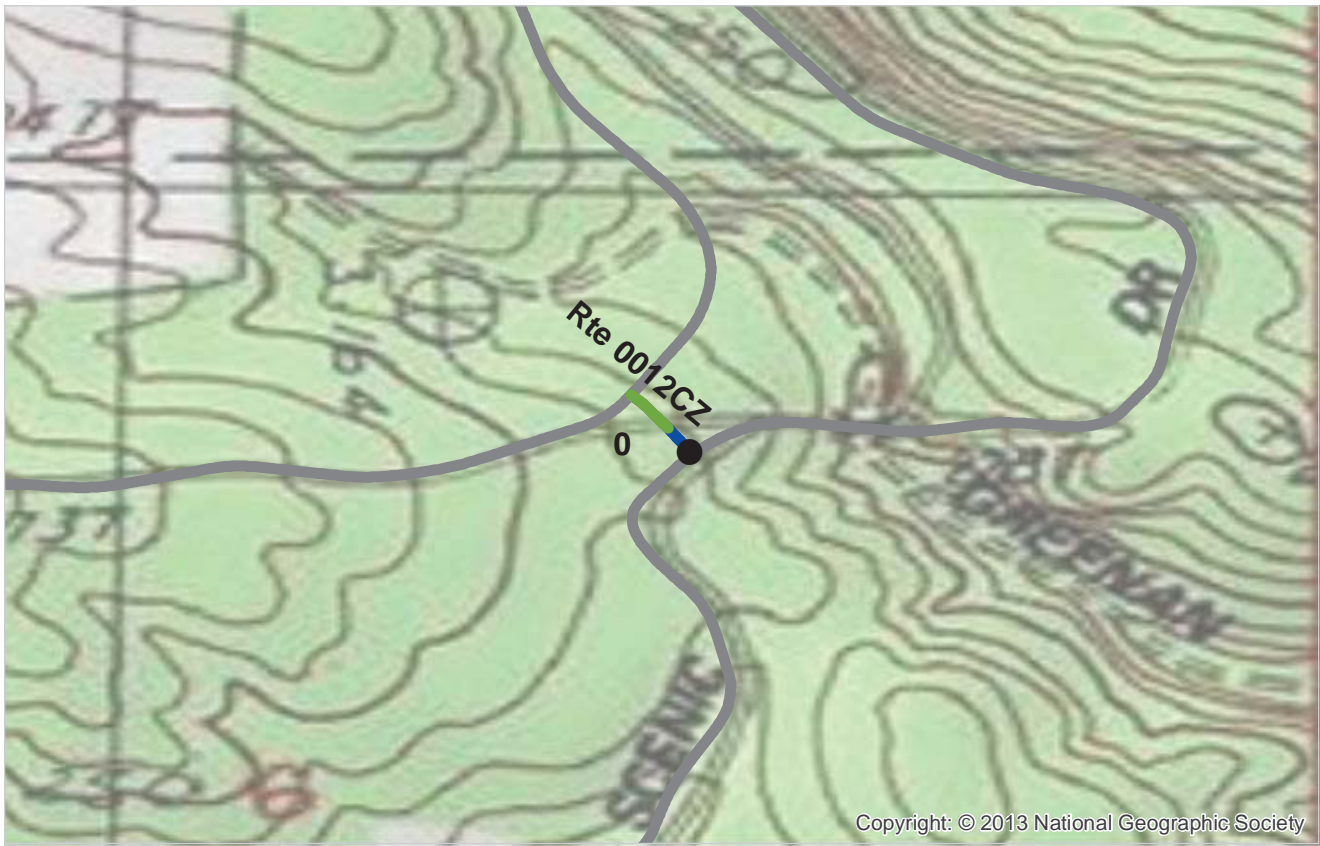
ROUTE: 0012CZ STOCKING SCENIC DRIVE EMERGENCY CUT-OFF ROAD

| SCR (Surface Condition Rating) | 93 | | | | |
| PCR (Pavement Condition Rating) | 93 | | | | |

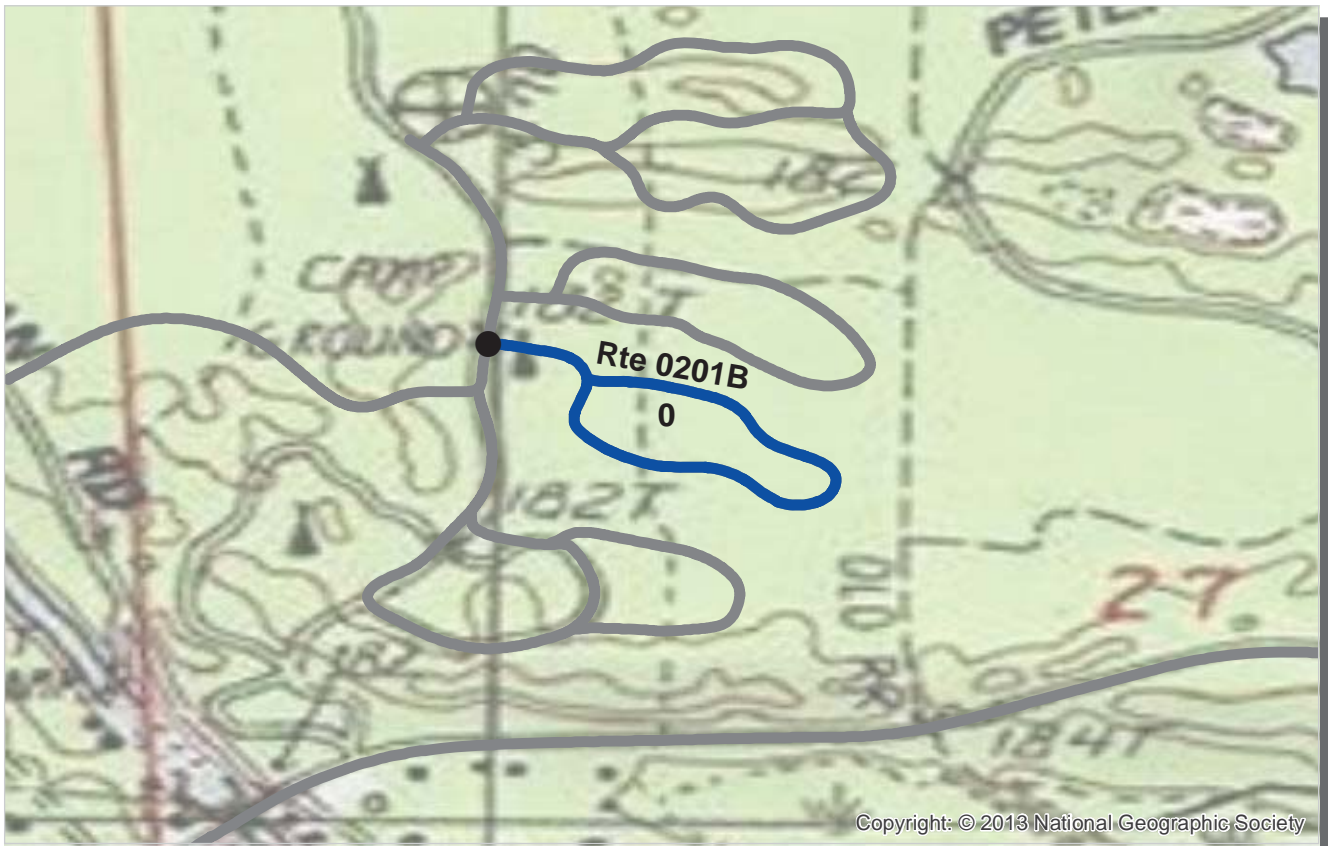
ROUTE: 0201B PRCG LOOP 2 ROAD

| SCR (Surface Condition Rating) | 99 | | | | |
| PCR (Pavement Condition Rating) | 99 | | | | |

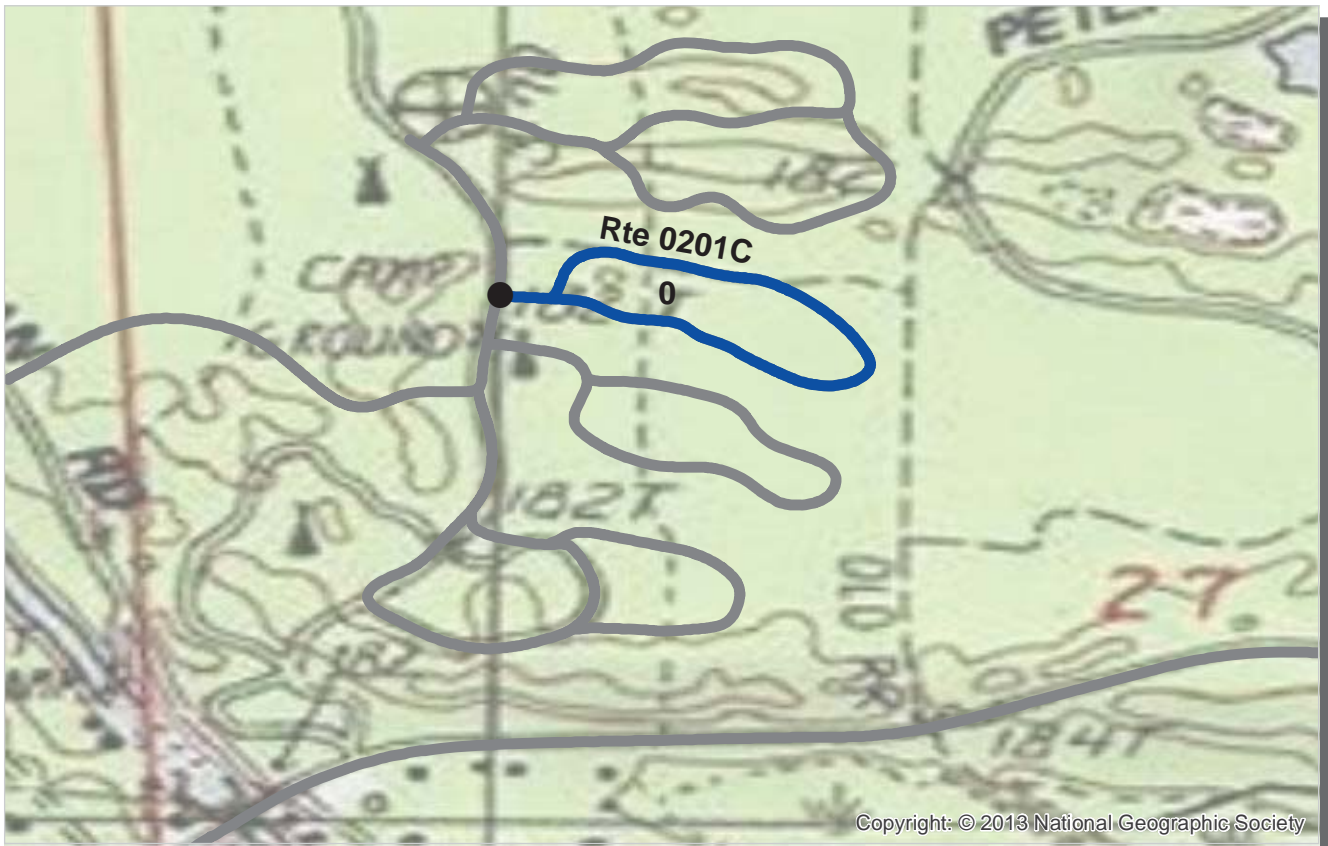
ROUTE: 0201C PRCG LOOP 3 ROAD

| SCR (Surface Condition Rating) | 99 | | | | |
| PCR (Pavement Condition Rating) | 99 | | | | |

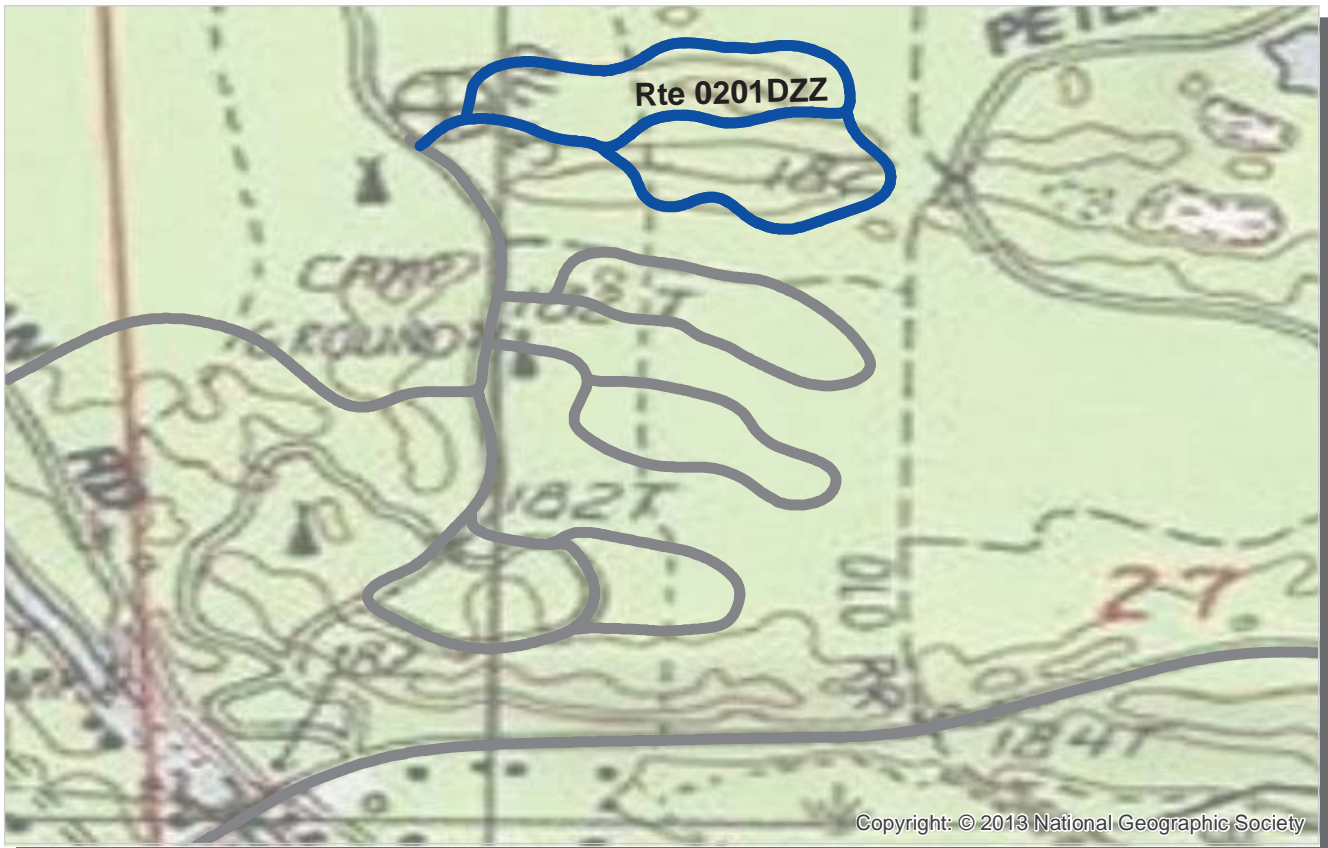
ROUTE: 0201DZZ PRCG LOOP 4 ROAD

| SCR (Surface Condition Rating) | 100 | | | | |
| PCR (Pavement Condition Rating) | 100 | | | | |

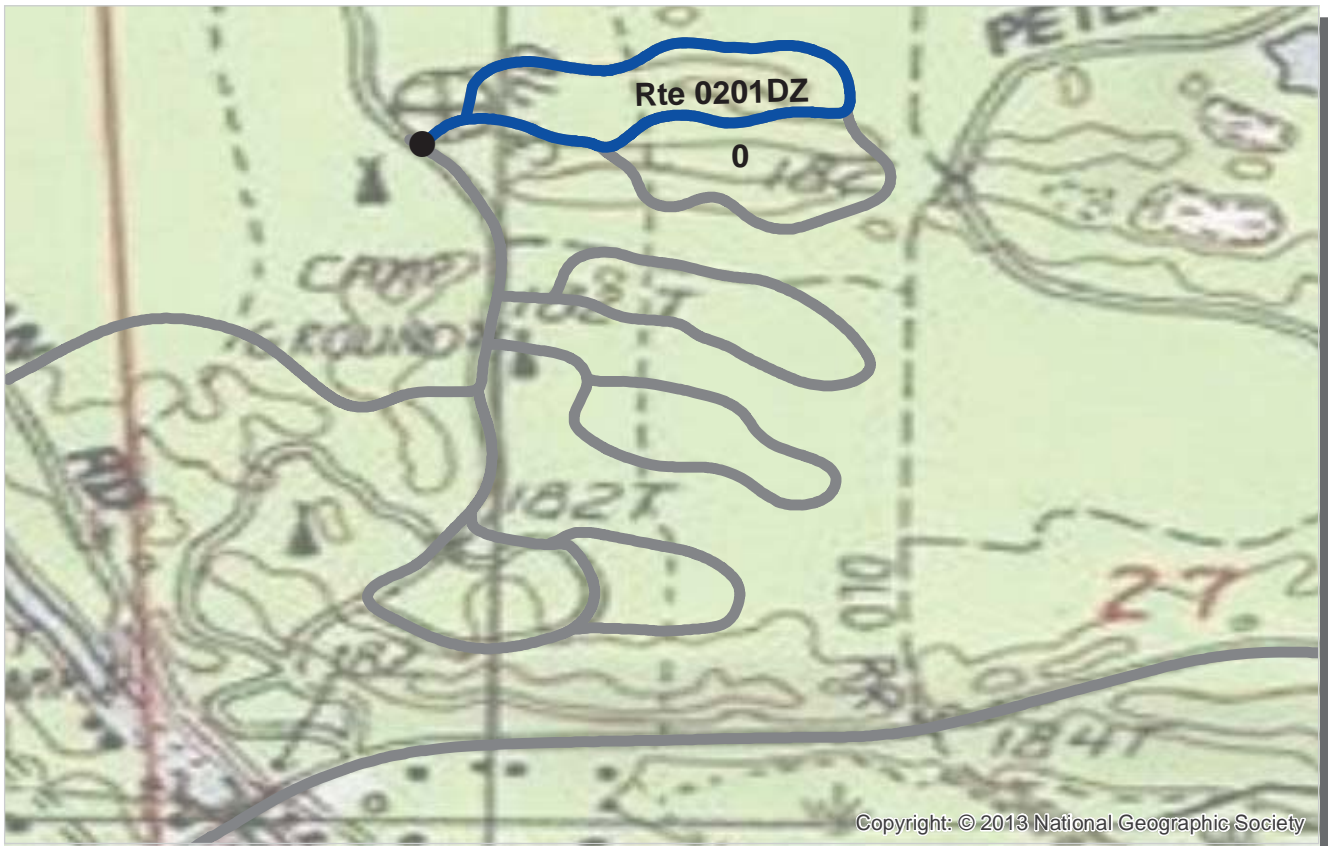
ROUTE: 0201DZ PRCG LOOP 4DZ ROAD

| SCR (Surface Condition Rating) | 100 | | | | |
| PCR (Pavement Condition Rating) | 100 | | | | |

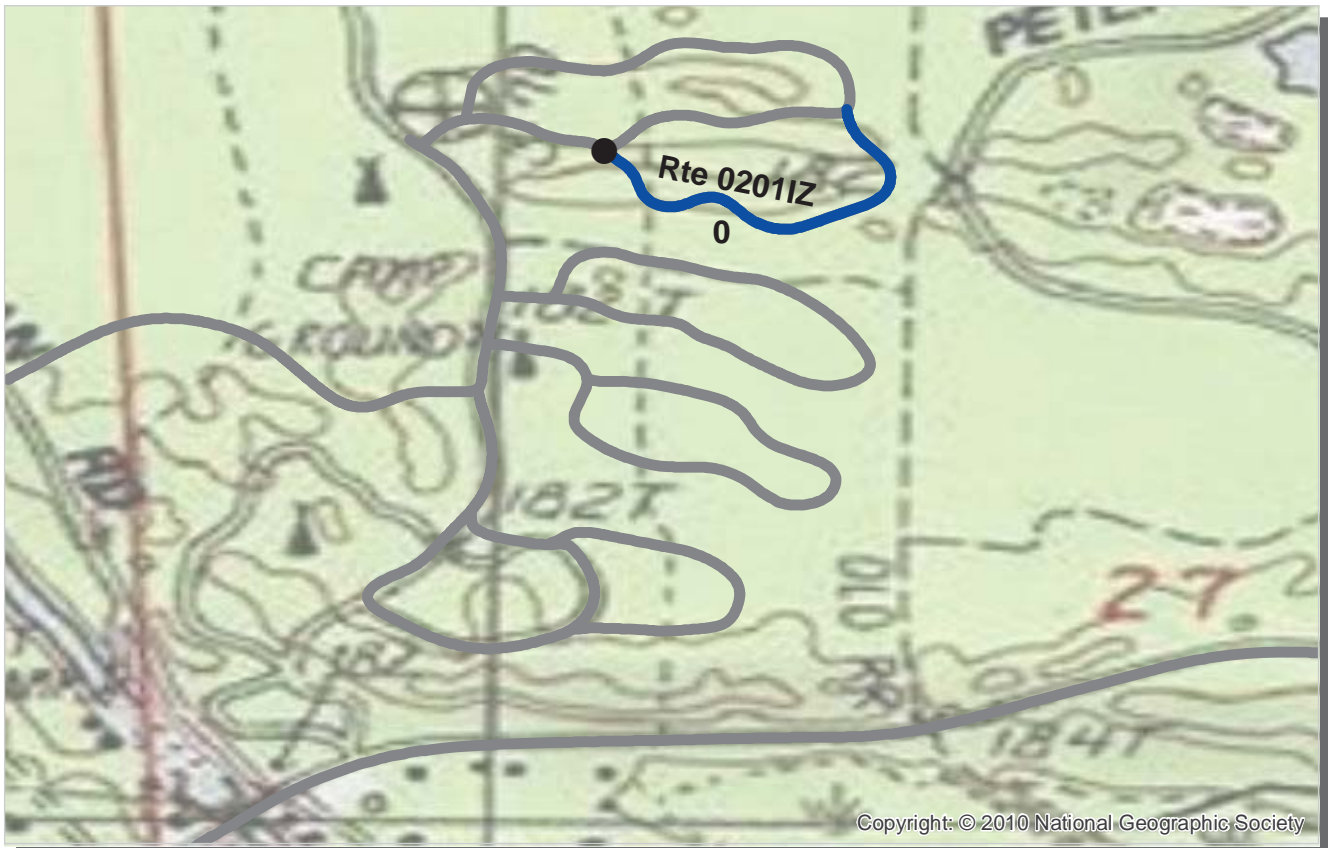
ROUTE: 02011Z PRCG LOOP 4IZ ROAD

| SCR (Surface Condition Rating) | 99 | | | | |
| PCR (Pavement Condition Rating) | 99 | | | | |

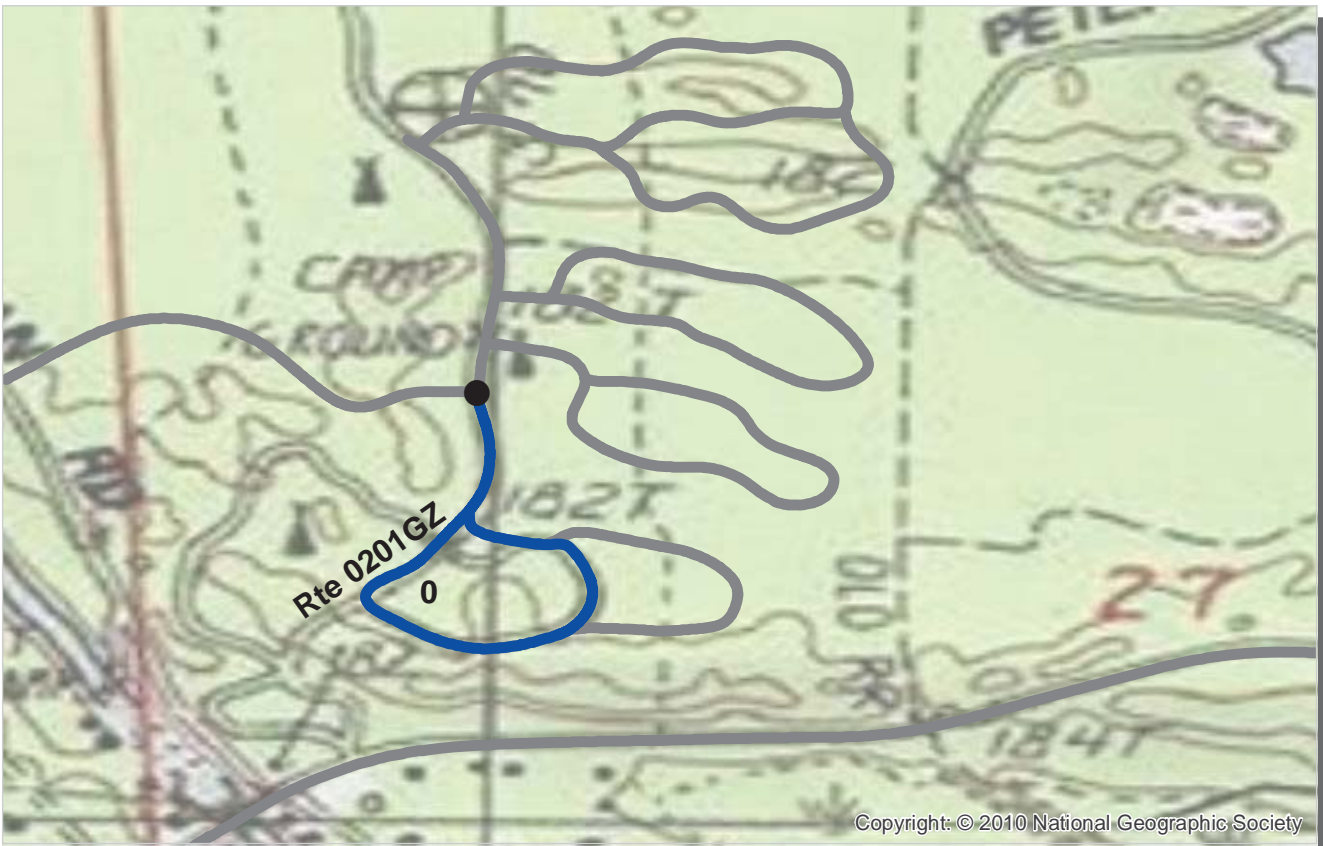
ROUTE: 0201GZ PRCG LOOP 1GZ ROAD

| SCR (Surface Condition Rating) | 99 | | | | |
| PCR (Pavement Condition Rating) | 99 | | | | |

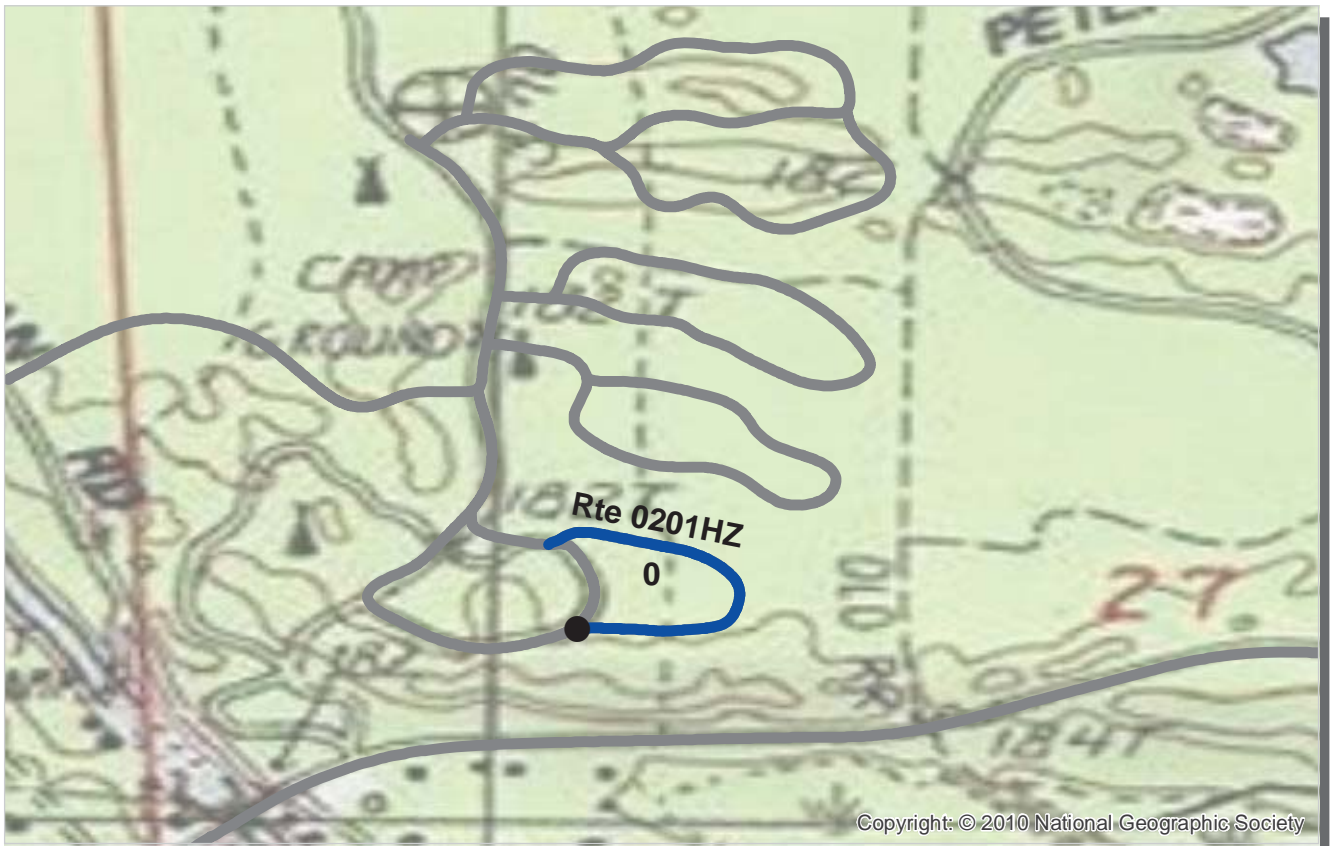
| PCR | Poor | <span style="display:inline-block; width:15px; height:15px; background-color:red;"></span> | Fair | <span style="display:inline-block; width:15px; height:15px; background-color:yellow;"></span> | Good | <span style="display:inline-block; width:15px; height:15px; background-color:green;"></span> | Excellent | <span style="display:inline-block; width:15px; height:15px; background-color:blue;"></span> | No Data | <span style="display:inline-block; width:15px; height:15px; background-color:black;"></span> |
| | | (0 - 60) | | (61 - 84) | | (85 - 94) | | (95 - 100) | | |

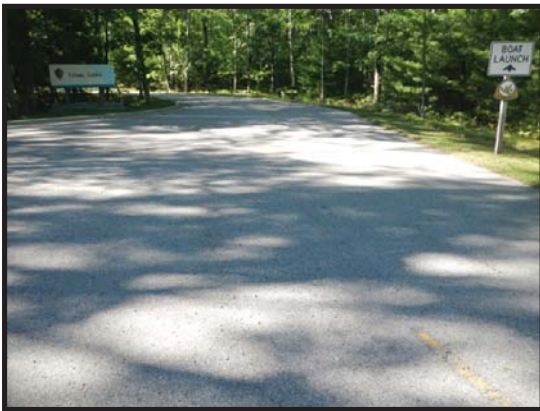
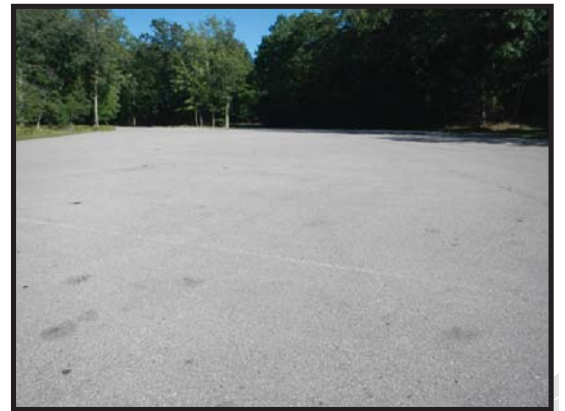
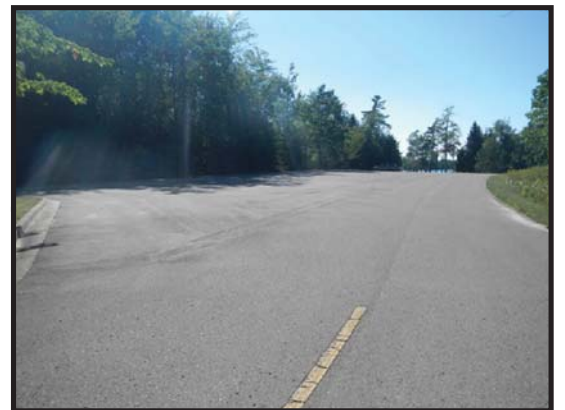
| Route Number | Public / NonPublic | Date Visited | Area (sq ft) | Lane Miles * | Surface Type |
|---|---|---|---|---|---|
| 0 | 0 | 0 | CONCRETE CURB AND GUTTER | NO CURB | GOOD/90 |

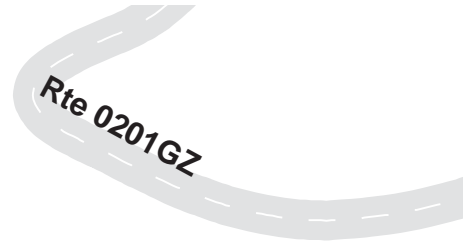
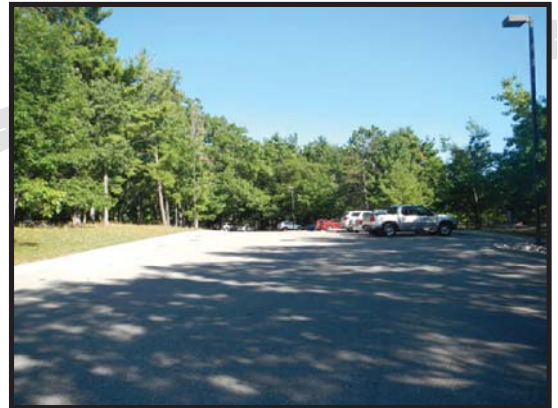
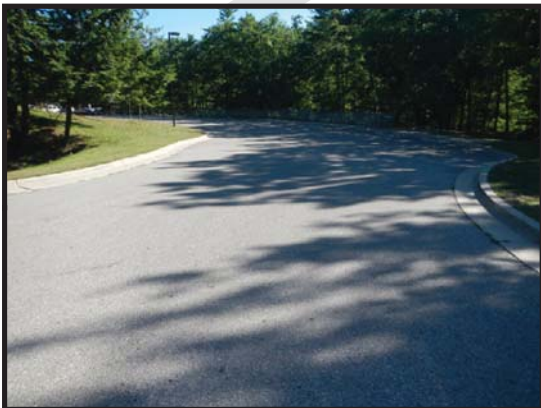
Rte 5022

| Route Number | Public / NonPublic | Date Visited | Area (sq ft) | Lane Miles * | Surface Type |
|---|---|---|---|---|---|
| 0 | 0 | 0 | CONCRETE CURB AND GUTTER | NO CURB | GOOD/90 |

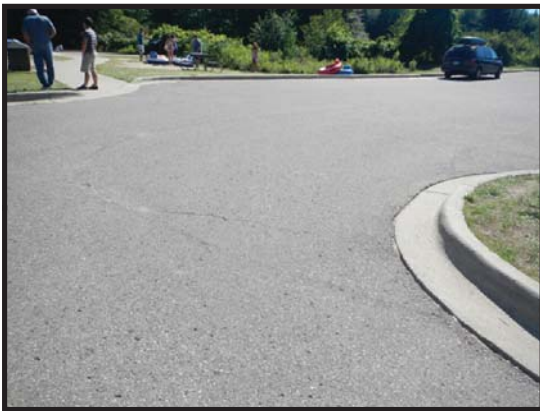
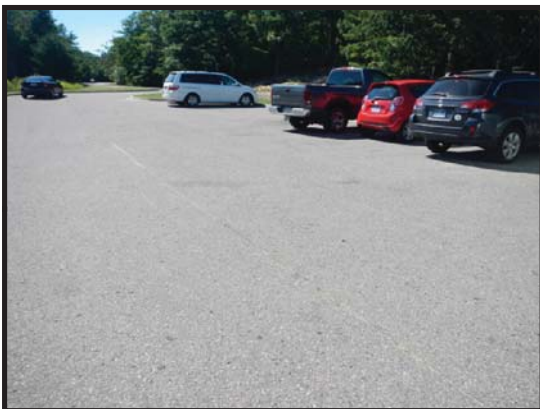
| Route Number | Public / NonPublic | Date Visited | Area (sq ft) | Lane Miles * | Surface Type |
|---|---|---|---|---|---|
| 0 | 0 | 0 | CONCRETE CURB AND GUTTER | NO CURB | GOOD/90 |

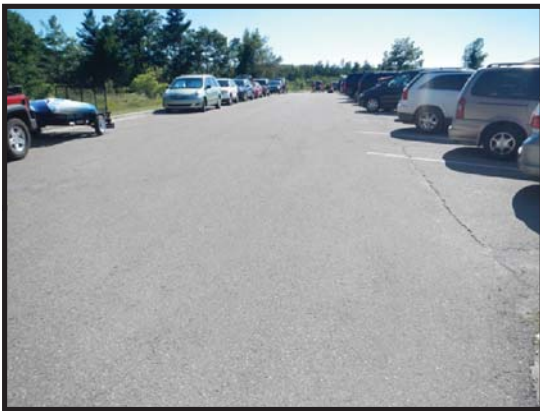
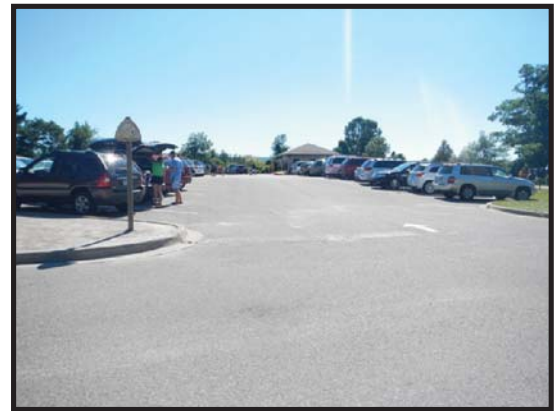
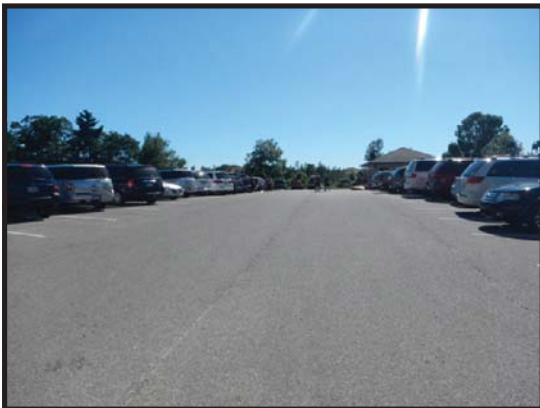
| Route Number | Public / NonPublic | Date Visited | Area (sq ft) | Lane Miles * | Surface Type |
|---|---|---|---|---|---|
| 0 | 1 | 0 | CONCRETE CURB AND GUTTER | NO CURB | GOOD/90 |

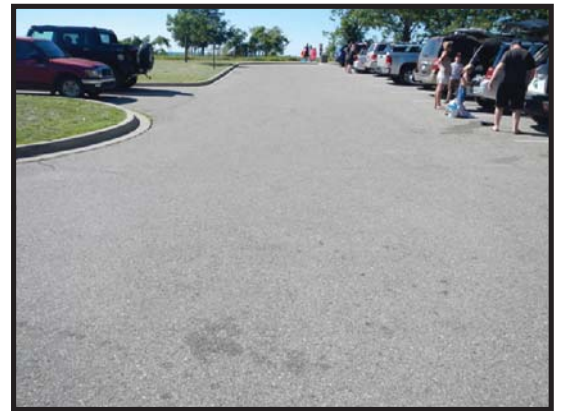
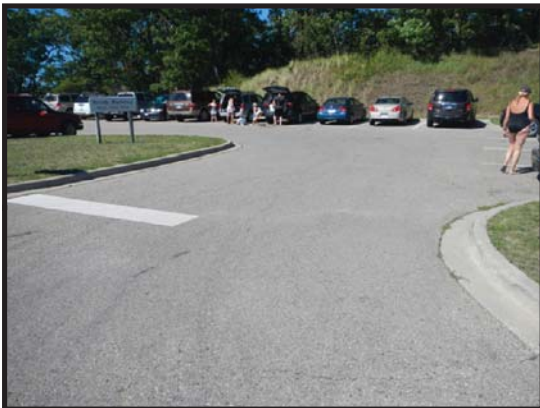
| Route Number | Public / NonPublic | Date Visited | Area (sq ft) | Lane Miles * | Surface Type |
|---|---|---|---|---|---|
| 0 | 1 | 0 | CONCRETE CURB AND GUTTER | NO CURB | GOOD/90 |

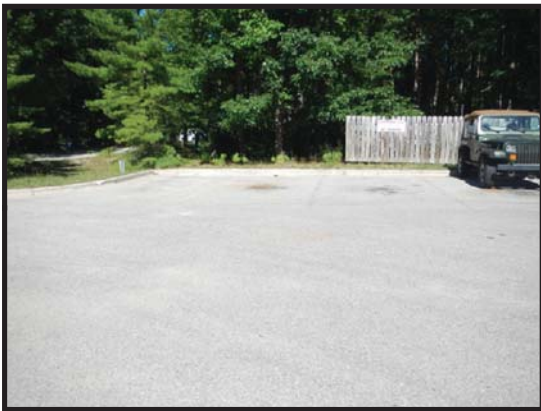
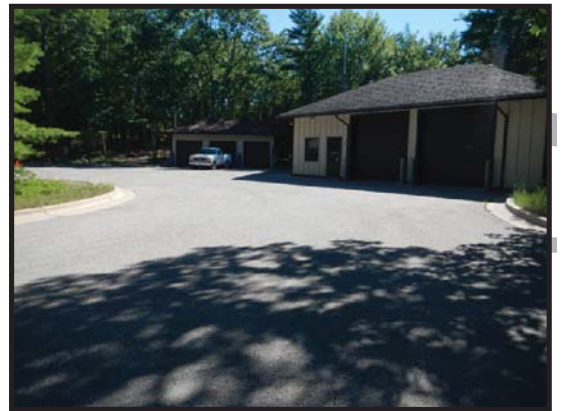
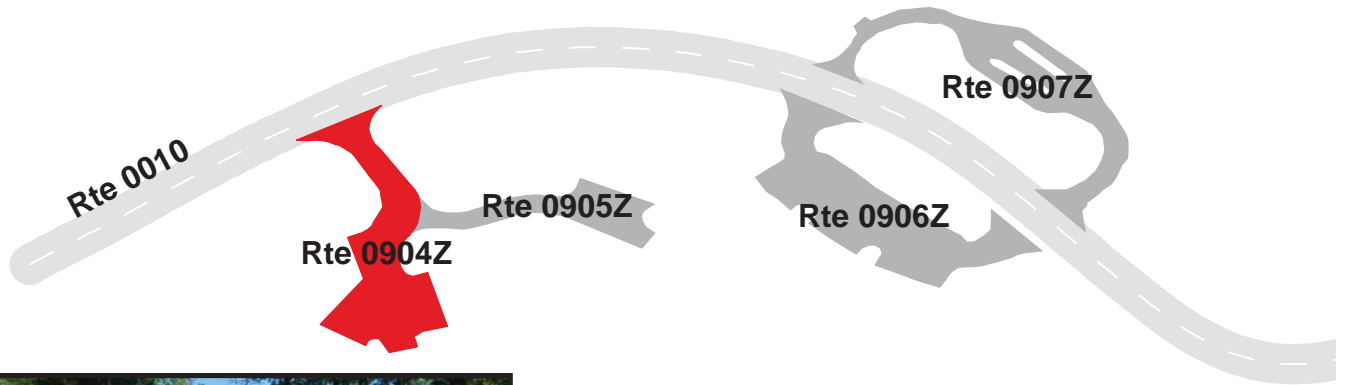
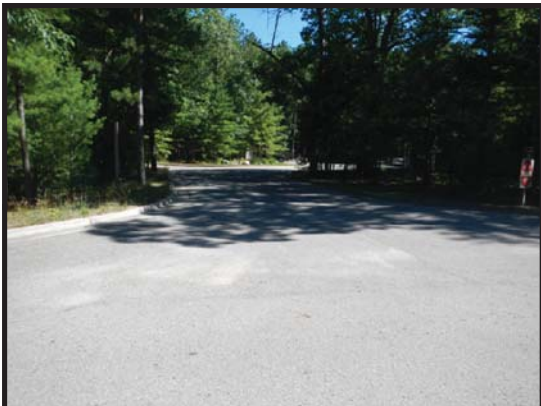
| Route Number | Public / NonPublic | Date Visited | Area (sq ft) | Lane Miles * | Surface Type |
|---|---|---|---|---|---|
| 0 | 0 | 0 | CONCRETE CURB AND GUTTER | NO CURB | GOOD/90 |

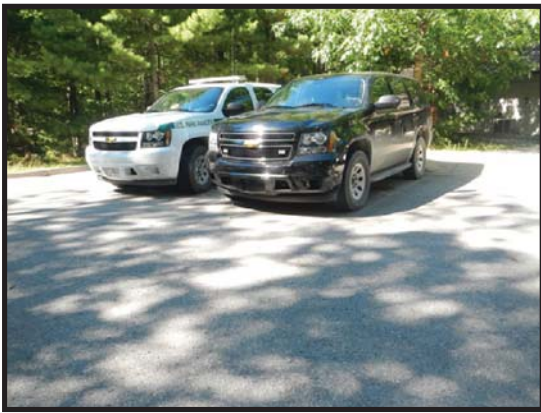
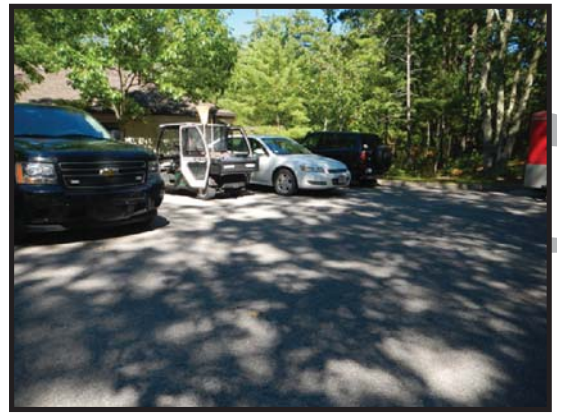
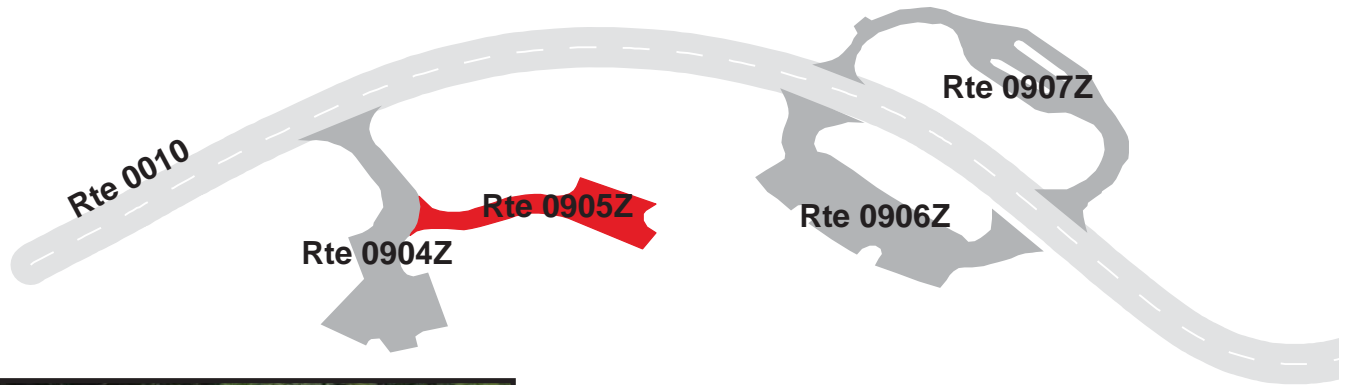
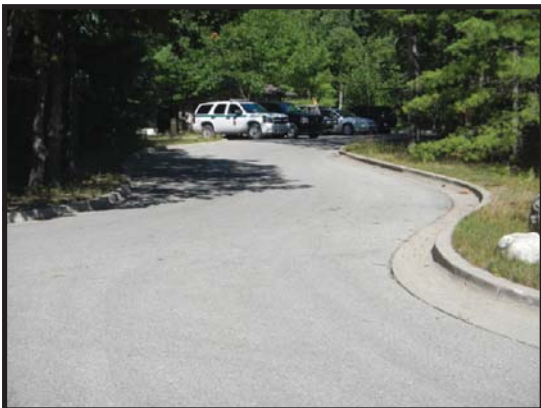
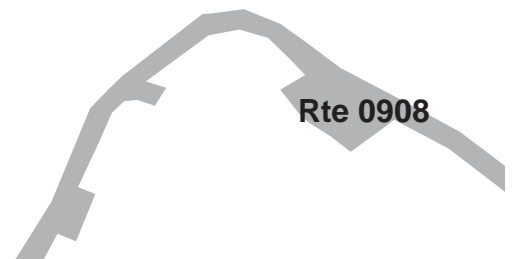
| Route Number | Public / NonPublic | Date Visited | Area (sq ft) | Lane Miles * | Surface Type |
|---|---|---|---|---|---|
| 0 | 0 | 0 | CONCRETE CURB AND GUTTER | NO CURB | GOOD/90 |

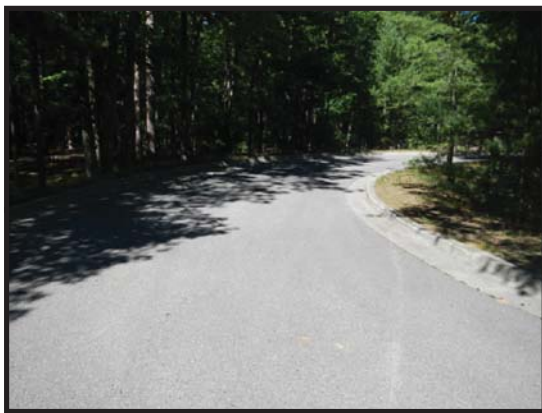
## Route 0907Z

| Route Number | Public / NonPublic | Date Visited | Area (sq ft) | Lane Miles * | Surface Type |
|---|---|---|---|---|---|
| 0 | 0 | 0 | CONCRETE CURB AND GUTTER | CONCRETE CURB | GOOD/90 |

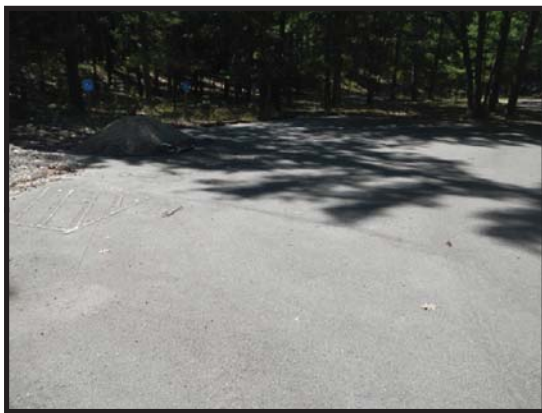
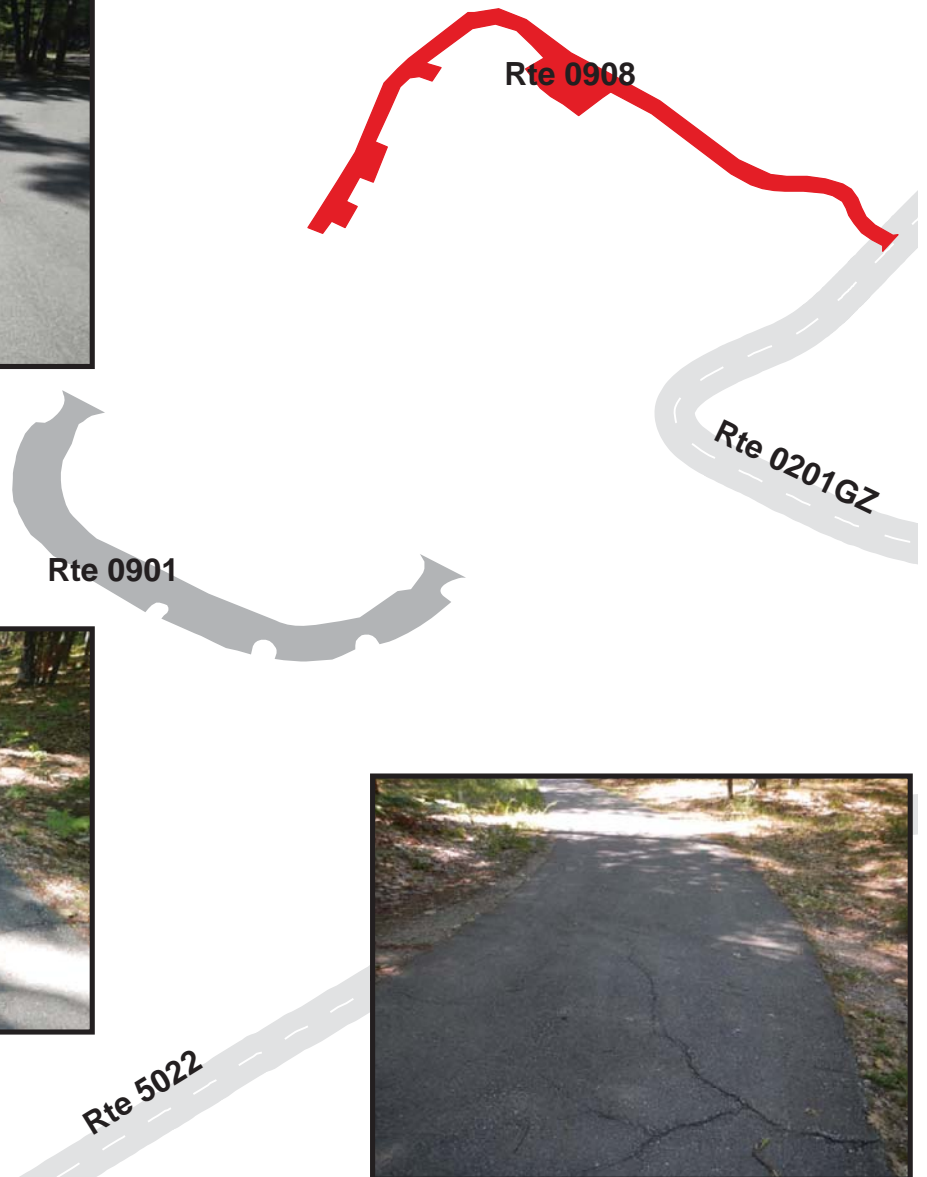
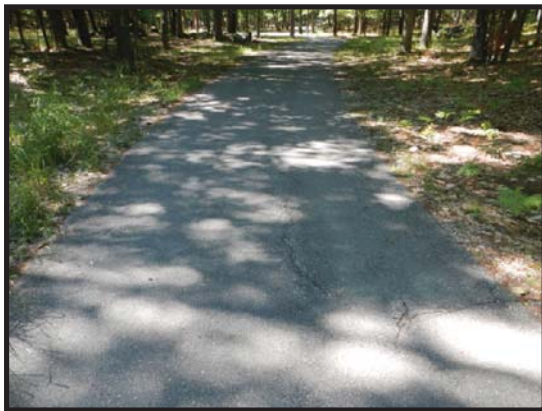
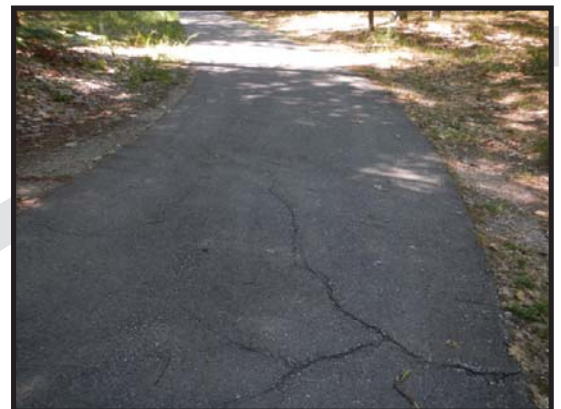
## Route 0908

| Route Number | Public / NonPublic | Date Visited | Area (sq ft) | Lane Miles * | Surface Type |
|---|---|---|---|---|---|
| 0 | 0 | 1 | CONCRETE CURB AND GUTTER | NO CURB | FAIR/73 |
