# Federal Lands Highway Road Inventory Program

Road Inventory and Condition Assessment

## Sleeping Bear Dunes National Lakeshore SLBE

### Cycle 5 Report

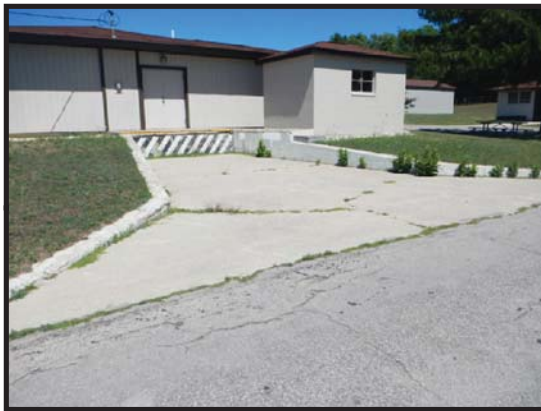
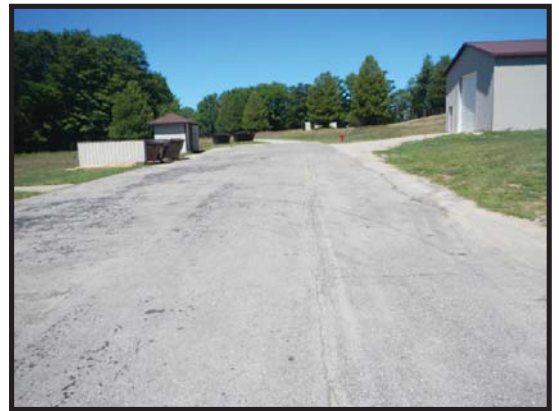
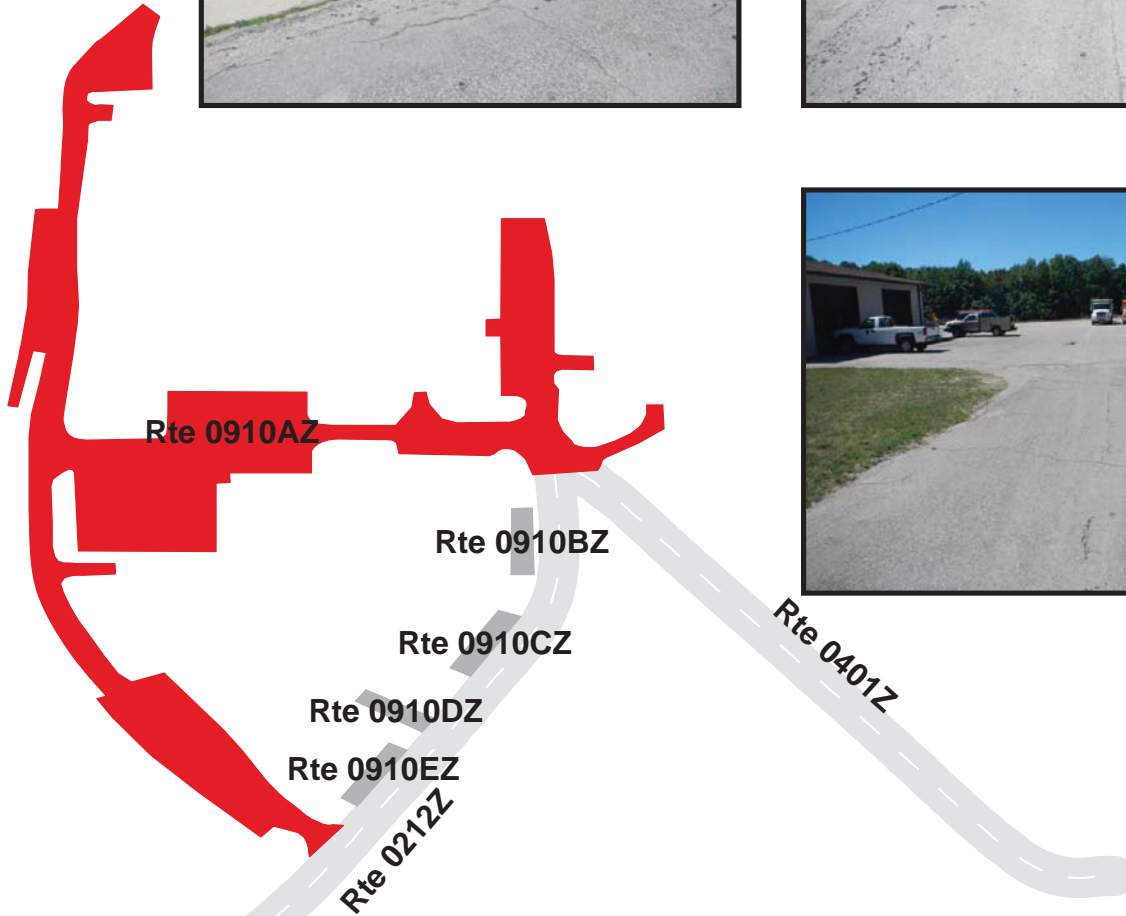
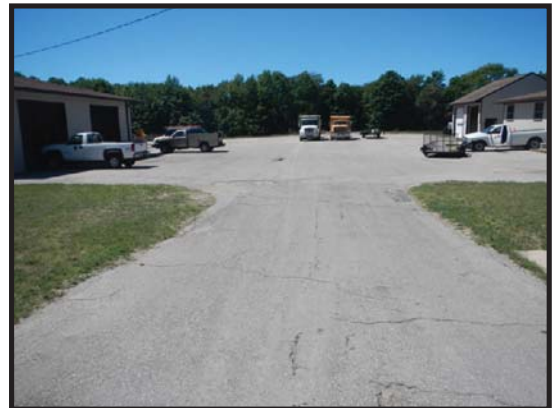
## Route 0910ZZ

| Route Number | Public / NonPublic | Date Visited | Area (sq ft) | Lane Miles * | Surface Type |
|---|---|---|---|---|---|
| 1 | 1 | 0 | NO CURB AND GUTTER | ASPHALT & WOOD CURB | POOR/45 |

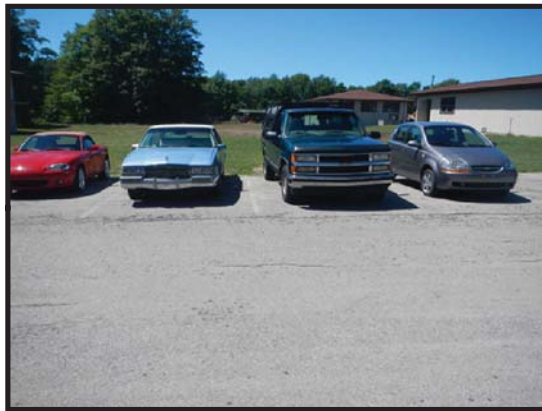
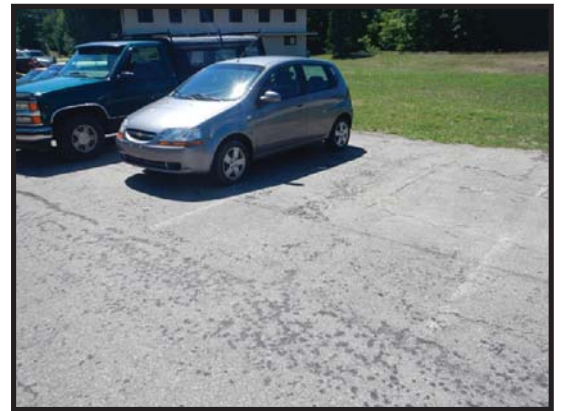
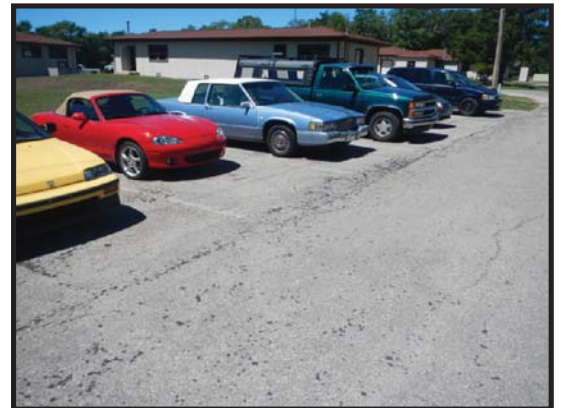
## Route 0910BZ

| Route Number | Public / NonPublic | Date Visited | Area (sq ft) | Lane Miles * | Surface Type |
|---|---|---|---|---|---|
| 0 | 0 | 0 | NO CURB AND GUTTER | NO CURB | POOR/45 |

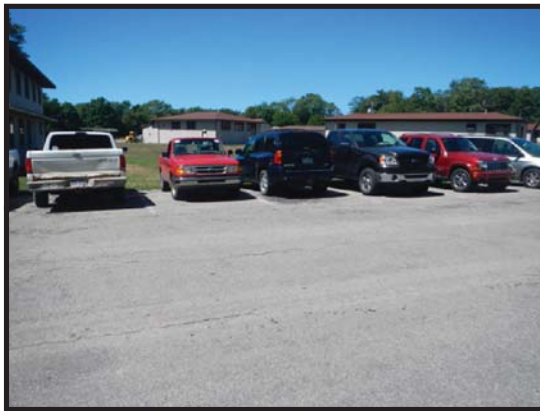
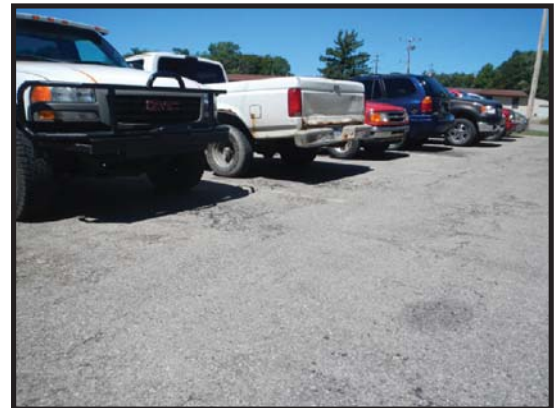
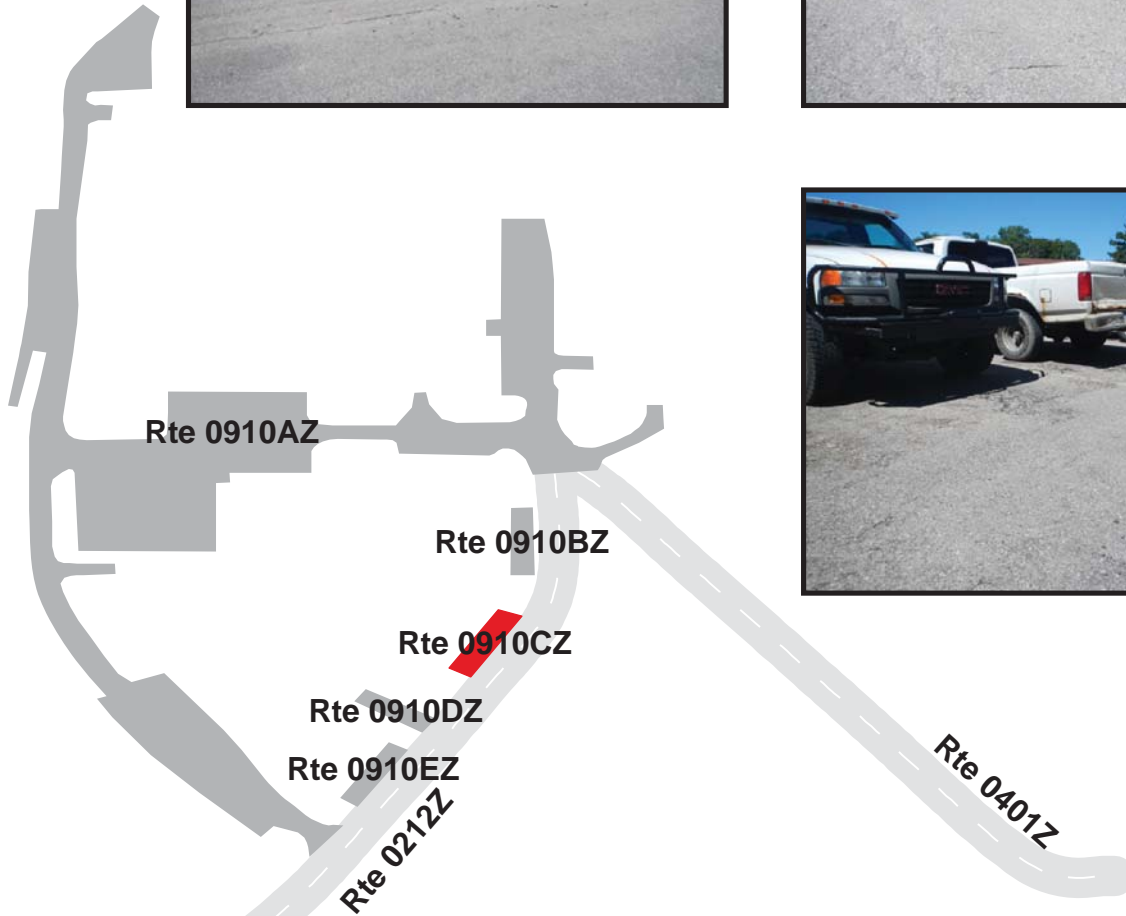
## Route 0910CZ

| Route Number | Public / NonPublic | Date Visited | Area (sq ft) | Lane Miles * | Surface Type |
|---|---|---|---|---|---|
| 0 | 0 | 0 | NO CURB AND GUTTER | NO CURB | POOR/45 |

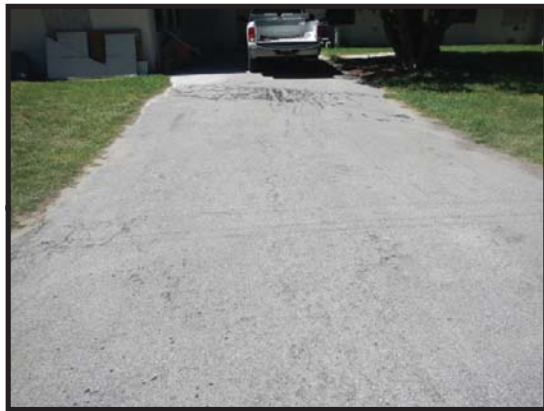
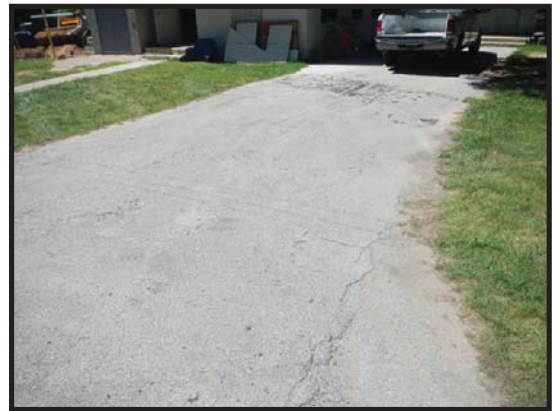
## Route 0910DZ

| Route Number | Public / NonPublic | Date Visited | Area (sq ft) | Lane Miles * | Surface Type |
|---|---|---|---|---|---|
| 0 | 0 | 0 | NO CURB AND GUTTER | NO CURB | POOR/45 |

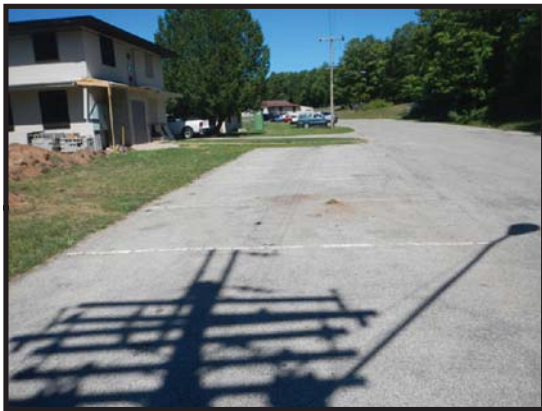
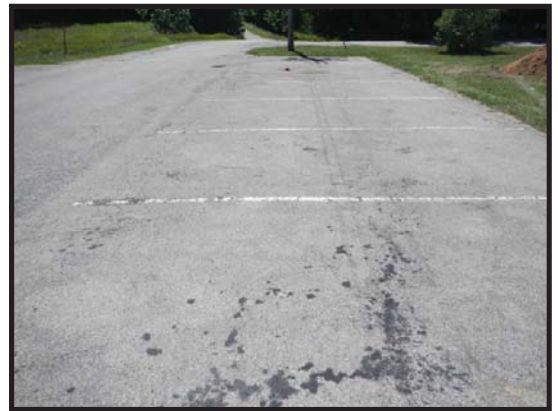
## Route 0910EZ

| Route Number | Public / NonPublic | Date Visited | Area (sq ft) | Lane Miles * | Surface Type |
|---|---|---|---|---|---|
| 0 | 0 | 0 | NO CURB AND GUTTER | NO CURB | FAIR/73 |

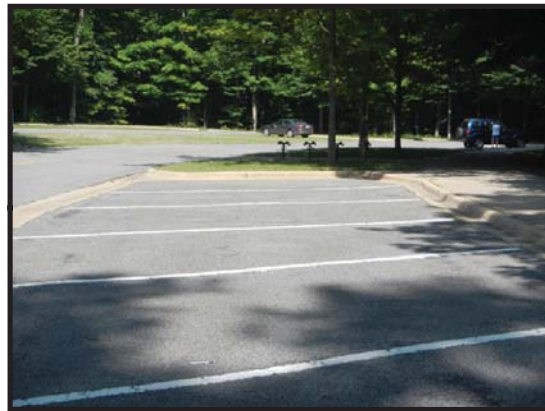
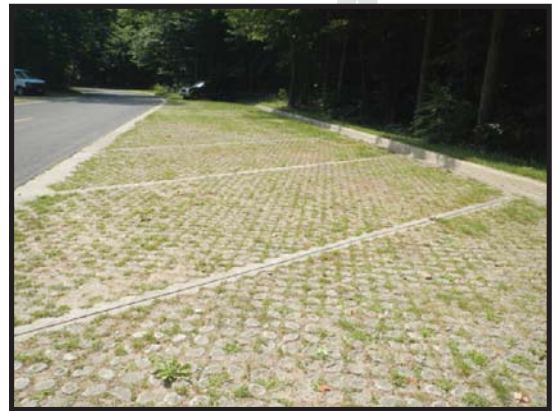
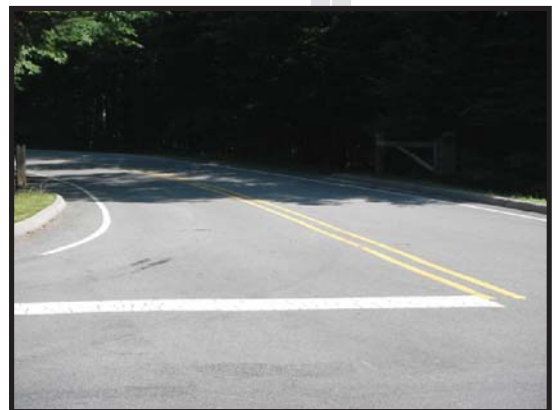
## Route 0911ZZ

| Route Number | Public / NonPublic | Date Visited | Area (sq ft) | Lane Miles * | Surface Type |
|---|---|---|---|---|---|
| 0 | 0 | 1 | CONCRETE CURB AND GUTTER | ASPHALT CURB | GOOD/90 |

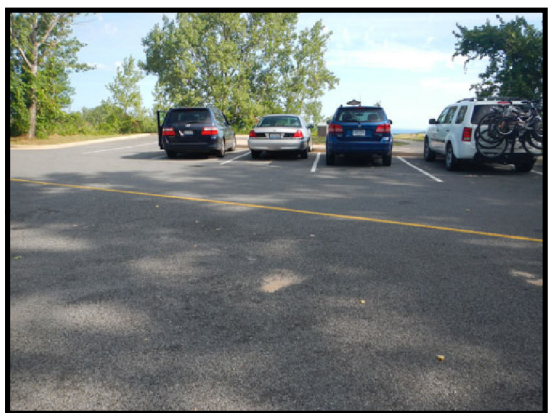
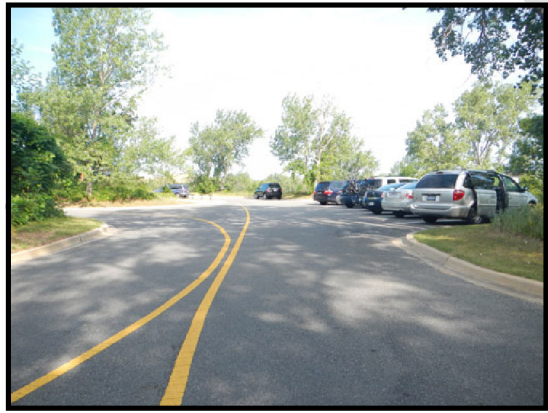
## Route 0914Z

| Route Number | Public / NonPublic | Date Visited | Area (sq ft) | Lane Miles * | Surface Type |
|---|---|---|---|---|---|
| 0 | 1 | 0 | CONCRETE CURB AND GUTTER | NO CURB | GOOD/90 |

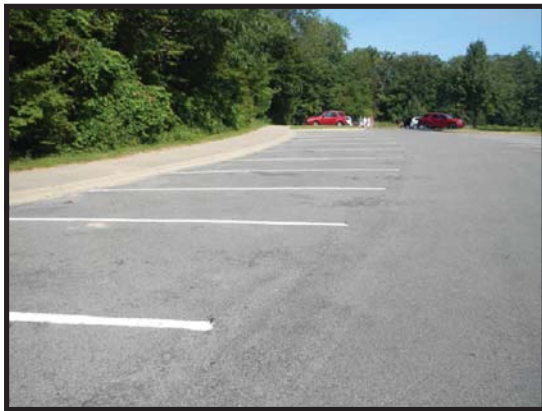
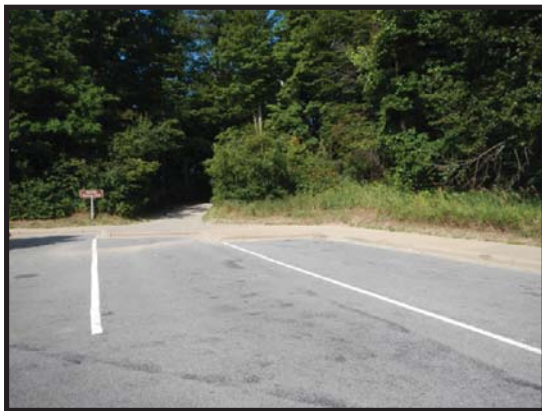
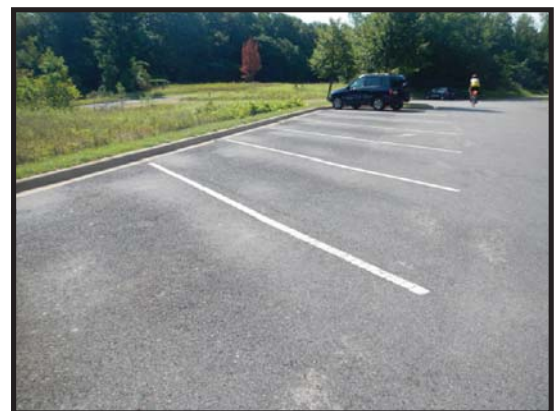
## Route 0918Z

| Route Number | Public / NonPublic | Date Visited | Area (sq ft) | Lane Miles * | Surface Type |
|---|---|---|---|---|---|
| 0 | 3 | 1 | CONCRETE CURB AND GUTTER | NO CURB | GOOD/90 |

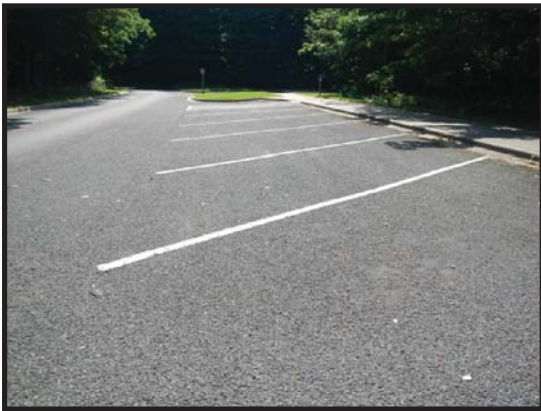
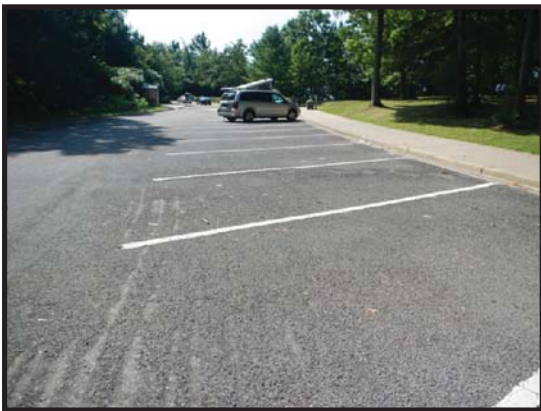
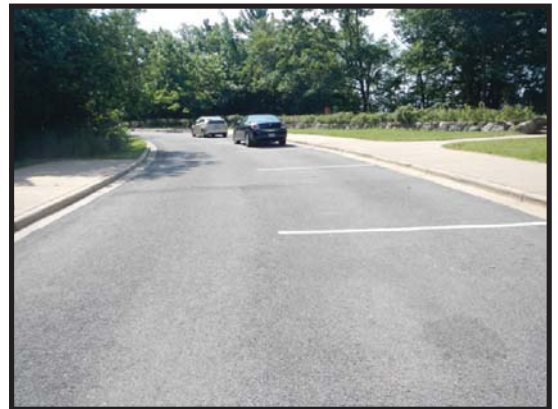
## Route 0919Z

| Route Number | Public / NonPublic | Date Visited | Area (sq ft) | Lane Miles * | Surface Type |
|---|---|---|---|---|---|
| 0 | 2 | 1 | CONCRETE CURB AND GUTTER | NO CURB | GOOD/90 |

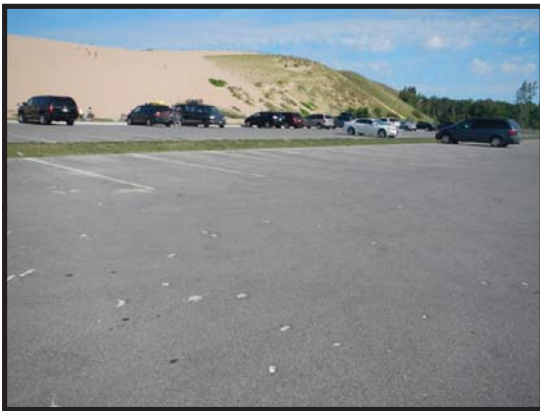
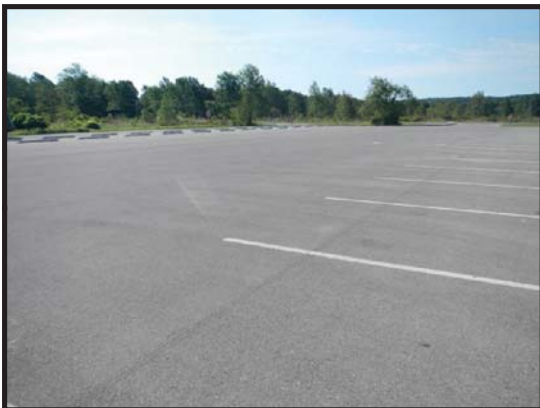
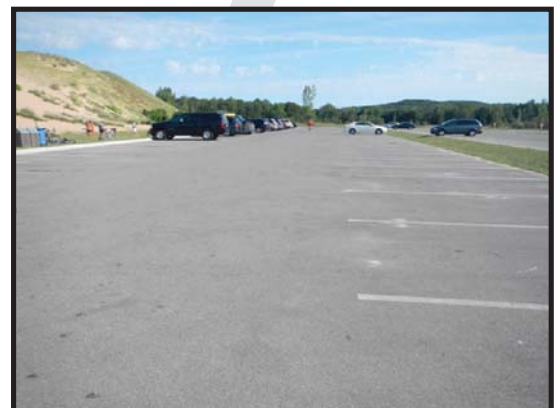
## Route 0920

| Route Number | Public / NonPublic | Date Visited | Area (sq ft) | Lane Miles * | Surface Type |
|---|---|---|---|---|---|
| 0 | 0 | 0 | CONCRETE CURB AND GUTTER | NO CURB | GOOD/90 |

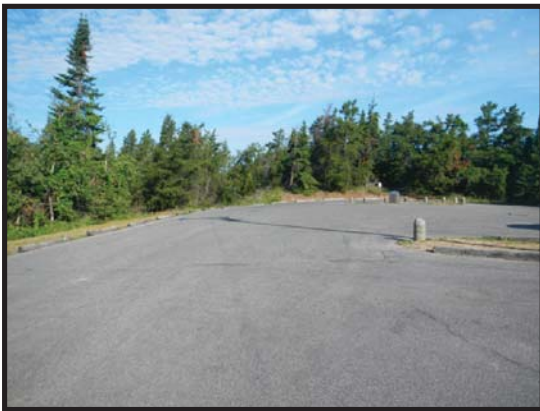
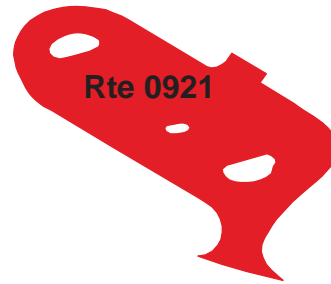
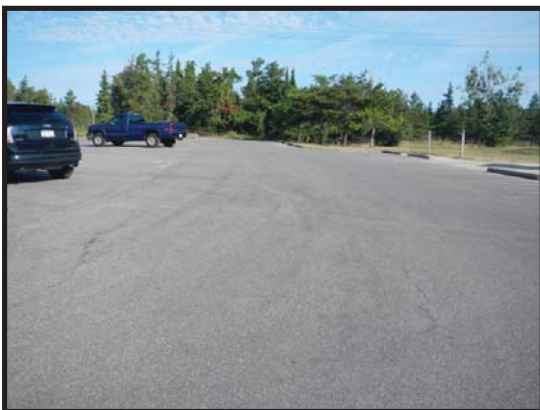
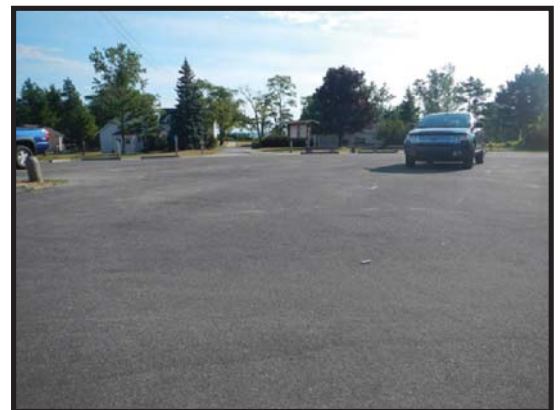
## Route 0921

| Route Number | Public / NonPublic | Date Visited | Area (sq ft) | Lane Miles * | Surface Type |
|---|---|---|---|---|---|
| 0 | 0 | 0 | NO CURB AND GUTTER | NO CURB | FAIR/73 |
