Federal Lands Highway Road Inventory Program

Road Inventory and Condition Assessment

Sunset Crater Volcano National Monument SUCR

Cycle 5 Report

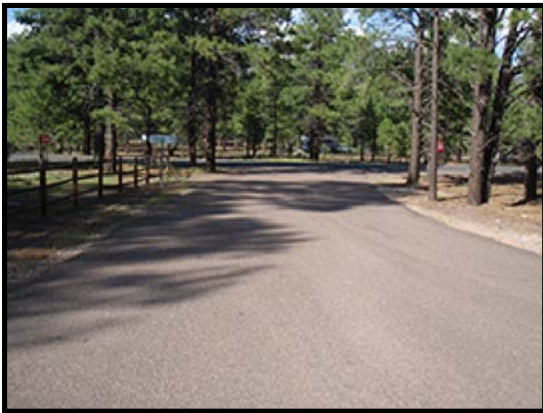
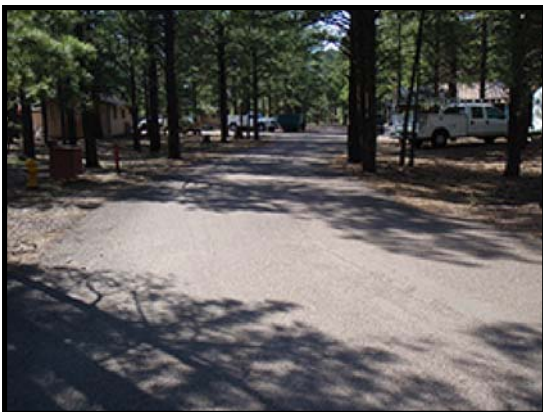
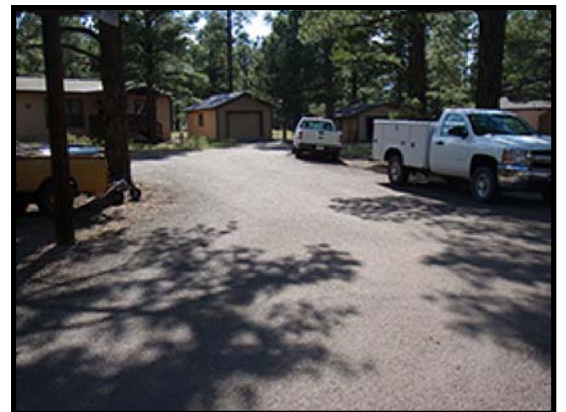
| Route Number | Public / NonPublic | Date Visited | Area (sq ft) | Lane Miles * | Surface Type |
|---|---|---|---|---|---|
| 0 | 0 | 0 | NO CURB AND GUTTER | CONCRETE CURB | GOOD/90 |

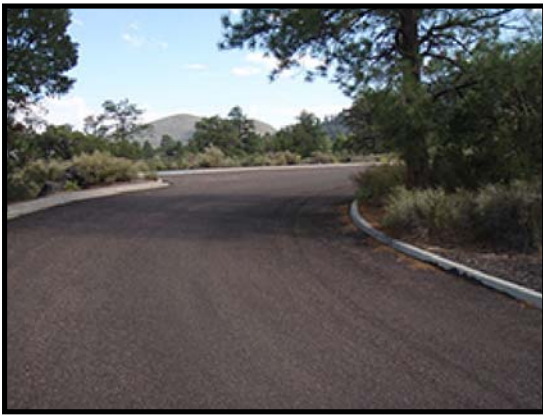
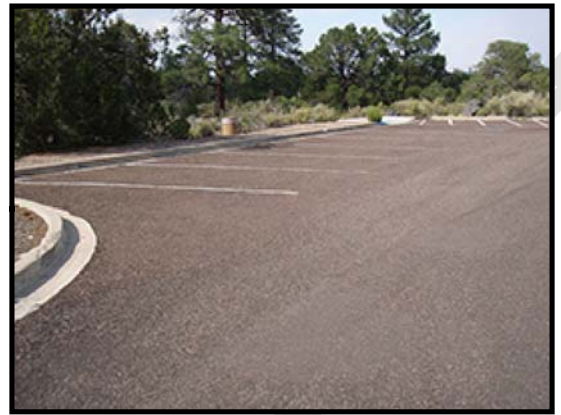
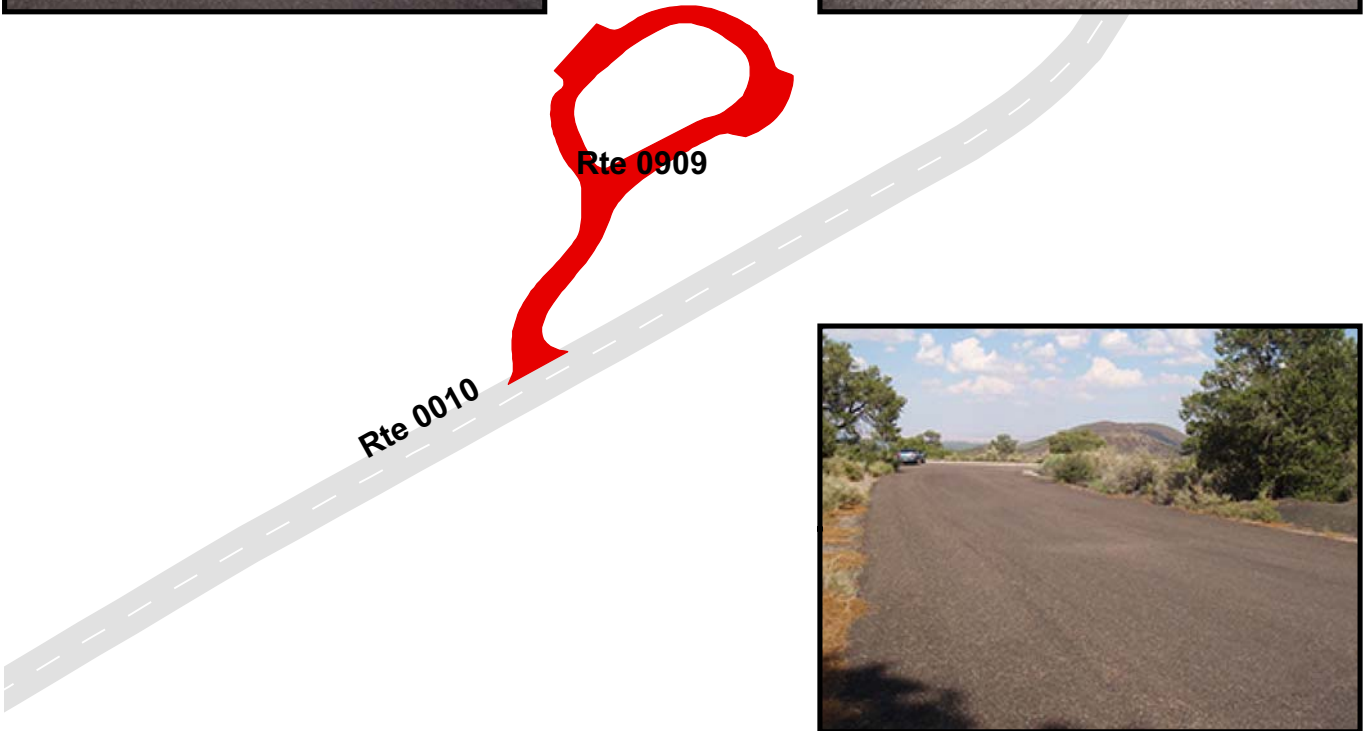
| Route Number | Public / NonPublic | Date Visited | Area (sq ft) | Lane Miles * | Surface Type |
|---|---|---|---|---|---|
| 0 | 1 | 0 | CONCRETE CURB AND GUTTER | CONCRETE CURB | GOOD/90 |

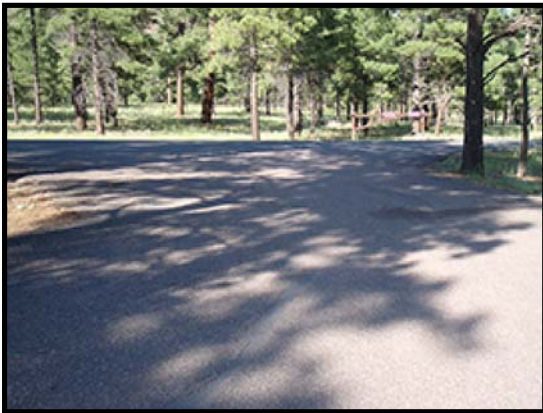
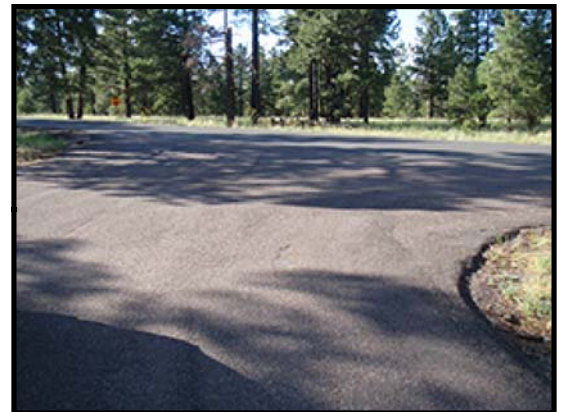
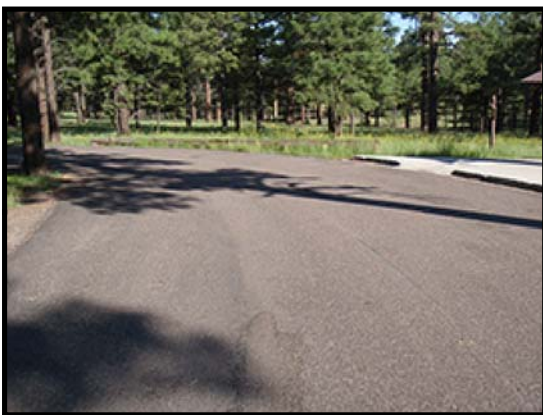
Route 0916

| Route Number | Public / NonPublic | Date Visited | Area (sq ft) | Lane Miles * | Surface Type |
|---|---|---|---|---|---|
| 0 | 0 | 0 | NO CURB AND GUTTER | NO CURB | GOOD/90 |

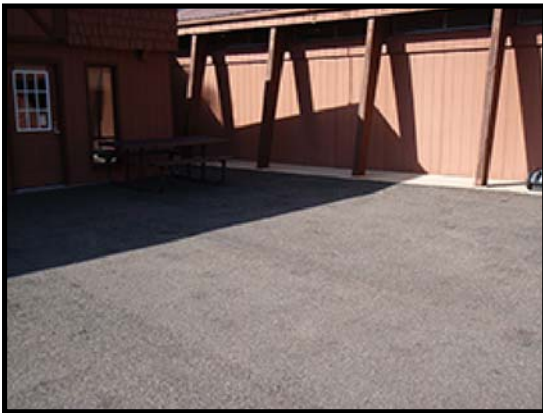
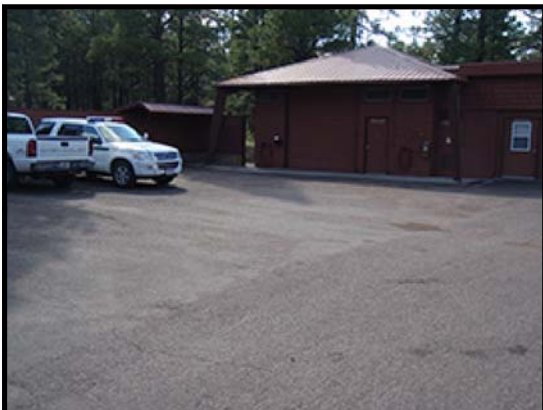
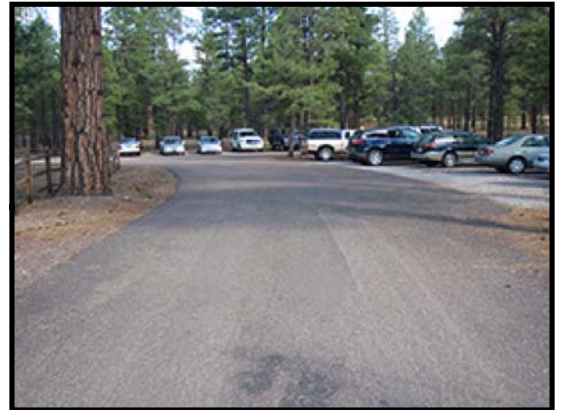
Route 0919

| Route Number | Public / NonPublic | Date Visited | Area (sq ft) | Lane Miles * | Surface Type |
|---|---|---|---|---|---|
| 0 | 1 | 0 | NO CURB AND GUTTER | NO CURB | FAIR/73 |
