# Federal Lands Highway Road Inventory Program

Road Inventory and Condition Assessment

## Walnut Canyon National Monument WACA

### Cycle 5 Report

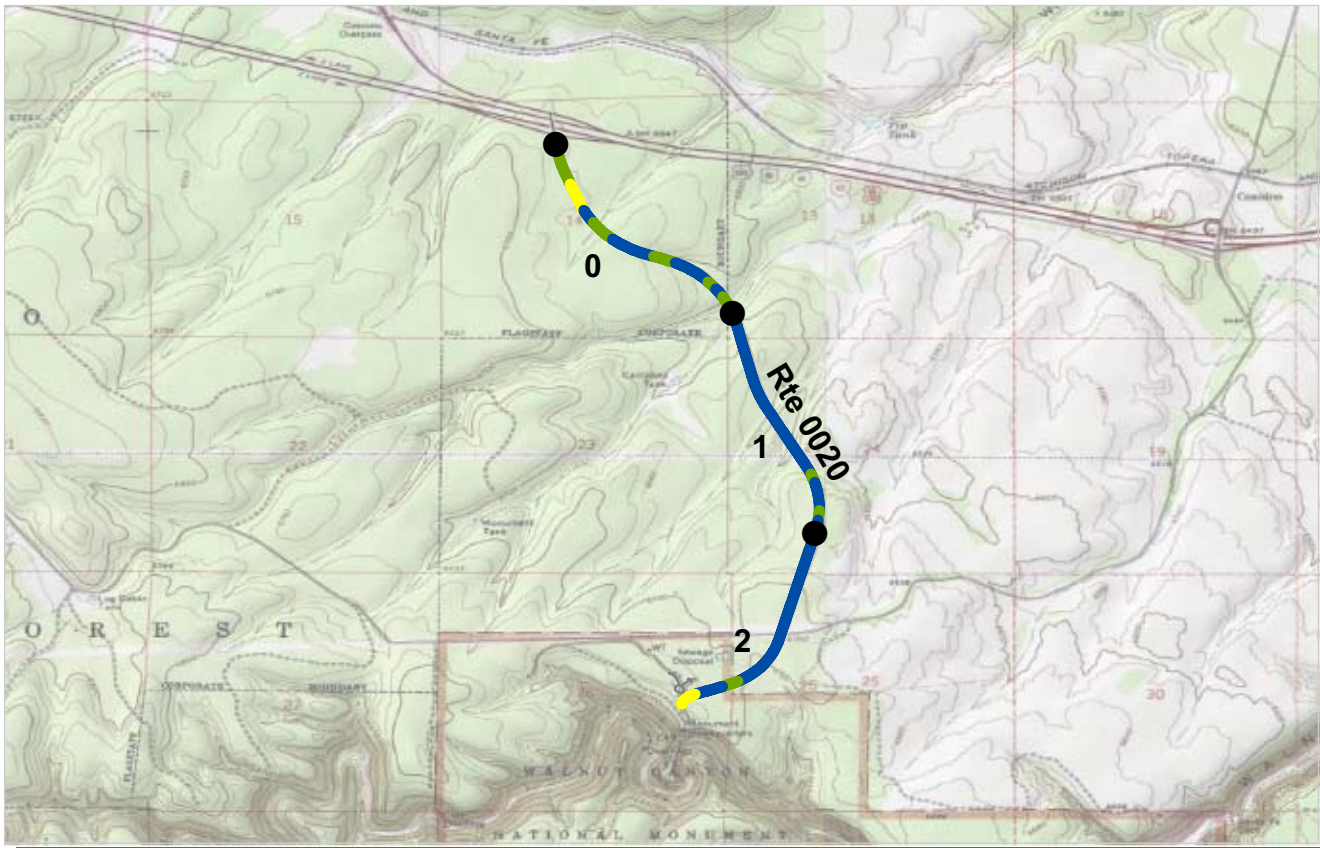
**ROUTE: 0020 WALNUT CANYON ENTRANCE ROAD**

PCR    Poor ■    Fair ■    Good ■    Excellent ■    No Data ■  
           (0 - 60)           (61 - 84)           (85 - 94)           (95 - 100)

\* If the PCR rating is not available for a section, the SCR rating will be displayed. See appendix for definitions and formulas.

<i>Section Number</i>	0	1	2		
<i>Section Length (mi)</i>	1.00	1.00	0.93		
<i>Cross Section Information</i>					
Number of Lanes	2	2	2		
Paved Width (ft)	28	26	26		
Lane Width (ft)	12	12	12		
<i>Roadway Condition Information</i>					
SCR (Surface Condition Rating)	92	95	95		
PCR (Pavement Condition Rating)	90	97	97		
<i>Distress Index Values</i>					
Structural Crack Index	95	100	100		
Transverse Cracking Index	92	95	95		
Patching Index	100	100	100		
Rutting Index	99	100	100		
Roughness Condition Index (RCI)	87	100	100

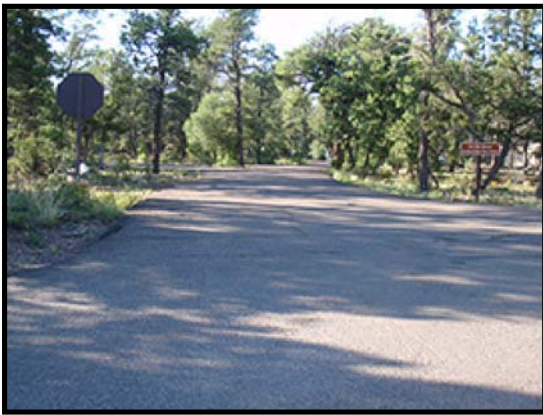
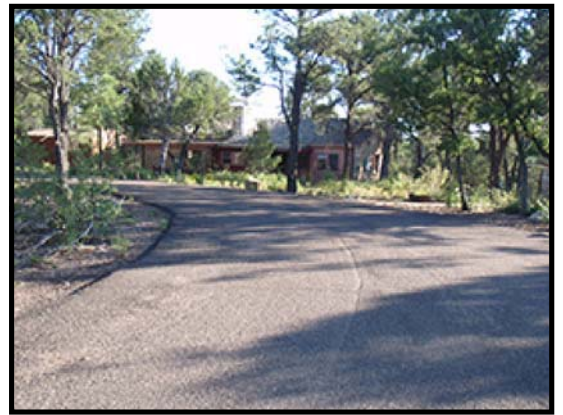
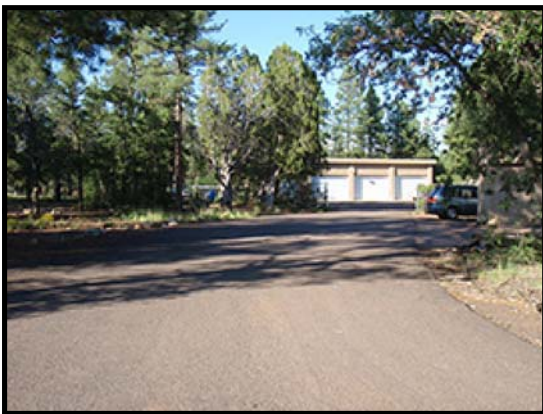
Route Number	Public / NonPublic	Date Visited	Area (sq ft)	Lane Miles *	Surface Type
0405	PUBLIC	8/31/2011	36,368	0.63	AS
Culverts	Drop Inlets	Gates	Curb & Gutter	Curb	PCR
0	0	1	NO CURB AND GUTTER	NO CURB	GOOD/90

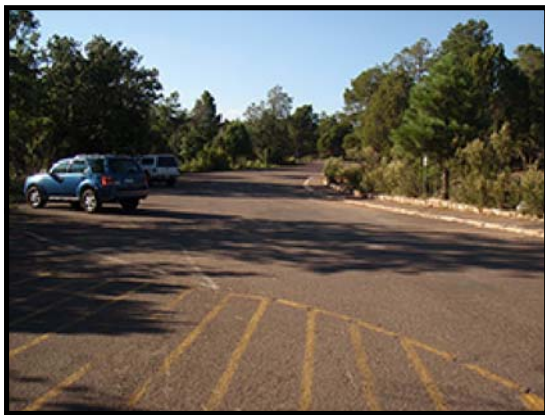
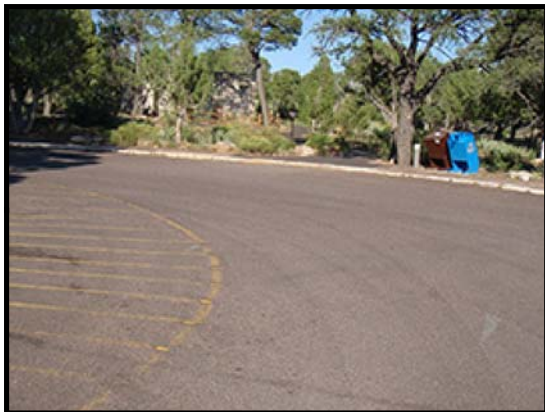
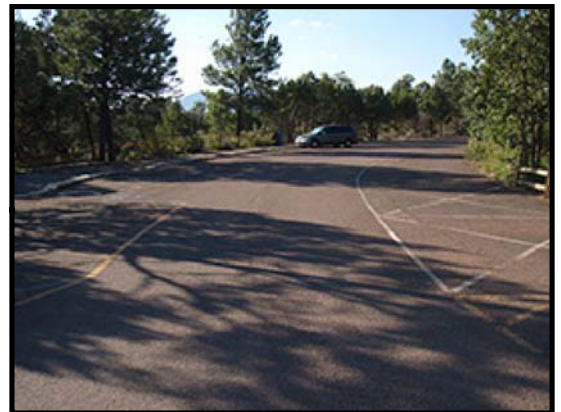
Route Number	Public / NonPublic	Date Visited	Area (sq ft)	Lane Miles *	Surface Type
0918	PUBLIC	8/31/2011	33,751	0.58	AS
Culverts	Drop Inlets	Gates	Curb & Gutter	Curb	PCR
0	2	0	NO CURB AND GUTTER	STONE CURB	FAIR/73

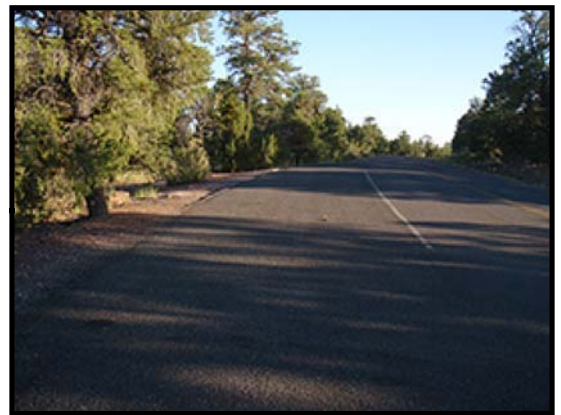
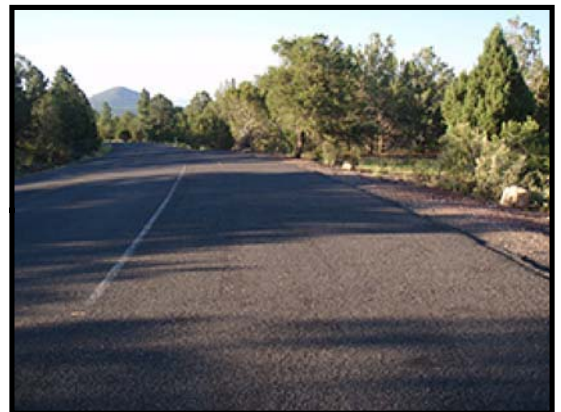
## Route 0919

Route Number	Public / NonPublic	Date Visited	Area (sq ft)	Lane Miles *	Surface Type
0919	PUBLIC	8/31/2011	1,968	0.03	AS
Culverts	Drop Inlets	Gates	Curb & Gutter	Curb	PCR
0	0	0	NO CURB AND GUTTER	NO CURB	GOOD/90
