# Federal Lands Highway Road Inventory Program

Road Inventory and Condition Assessment

**White Sands National Monument**

**Cycle 5 Report**

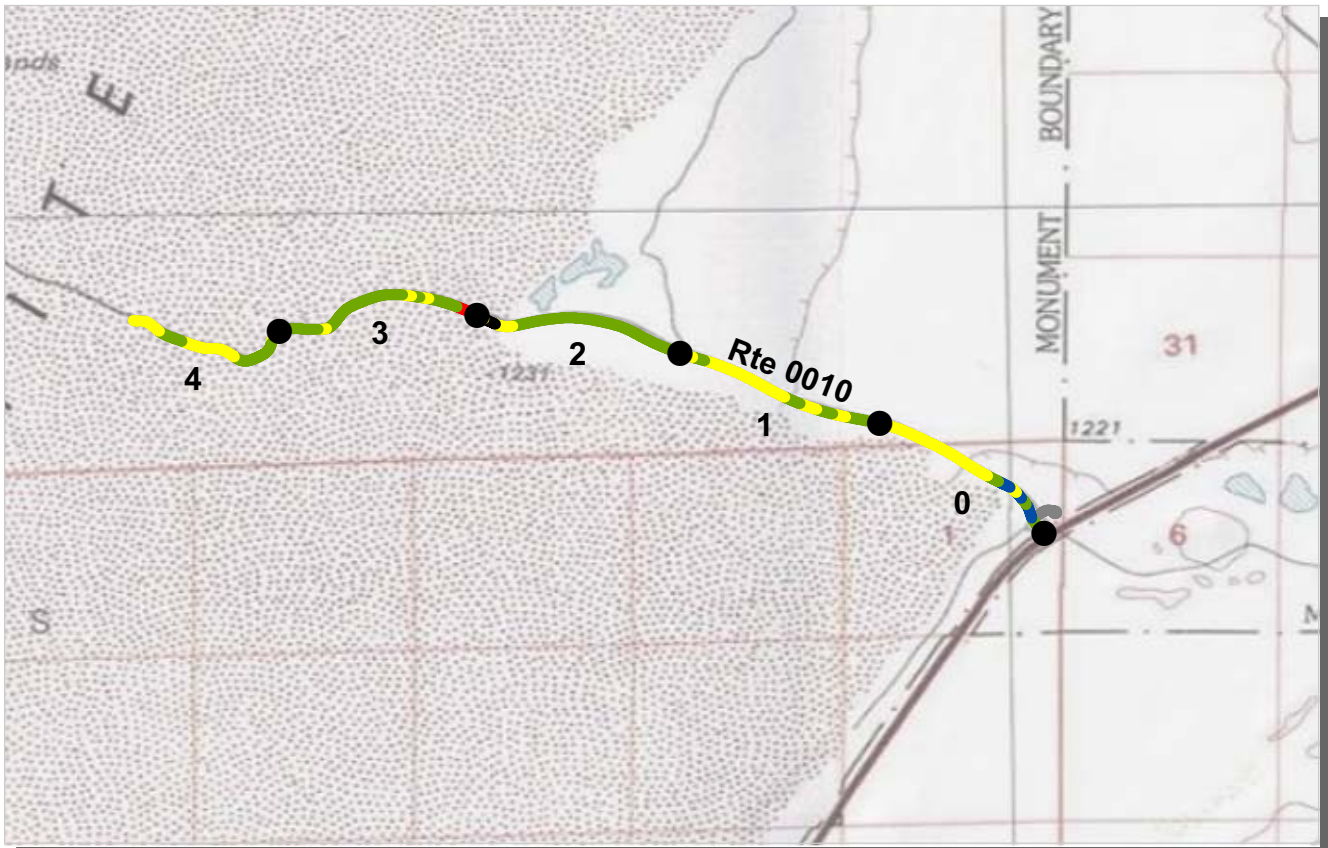
<i>Section Number</i>	0	1	2	3	4
<i>Section Length (mi)</i>	1.00	1.00	1.00	1.00	0.82
<i>Cross Section Information</i>					
Number of Lanes	2	2	2	2	2
Paved Width (ft)	26	21	21	21	21
Lane Width (ft)	10	10	10	10	10
<i>Roadway Condition Information</i>					
SCR (Surface Condition Rating)	90	85	79	73	75
PCR (Pavement Condition Rating)	80	81	87	84	85
<i>Distress Index Values</i>					
Structural Crack Index	92	94	95	91	92
Transverse Cracking Index	90	85	79	73	75
Patching Index	100	100	100	100	100
Rutting Index	94	94	94	93	91
Roughness Condition Index (RCI)	66	74	100	100	100

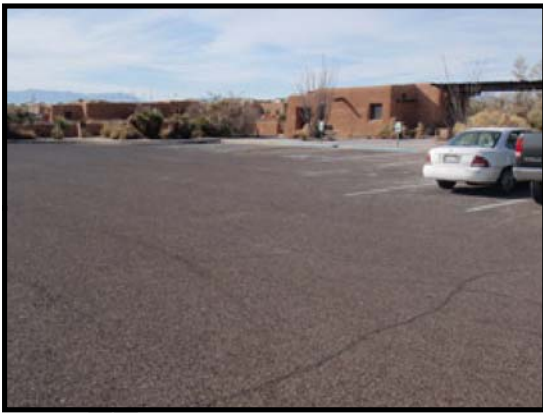
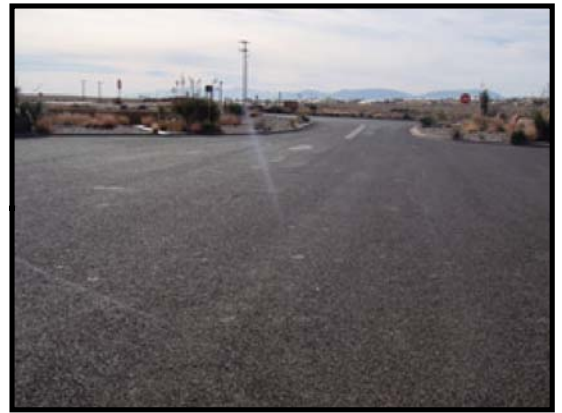
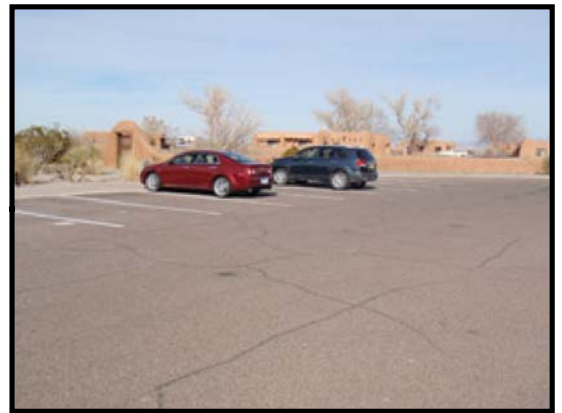
## Route 0900

Route Number	Public / NonPublic	Date Visited	Area (sq ft)	Lane Miles *	Surface Type
0900	PUBLIC	12/4/2010	32,622	0.56	AS
Culverts	Drop Inlets	Gates	Curb & Gutter	Curb	PCR
0	0	0	CONCRETE CURB AND GUTTER	CONCRETE CURB	FAIR/73

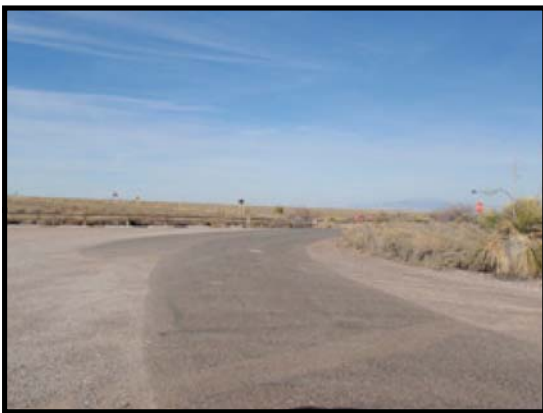
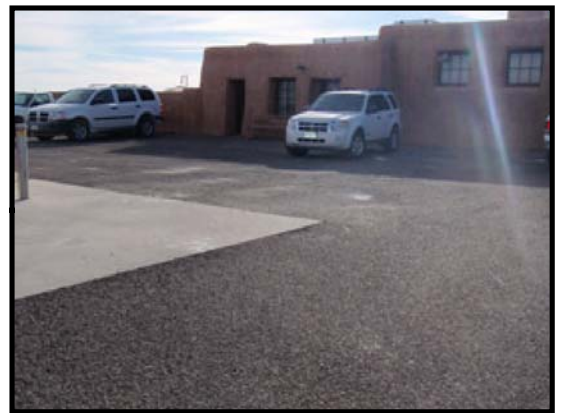
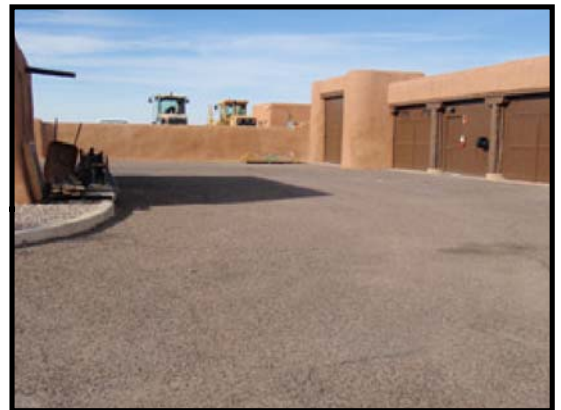
## Route 0901

Route Number	Public / NonPublic	Date Visited	Area (sq ft)	Lane Miles *	Surface Type
0901	NONPUBLIC	12/4/2010	14,328	0.25	AS
Culverts	Drop Inlets	Gates	Curb & Gutter	Curb	PCR
0	0	0	NO CURB AND GUTTER	CONCRETE CURB	FAIR/73

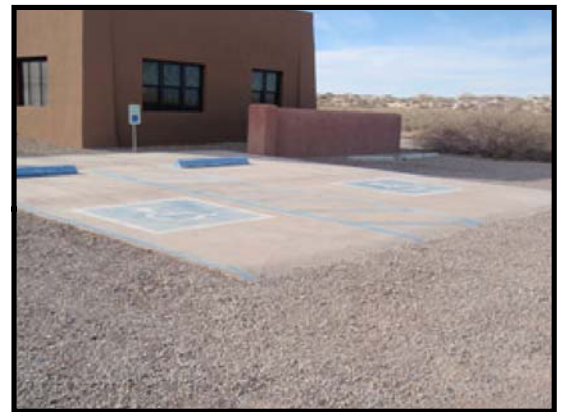
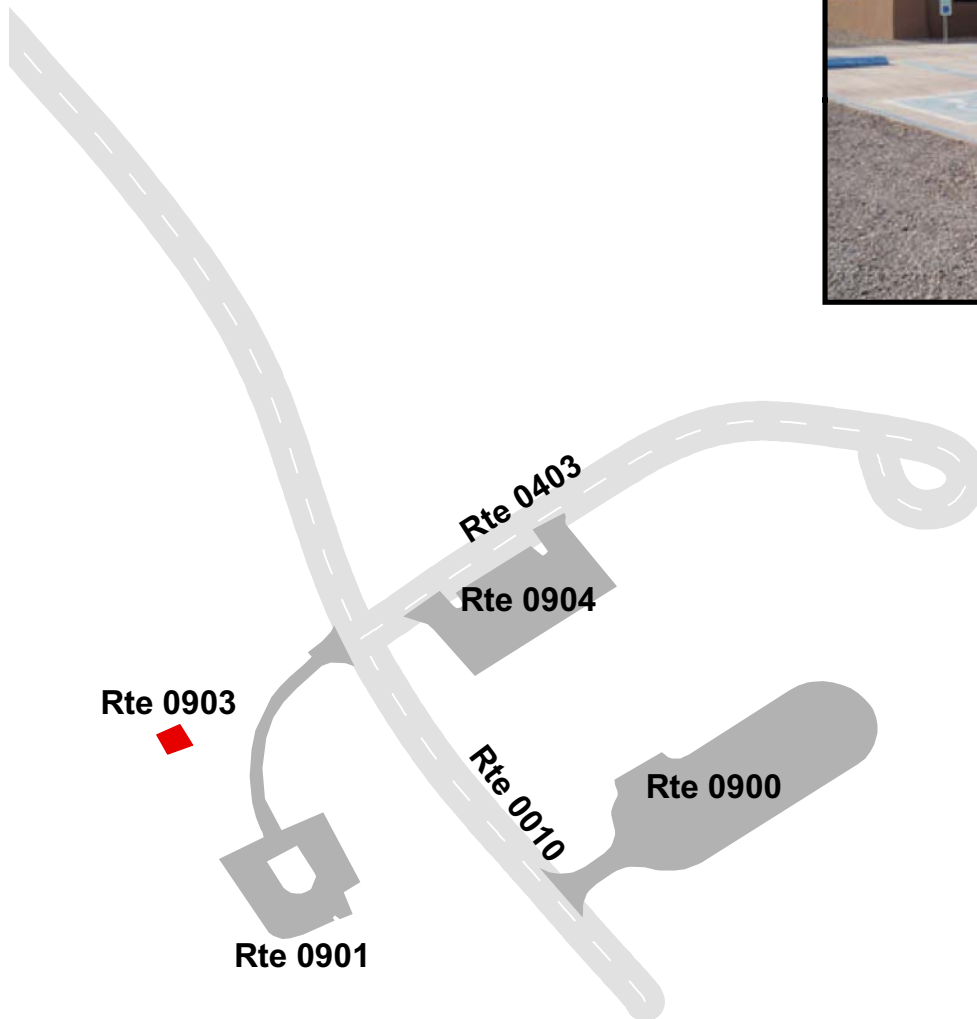
## Route 0903

Route Number	Public / NonPublic	Date Visited	Area (sq ft)	Lane Miles *	Surface Type
0903	PUBLIC	12/4/2010	649	0.01	CO
Culverts	Drop Inlets	Gates	Curb & Gutter	Curb	PCR
0	0	0	NO CURB AND GUTTER	NO CURB	GOOD/90

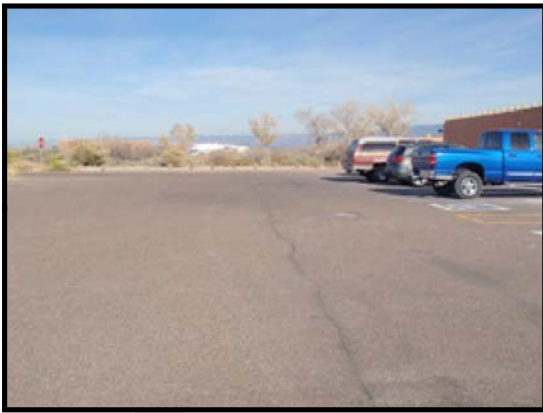
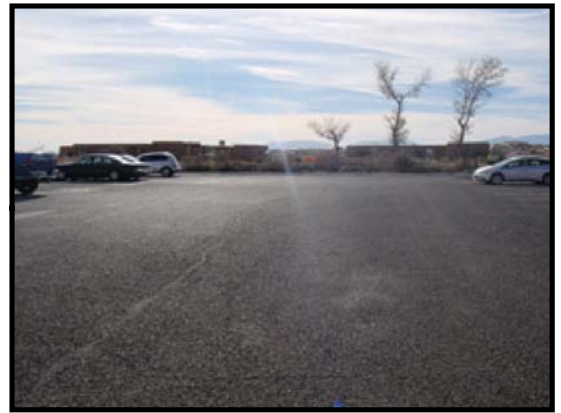
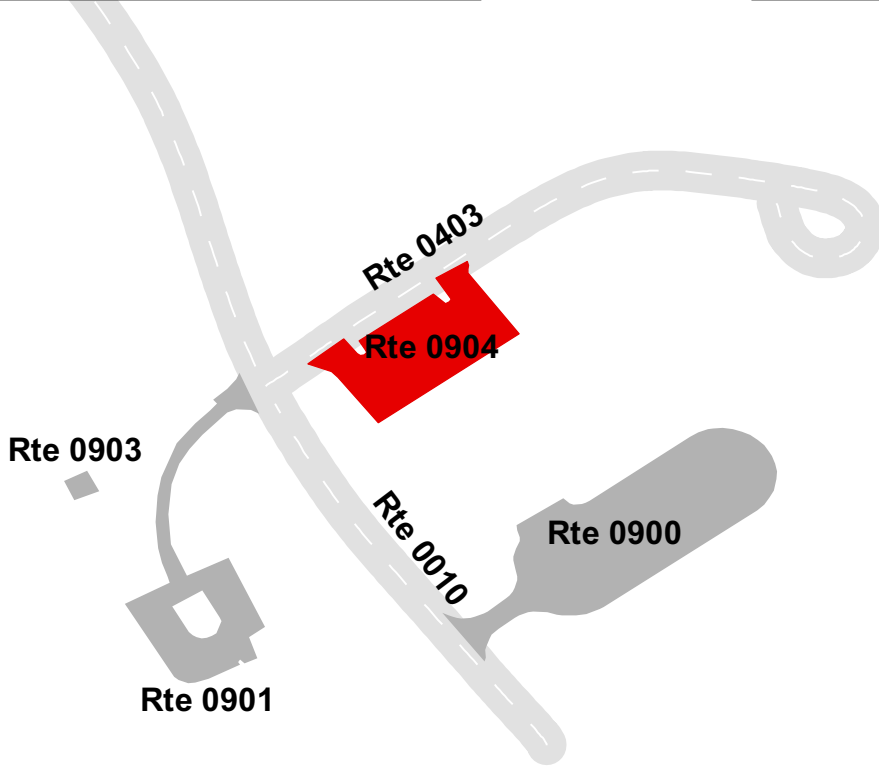
## Route 0904

Route Number	Public / NonPublic	Date Visited	Area (sq ft)	Lane Miles *	Surface Type
0904	PUBLIC	12/4/2010	15,745	0.27	AS
Culverts	Drop Inlets	Gates	Curb & Gutter	Curb	PCR
0	0	0	CONCRETE CURB AND GUTTER	CONCRETE CURB	FAIR/73
