Road Inventory and Condition Assessment

Wrangell-St. Elias National Park & Preserve WRST – 9865

Cycle 5 Report

Prepared By: Federal Highway Administration Road Inventory Program (RIP) Data Collection Date: 07/2010 Report Date: 08/2011

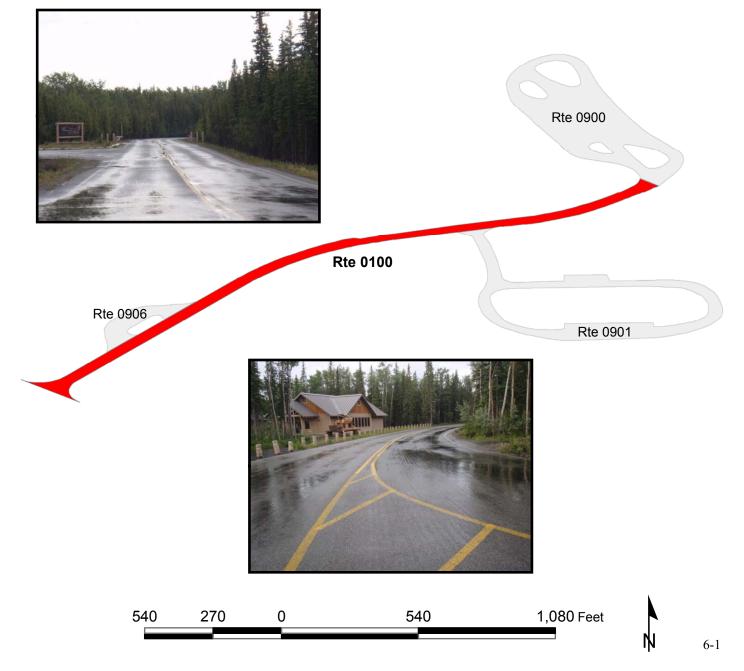
COPPER CENTER HQ & VC ROAD FROM RICHARDSON HIGHWAY / NON NPS TO ROUTE 0900 (COPPER CENTER VISITOR PARKING AREA)

Route Number	Public / Non Public	Date Visited	Area (sq ft)	Lane Miles *	Surface Type
0100	PUBLIC	7/1/2010	41295	0.711	AS
Culverts	Drop Inlets	Gates	Curb & Gutter	Curb	PCR
1	0	2	NO CURB AND GUTTER	NO CURB	GOOD/90

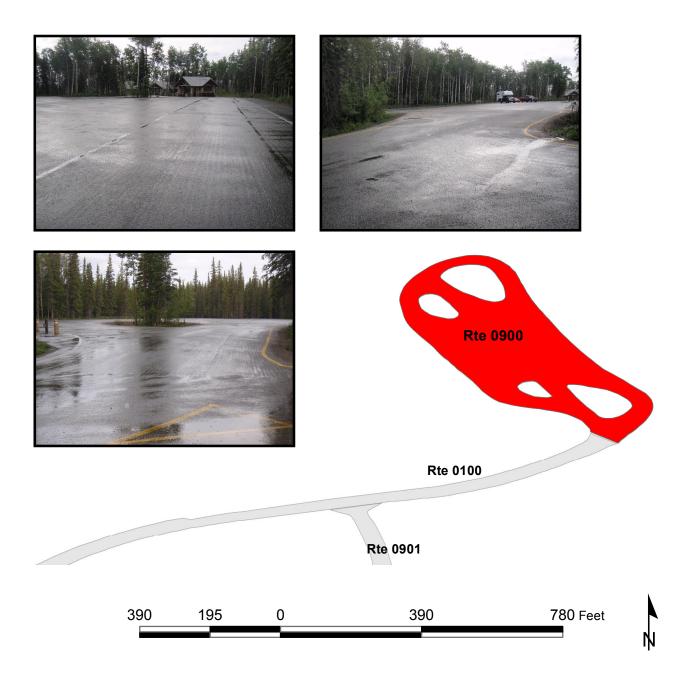
COPPER CENTER VISTOR PARKING AREA

Route Number	Public / Non Public	Date Visited	Area (sq ft)	Lane Miles *	Surface Type
0900	Public	7/1/2010	6735	0.116	AS
Culverts	Drop Inlets	Gates	Curb & Gutter	Curb	PCR
0	0	0	NO CURB AND GUTTER	NO CURB	FAIR/73

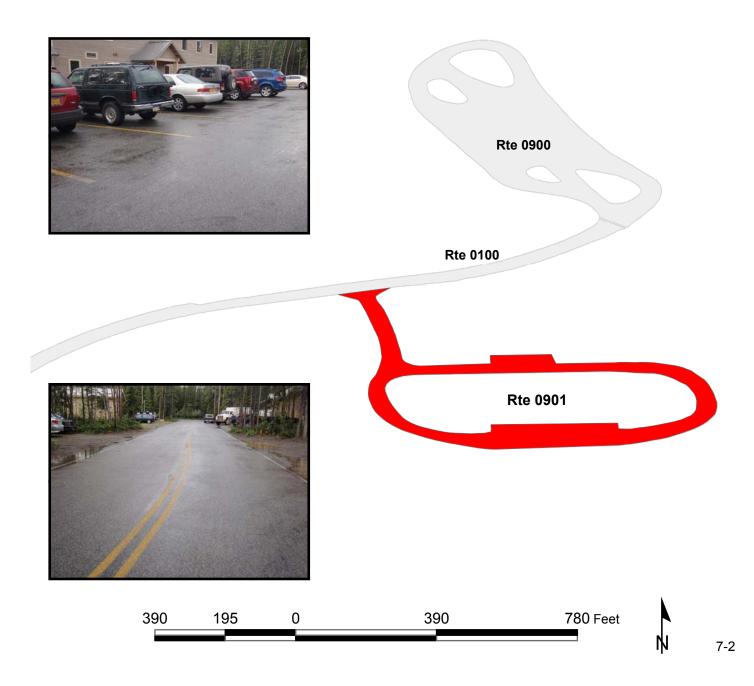
COPPER CENTER ADMIN PARKING AREA

Route Number	Public / Non Public	Date Visited	Area (sq ft)	Lane Miles *	Surface Type
0901	Public	7/1/2010	43791	0.754	AS
Culverts	Drop Inlets	Gates	Curb & Gutter	Curb	PCR
0	0	0	NO CURB AND GUTTER	NO CURB	GOOD/90

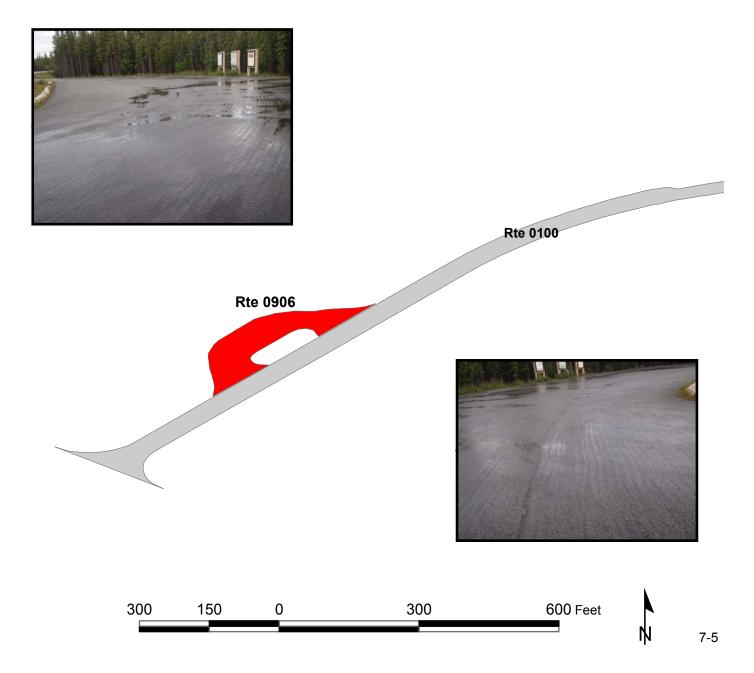
COPPER CENTER HEADQUARTERS ENTRANCE WAYSIDE PARKING

Route Number	Public / Non Public	Date Visited	Area (sq ft)	Lane Miles *	Surface Type
0906	Public	7/1/2010	9968	0.172	AS
Culverts	Drop Inlets	Gates	Curb & Gutter	Curb	PCR
0	0	0	NO CURB AND GUTTER	NO CURB	GOOD/90
