ANJO Cycle 6

Final Report

Road Inventory and Condition Assessment of Paved Routes Andrew Johnson National Historic Site

Report Date: May 2022

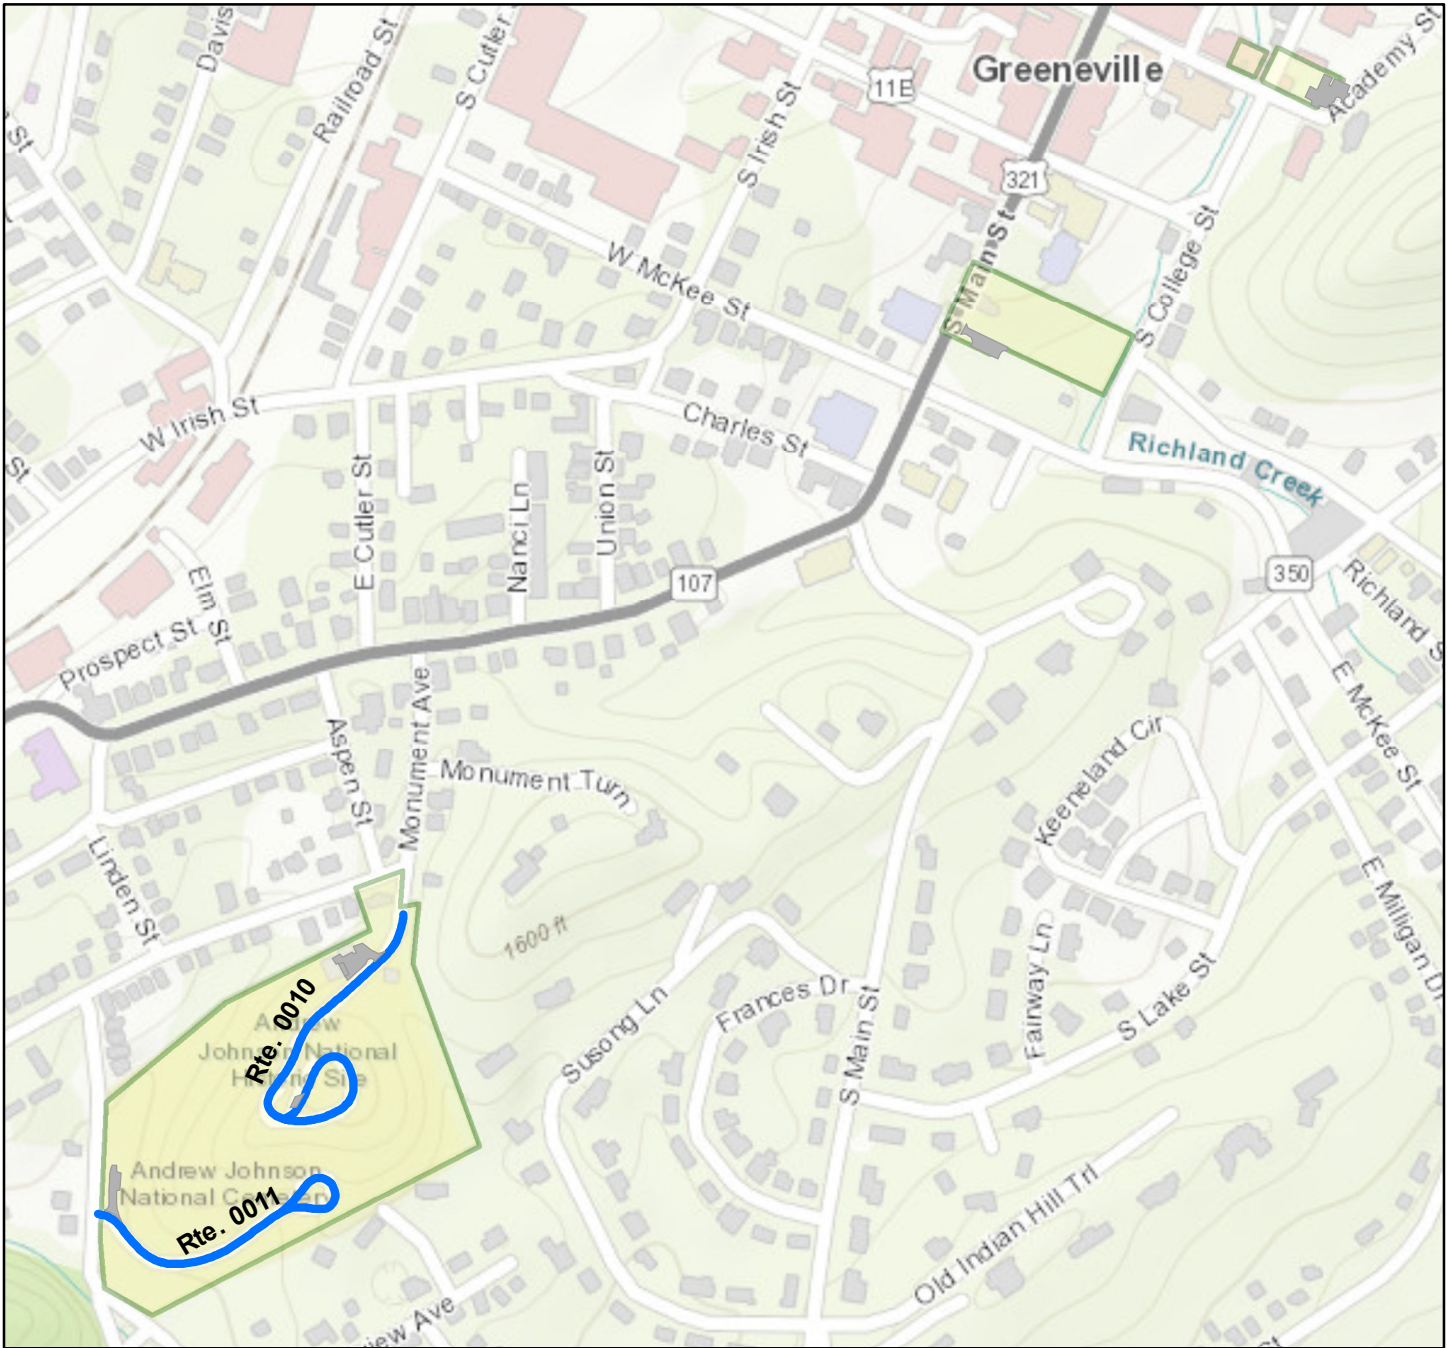
Area Map 1

ROUTE CONDITION MAP

PCR - MILE BY MILE

Colors on map represent condition scores at 1-mile intervals. See Appendix for definitions and formulas
 Only Data Collection Vehicle and Manually Rated Roads are displayed

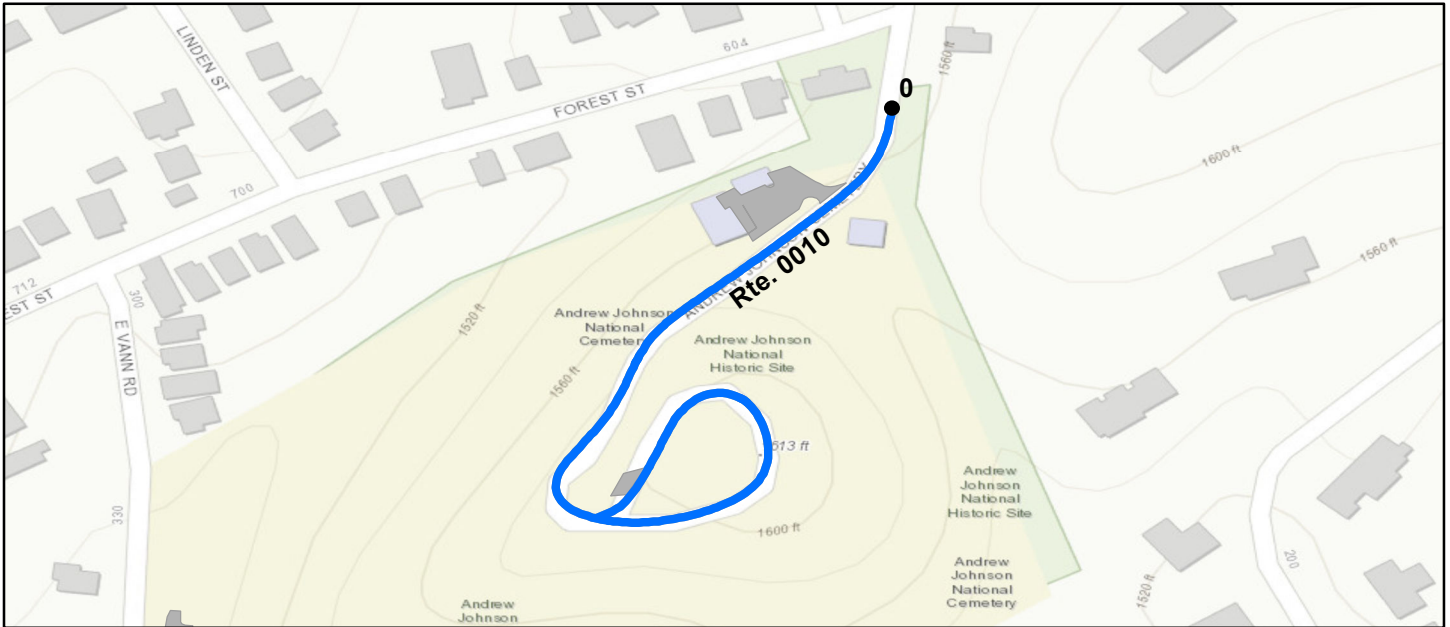
ROUTE 0010: MONUMENT AVENUE

Route Condition Legend – Pavement Condition Rating (PCR)										
Poor (0 - 60)		Fair (61- 84)		Good (85 - 94)		Excellent (95 - 100)		Not Rated		
Colors on map represent condition scores at 0.10-mile intervals. See Appendix for definitions and formulas.										
Inspection Date: 7/14/2021		Beginning Section MP		0						
Paved Length (Miles): 0.25		Section Length (MI)		0.25						
Surface Type: ASPHALT		Route Summary								
Roadway Condition Information										
Pavement Condition Rating (PCR)		98		98						
Surface Condition Rating (SCR)		98		98						
Roughness Condition Index (RCI)		N/A		N/A						
Distress Index Values										
Structural Crack Index		100		100						
Alligator Crack Index		100		100						
Longitudinal Crack Index		100		100						
Transverse Cracking Index		100		100						
Patching Index		100		100						
Rutting Index		98		98						
International Roughness Index (IRI)		N/A		N/A						
Lane & Width Information

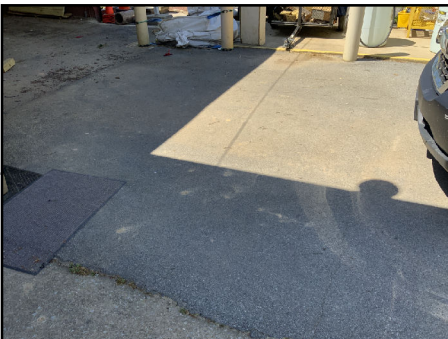
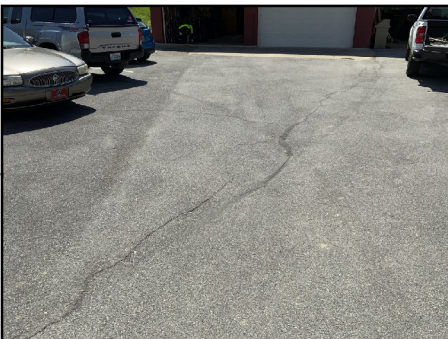
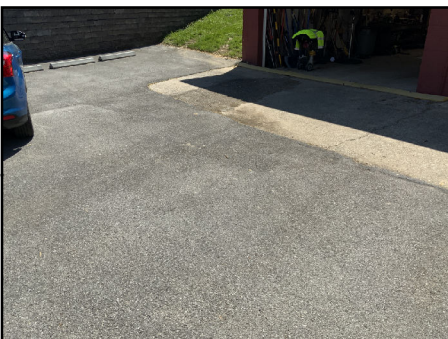
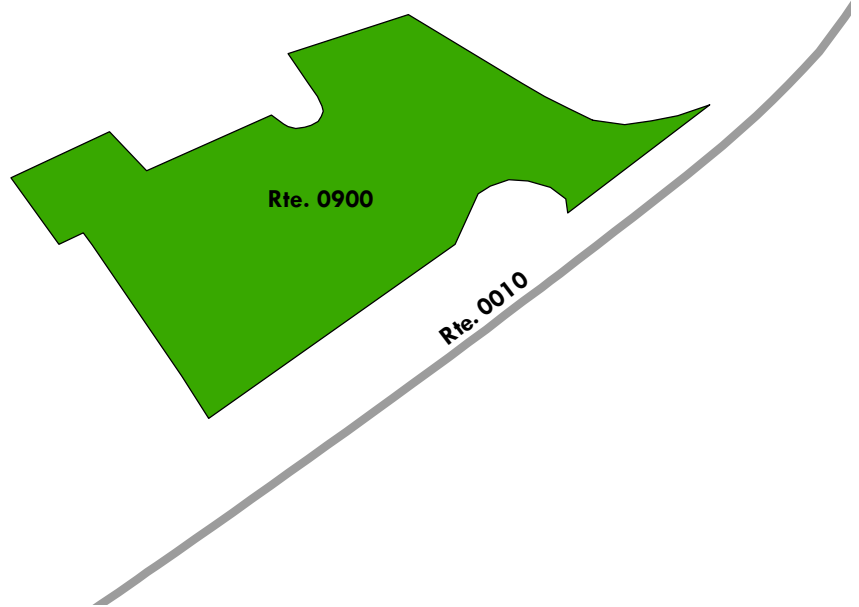
Inspection Date	FMSS Number	User Access	Surface Type
4/12/2021	74023	PUBLIC	ASPHALT
Area (Sq. Ft.)	Lane Miles (11' Widths)	Curb Reveal (Inches)	Curb Recommendation
5,171	0.089	3	DO NOTHING
Curb Type		Curb & Gutter Type	
CONCRETE		NO CURB AND GUTTER	
Pavement Recommendation		Condition Rating / PCR	
PREVENTIVE MAINTENANCE		GOOD / 90

MULTIPLE SURFACE TYPES: ASPHALT = 4,738 SQFT; CONCRETE = 433 SQFT.

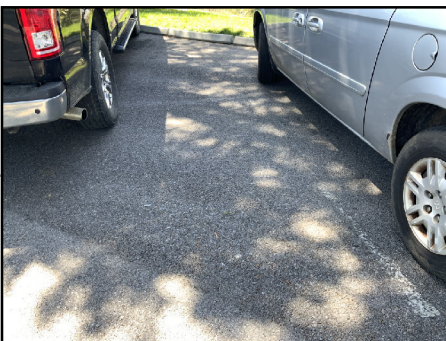
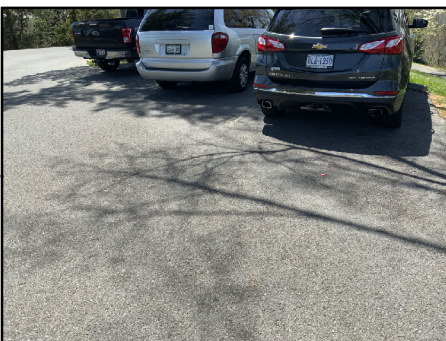
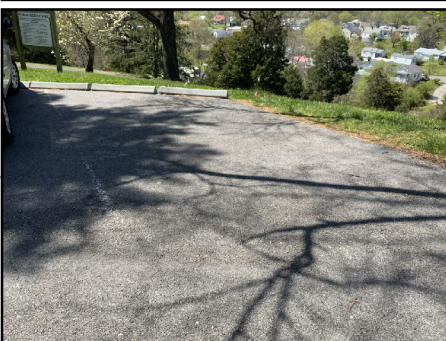
ROUTE 0901: MONUMENT PARKING

Inspection Date	FMSS Number	User Access	Surface Type
4/12/2021	74026	PUBLIC	ASPHALT
Area (Sq. Ft.)	Lane Miles (11' Widths)	Curb Reveal (Inches)	Curb Recommendation
564	0.01	NOT APPLICABLE	NOT APPLICABLE
Curb Type		Curb & Gutter Type	
NO CURB		NO CURB AND GUTTER	
Pavement Recommendation		Condition Rating / PCR	
PREVENTIVE MAINTENANCE		GOOD / 90

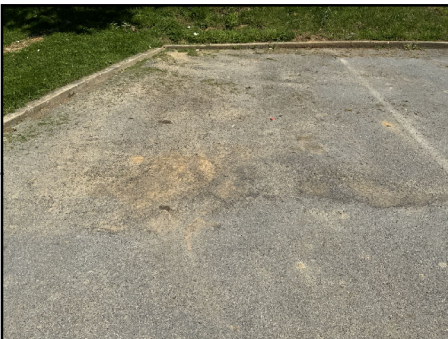
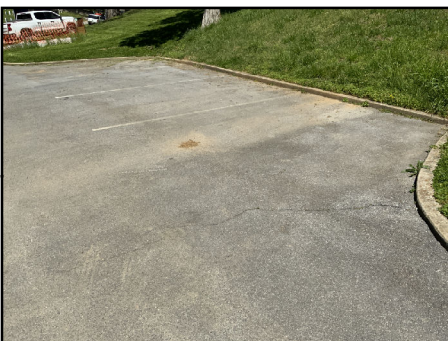
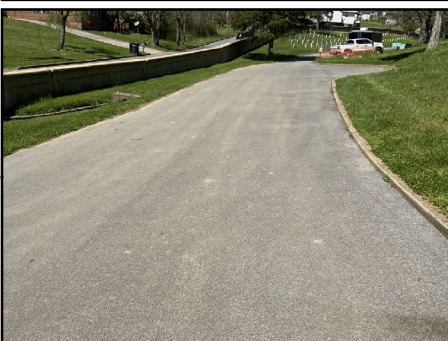
ROUTE 0902: LOWER CEMETERY PARKING

Inspection Date	FMSS Number	User Access	Surface Type
4/12/2021	74028	PUBLIC	ASPHALT
Area (Sq. Ft.)	Lane Miles (11' Widths)	Curb Reveal (Inches)	Curb Recommendation
3,014	0.052	4	DO NOTHING
Curb Type		Curb & Gutter Type	
CONCRETE		NO CURB AND GUTTER	
Pavement Recommendation		Condition Rating / PCR	
PREVENTIVE MAINTENANCE		GOOD / 90

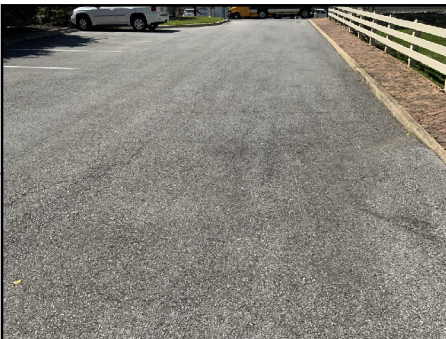
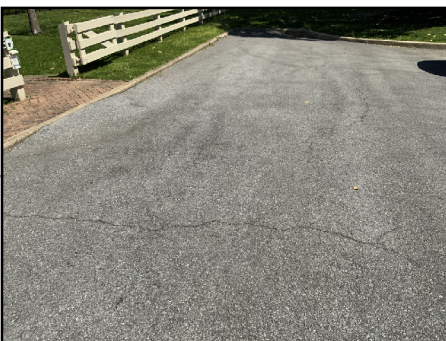
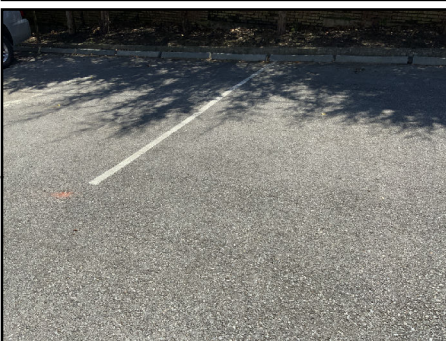
ROUTE 0903: HOMESTEAD PARKING

Inspection Date	FMSS Number	User Access	Surface Type
4/12/2021	69998	PUBLIC	ASPHALT
Area (Sq. Ft.)	Lane Miles (11' Widths)	Curb Reveal (Inches)	Curb Recommendation
3,941	0.068	6	DO NOTHING
Curb Type		Curb & Gutter Type	
CONCRETE		NO CURB AND GUTTER	
Pavement Recommendation		Condition Rating / PCR	
PREVENTIVE MAINTENANCE		GOOD / 90

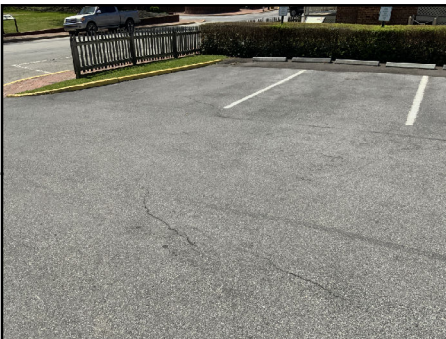
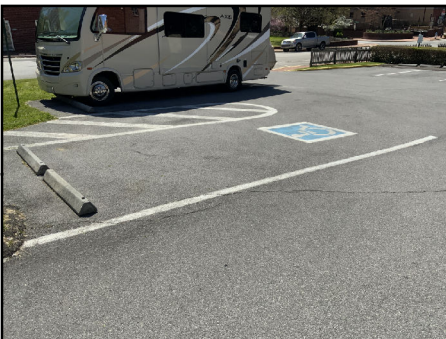
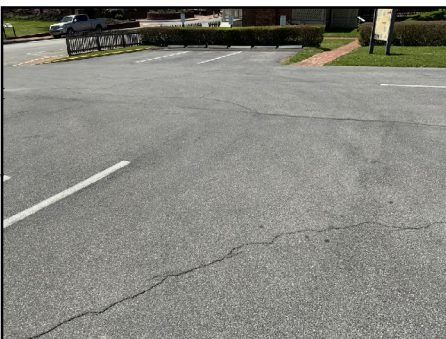
ROUTE 0904: VISITOR CENTER PARKING

Inspection Date	FMSS Number	User Access	Surface Type
4/12/2021	69994	PUBLIC	ASPHALT
Area (Sq. Ft.)	Lane Miles (11' Widths)	Curb Reveal (Inches)	Curb Recommendation
5,694	0.098	4	DO NOTHING
Curb Type		Curb & Gutter Type	
CONCRETE		NO CURB AND GUTTER	
Pavement Recommendation		Condition Rating / PCR	
PREVENTIVE MAINTENANCE		GOOD / 90
