APIS Cycle 6

Final Report

Road Inventory and Condition Assessment of Paved Routes Apostle Islands National Lakeshore

Report Date: June 2019

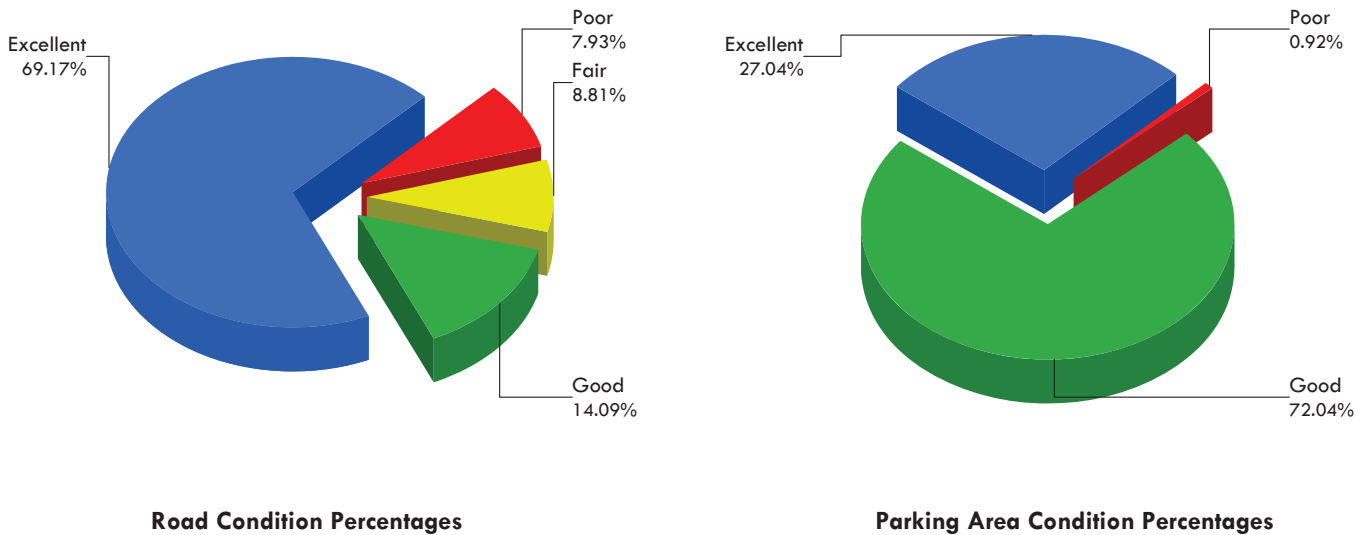
Figure 1: Pavement Condition Rating Breakdown for Paved Roads and Parking Areas

Explanation of the Excellent, Good, Fair, and Poor Condition Descriptions

The Road Inventory Program aims to provide assistance in translating the excellent / good / fair / poor rating categories into pavement needs categories. The PCR can be used to indicate the place in the Pavement Life Cycle and the type of treatments that should be considered now and into the future.

- Excellent / New: PCR of 95-100
 - Pavements in this range will require only spot repairs
- Good: PCR of 85-94
 - Pavements in this range will likely be candidates for Preventive Maintenance. Examples include Chip and Slurry Seals, Micro Surfacing and Thin Overlays.
- Fair: PCR of 61-84
 - Pavements in this range will likely be candidates of Light Rehabilitation (L3R). Examples include singlelift overlays up to 2.5 inches in total thickness, milling and overlays.
- Poor: PCR of 0-60
 - Pavements in this range will likely be candidates of Heavy Rehabilitation or Reconstruction (H3R or 4R). Examples include Pulverization, Multiple Lift Overlays, and Reconstruction.

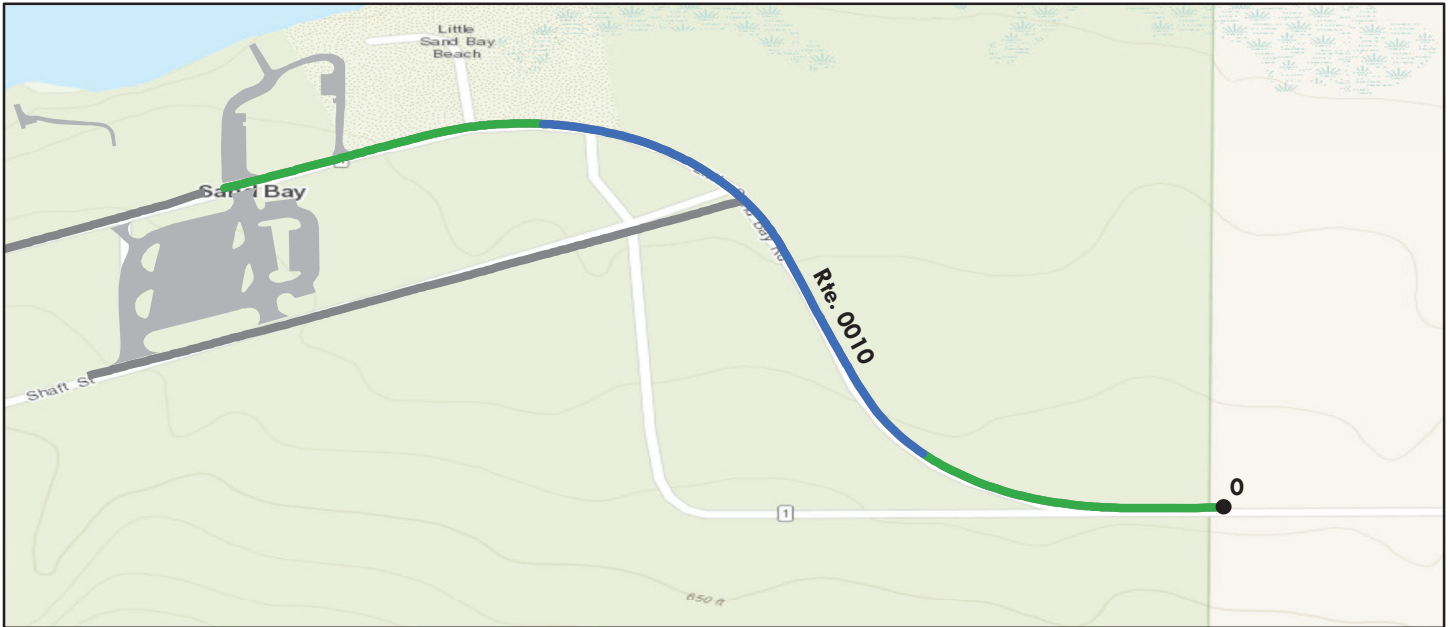
ROUTE 0010: LITTLE SAND BAY ROAD

Colors on map represent condition scores at 0.10-mile intervals. See Appendix for definitions and formulas.

Inspection Date:	10/13/2018	Beginning Section MP	0				
Paved Length (Miles):	0.4	Section Length (MI)	0.4				
Surface Type:	ASPHALT	Route Summary					
Roadway Condition Information							
Pavement Condition Rating (PCR)	95	95					
Surface Condition Rating (SCR)	95	95					
Roughness Condition Index (RCI)	N/A	N/A					
Distress Index Values							
Structural Crack Index	97	97					
Alligator Crack Index	100	100					
Longitudinal Crack Index	97	97					
Transverse Cracking Index	95	95					
Patching Index	100	100					
Rutting Index	100	100					
International Roughness Index (IRI)	N/A	N/A					
Lane & Width Information							
Number of Lanes	2	2					
Paved Width (ft)	23.6	23.6					
Lane Width (ft)	12.1	12.1

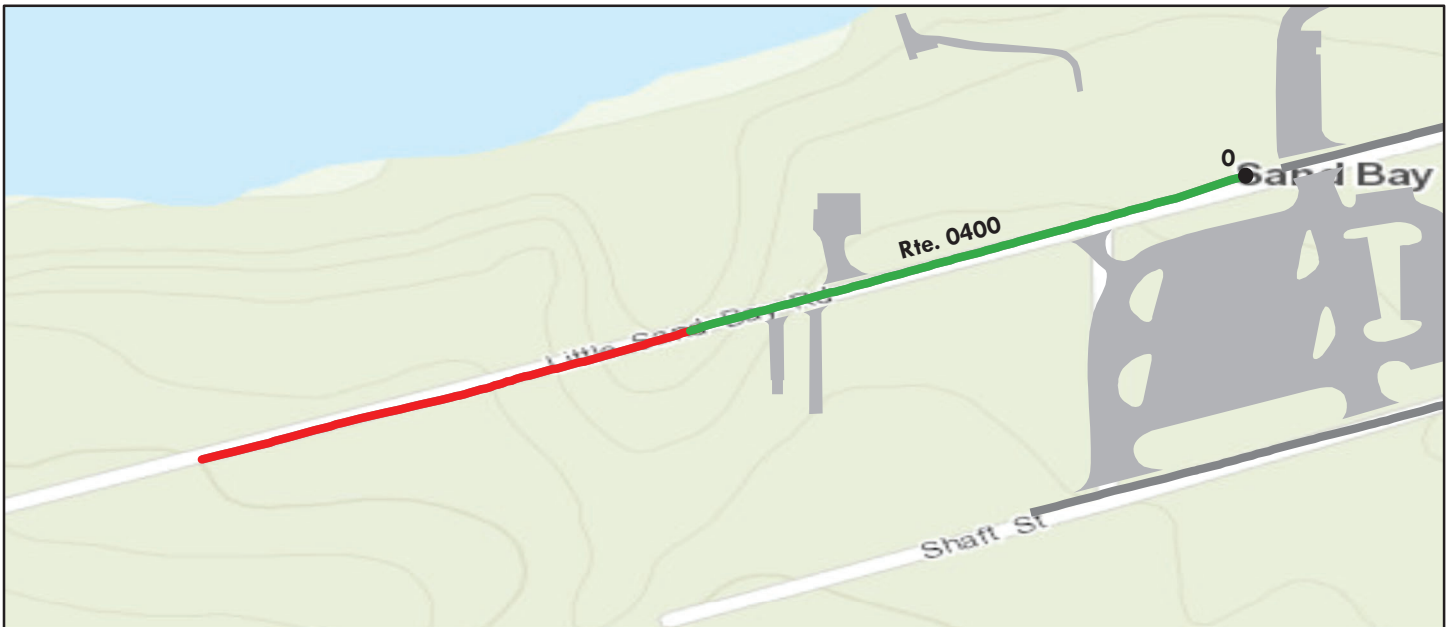
ROUTE 0400: LITTLE SAND BAY ROAD EXTENSION

Route Condition Legend – Pavement Condition Rating (PCR)							
Poor (0 - 60)		Fair (61- 84)		Good (85 - 94)		Excellent (95 - 100)	Not Rated
Colors on map represent condition scores at 0.10-mile intervals. See Appendix for definitions and formulas.							
Inspection Date:	10/13/2018	Beginning Section MP	0				
Paved Length (Miles):	0.19	Section Length (MI)	0.19				
Surface Type:	ASPHALT	Route Summary					
Roadway Condition Information							
Pavement Condition Rating (PCR)	71	71					
Surface Condition Rating (SCR)	N/A	N/A					
Roughness Condition Index (RCI)	N/A	N/A					
Distress Index Values							
Structural Crack Index	N/A	N/A					
Alligator Crack Index	N/A	N/A					
Longitudinal Crack Index	N/A	N/A					
Transverse Cracking Index	N/A	N/A					
Patching Index	N/A	N/A					
Rutting Index	N/A	N/A					
International Roughness Index (IRI)	N/A	N/A					
Lane & Width Information							
Number of Lanes	2	2					
Paved Width (ft)	21.5	21.5

Note: There was debris on road from MP 0.10 to 0.19. A manual rating of "Poor" was applied for this section.

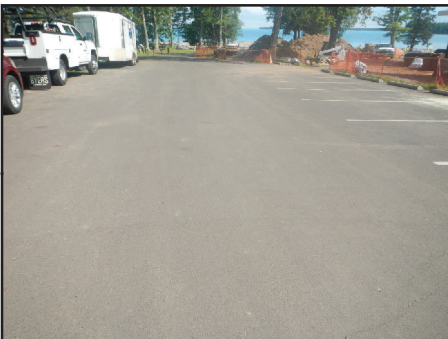
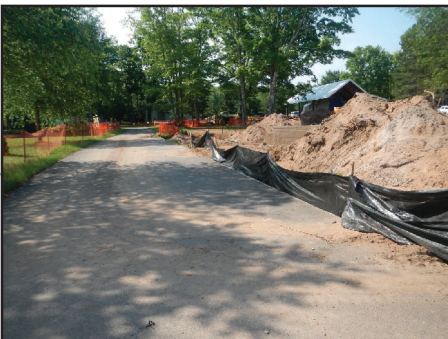
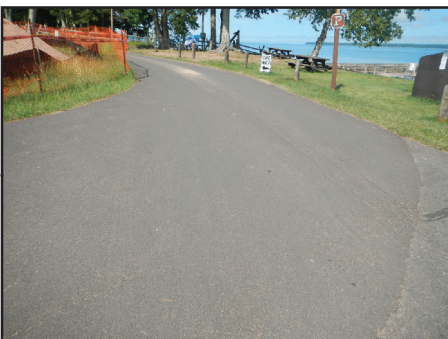
Inspection Date	FMSS Number	User Access	Surface Type
8/7/2018	40443	PUBLIC	ASPHALT
Area (Sq. Ft.)	Lane Miles (11' Widths)	Curb Reveal (Inches)	Curb Recommendation
17,080	0.294	NOT APPLICABLE	NOT APPLICABLE
Curb Type		Curb & Gutter Type	
NO CURB		NO CURB AND GUTTER	
Pavement Recommendation		Condition Rating / PCR	
PREVENTIVE MAINTENANCE		GOOD / 90

Note: Parking area partially under construction during manual collection.

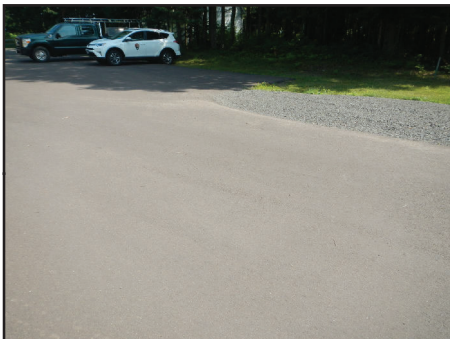
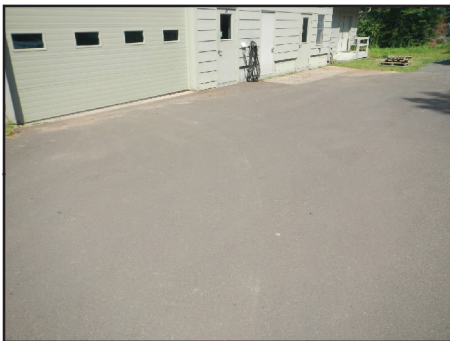
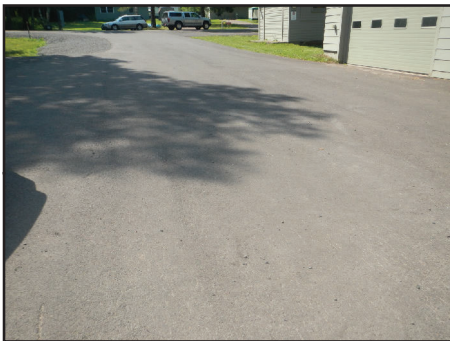
ROUTE 0901: MAINTENANCE SHOP / FIRE CACHE PARKING

Inspection Date	FMSS Number	User Access	Surface Type
8/7/2018	40444	NONPUBLIC	ASPHALT
Area (Sq. Ft.)	Lane Miles (11' Widths)	Curb Reveal (Inches)	Curb Recommendation
3,566	0.061	NOT APPLICABLE	NOT APPLICABLE
Curb Type		Curb & Gutter Type	
NO CURB		NO CURB AND GUTTER	
Pavement Recommendation		Condition Rating / PCR	
PREVENTIVE MAINTENANCE		GOOD / 90

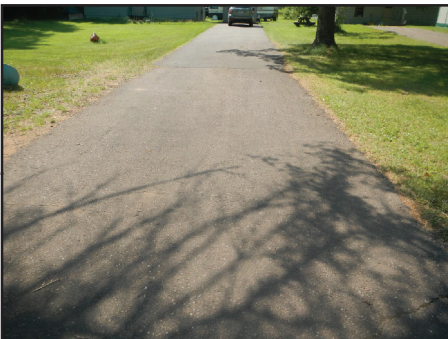
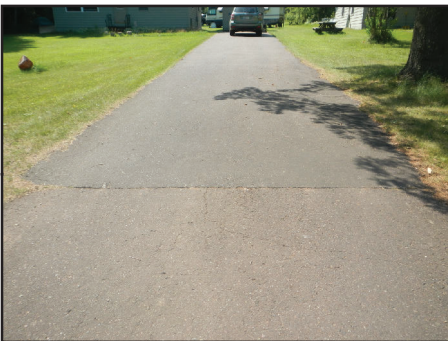
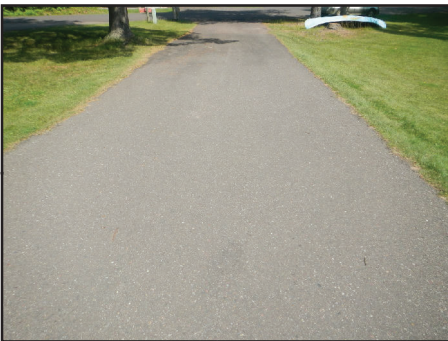
ROUTE 0902: EAST QUARTERS RESIDENCE PARKING #2

Inspection Date	FMSS Number	User Access	Surface Type
8/7/2018	40445	NONPUBLIC	ASPHALT
Area (Sq. Ft.)	Lane Miles (11' Widths)	Curb Reveal (Inches)	Curb Recommendation
1,532	0.026	NOT APPLICABLE	NOT APPLICABLE
Curb Type		Curb & Gutter Type	
NO CURB		NO CURB AND GUTTER	
Pavement Recommendation		Condition Rating / PCR	
PREVENTIVE MAINTENANCE		GOOD / 90

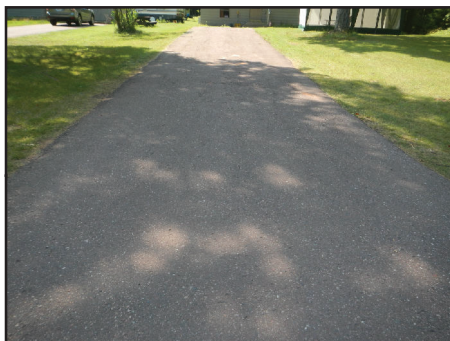
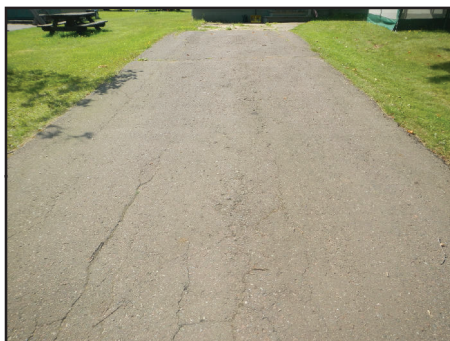
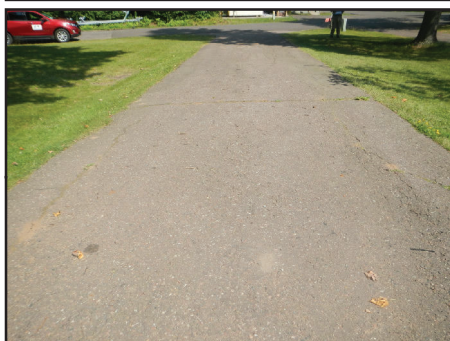
ROUTE 0903: WEST QUARTERS RESIDENCE PARKING #4

Inspection Date	FMSS Number	User Access	Surface Type
8/7/2018	40446	NONPUBLIC	ASPHALT
Area (Sq. Ft.)	Lane Miles (11' Widths)	Curb Reveal (Inches)	Curb Recommendation
1,206	0.021	NOT APPLICABLE	NOT APPLICABLE
Curb Type		Curb & Gutter Type	
NO CURB		NO CURB AND GUTTER	
Pavement Recommendation		Condition Rating / PCR	
RECONSTRUCTION		POOR / 30

Note: Parking area consists of multiple surface types: 1 part Asphalt at 1,038 square feet; 1 part Concrete at 168 square feet.

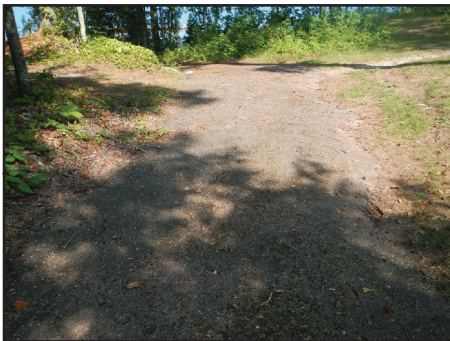
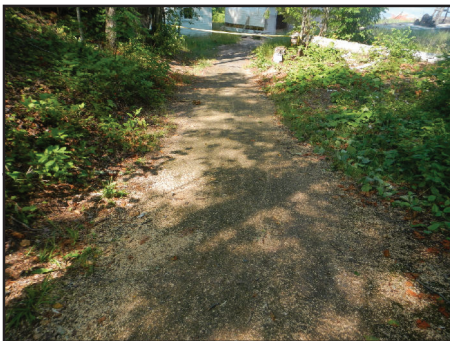
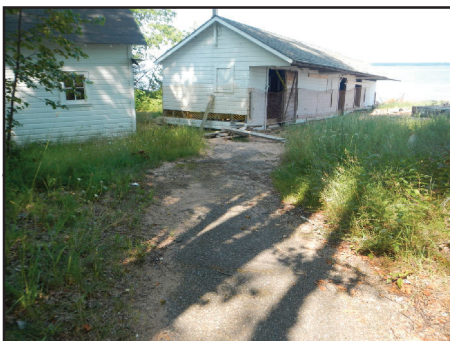
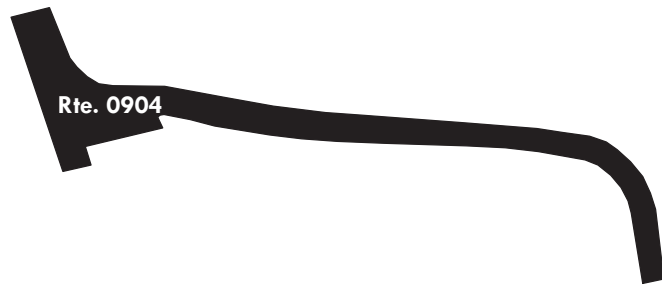
ROUTE 0904: HOKENSON HISTORIC FISHERY PARKING

Inspection Date	FMSS Number	User Access	Surface Type
8/7/2018	40447	NONPUBLIC	ASPHALT
Area (Sq. Ft.)	Lane Miles (11' Widths)	Curb Reveal (Inches)	Curb Recommendation
2,469	0.043	NOT APPLICABLE	NOT APPLICABLE
Curb Type		Curb & Gutter Type	
NO CURB		NO CURB AND GUTTER	
Pavement Recommendation		Condition Rating / PCR	
NOT APPLICABLE		NOT RATED

Note: Parking area not rated due to being covered with storm debris.

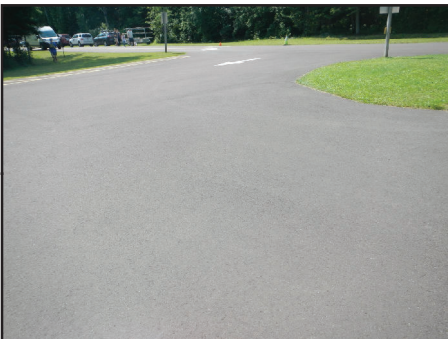
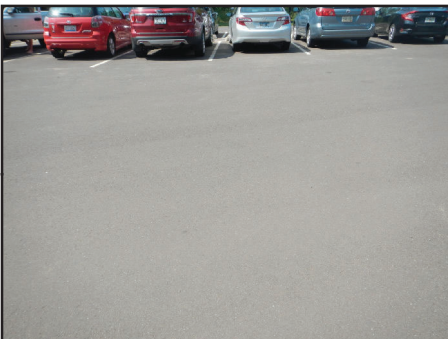
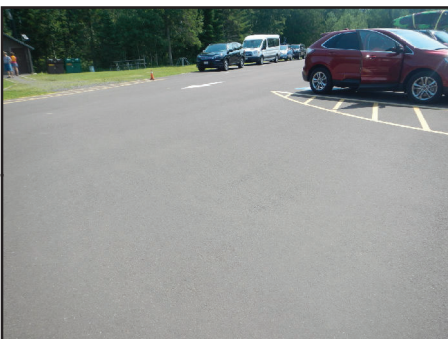
ROUTE 0907: MEYERS BEACH PARKING

Inspection Date	FMSS Number	User Access	Surface Type
8/7/2018	30466	PUBLIC	ASPHALT
Area (Sq. Ft.)	Lane Miles (11' Widths)	Curb Reveal (Inches)	Curb Recommendation
35,635	0.614	NOT APPLICABLE	NOT APPLICABLE
Curb Type		Curb & Gutter Type	
NO CURB		NO CURB AND GUTTER	
Pavement Recommendation		Condition Rating / PCR	
DO NOTHING		EXCELLENT / 97

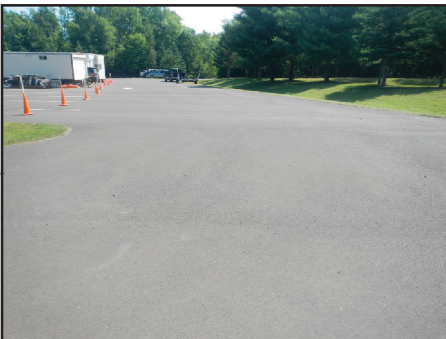
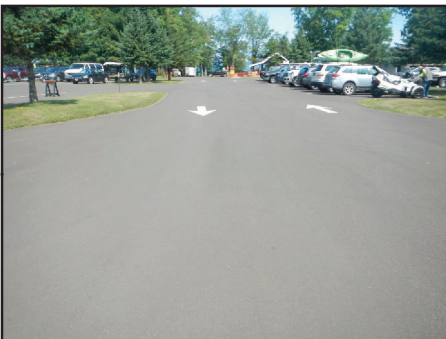
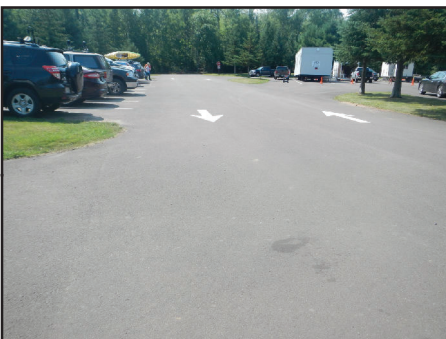
ROUTE 0908: LITTLE SAND BAY MAIN PARKING

Inspection Date	FMSS Number	User Access	Surface Type
8/7/2018	40449	PUBLIC	ASPHALT
Area (Sq. Ft.)	Lane Miles (11' Widths)	Curb Reveal (Inches)	Curb Recommendation
72,767	1.253	NOT APPLICABLE	NOT APPLICABLE
Curb Type		Curb & Gutter Type	
NO CURB		NO CURB AND GUTTER	
Pavement Recommendation		Condition Rating / PCR	
PREVENTIVE MAINTENANCE		GOOD / 90
