ARPO Cycle 6

Final Report

Road Inventory and Condition Assessment of Paved Routes Arkansas Post National Memorial

**Federal Highway Administration
Eastern Federal Lands Highway Division
Road Inventory Program (RIP)**

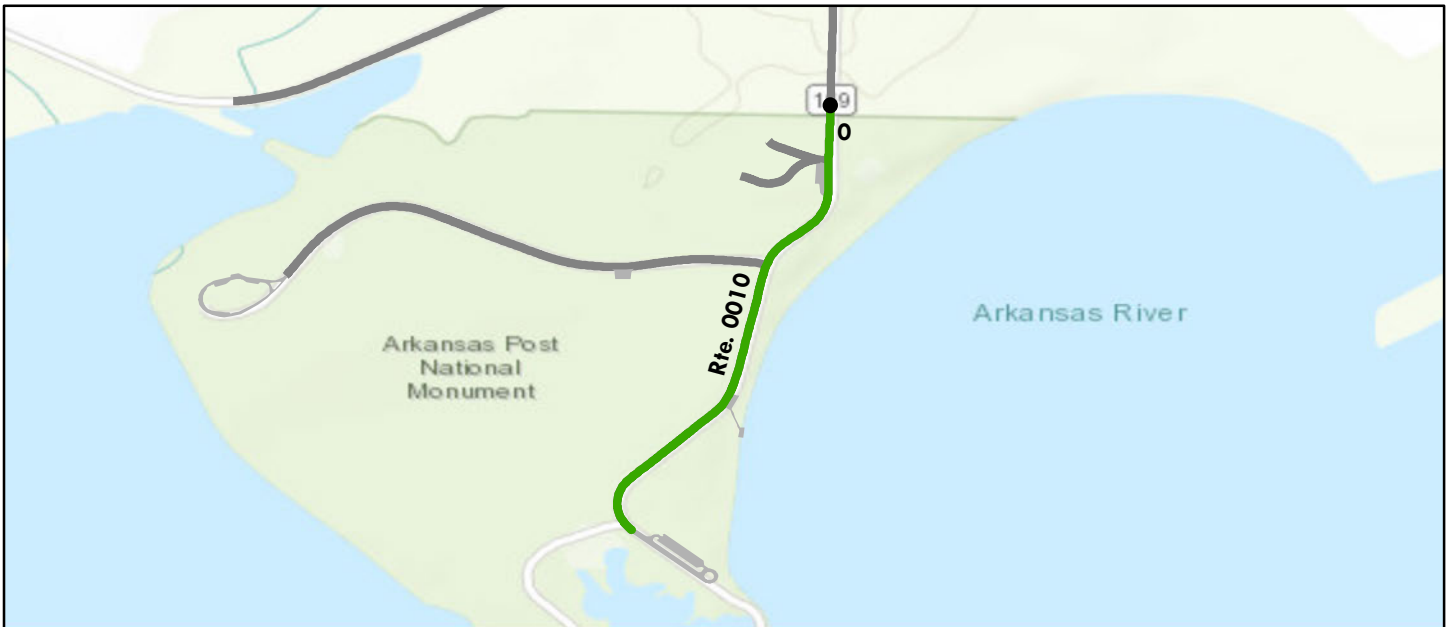
ROUTE 0010: MAIN ENTRANCE ROAD

Inspection Date: 5/7/2019	Beginning Section MP	0				
Paved Length (Miles): 0.56	Section Length (MI)	0.56				
Surface Type: ASPHALT	Route Summary					
Roadway Condition Information						
Pavement Condition Rating (PCR)	88	88				
Surface Condition Rating (SCR)	98	98				
Roughness Condition Index (RCI)	73	72				
Distress Index Values						
Structural Crack Index	100	100				
Alligator Crack Index	100	100				
Longitudinal Crack Index	100	100				
Transverse Cracking Index	100	100				
Patching Index	100	100				
Rutting Index	98	98				
International Roughness Index (IRI)	193	193				
Lane & Width Information						
Number of Lanes	2	2				
Paved Width (ft)	19.7	19.7				
Lane Width (ft)	9.8	9.8

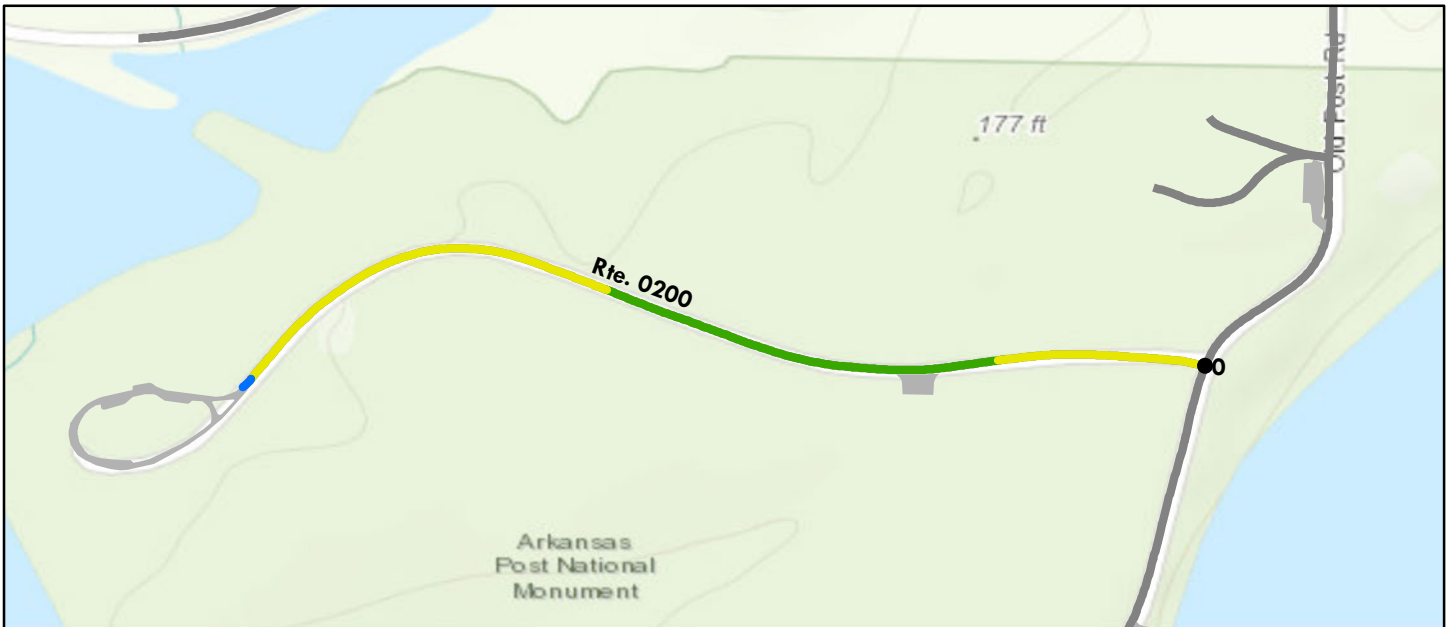
ROUTE 0200: PICNIC AREA ACCESS ROAD

Inspection Date: 5/7/2019	Beginning Section MP	0				
Paved Length (Miles): 0.51	Section Length (MI)	0.51				
Surface Type: ASPHALT	Route Summary					
Roadway Condition Information						
Pavement Condition Rating (PCR)	84	84				
Surface Condition Rating (SCR)	96	96				
Roughness Condition Index (RCI)	66	66				
Distress Index Values						
Structural Crack Index	99	99				
Alligator Crack Index	100	100				
Longitudinal Crack Index	99	99				
Transverse Cracking Index	100	100				
Patching Index	100	100				
Rutting Index	96	96				
International Roughness Index (IRI)	217	217				
Lane & Width Information						
Number of Lanes	2	2				
Paved Width (ft)	20.1	20.1				
Lane Width (ft)	10.1	10.1

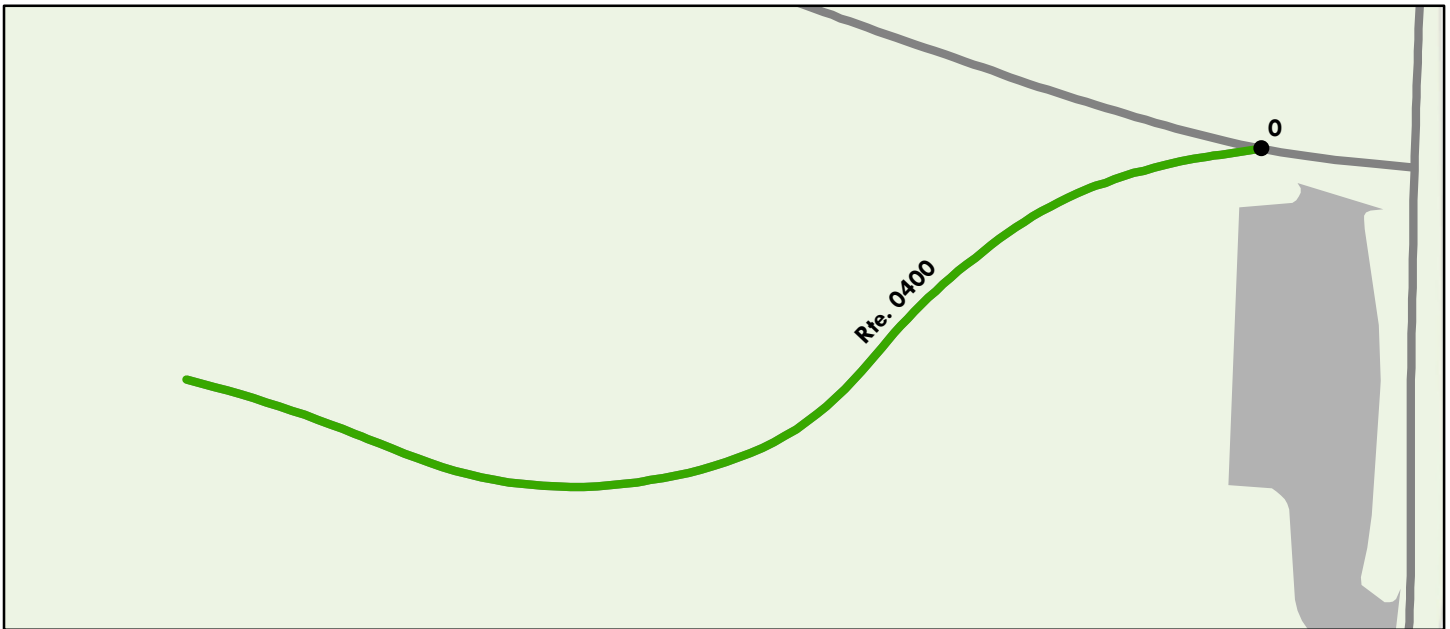
ROUTE 0400: MAINTENANCE ROAD

Route Condition Legend – Pavement Condition Rating (PCR)						
Poor (0 - 60)	Fair (61- 84)	Good (85 - 94)	Excellent (95 - 100)	Not Rated		
Colors on map represent condition scores at 0.10-mile intervals. See Appendix for definitions and formulas.						
Inspection Date: 5/7/2019	Beginning Section MP	0				
Paved Length (Miles): 0.08	Section Length (MI)	0.08				
Surface Type: ASPHALT	Route Summary					
Roadway Condition Information						
Pavement Condition Rating (PCR)	89	89				
Surface Condition Rating (SCR)	89	89				
Roughness Condition Index (RCI)	N/A	N/A				
Distress Index Values						
Structural Crack Index	97	97				
Alligator Crack Index	100	100				
Longitudinal Crack Index	97	97				
Transverse Cracking Index	89	89				
Patching Index	100	100				
Rutting Index	98	98				
International Roughness Index (IRI)	N/A	N/A				
Lane & Width Information						
Number of Lanes	1	1				
Paved Width (ft)	12.7	12.7				
Lane Width (ft)	12.7	12.7

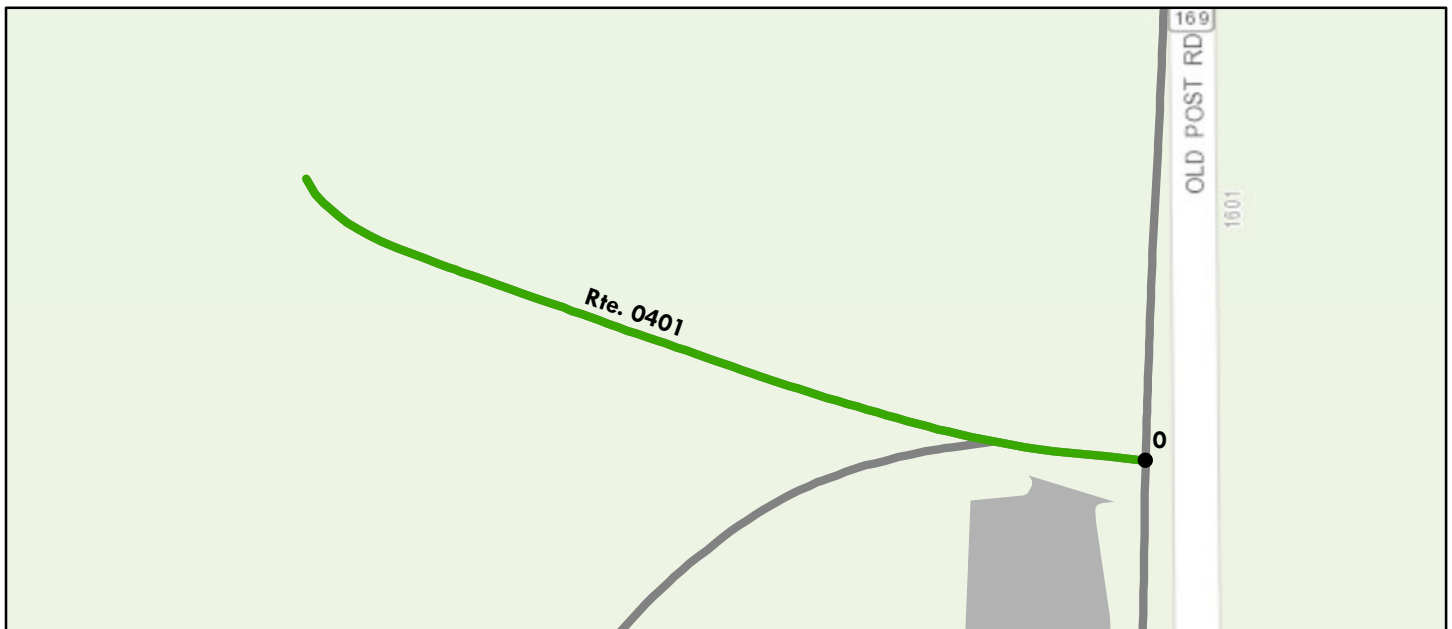
ROUTE 0401: HOUSING ROAD

Inspection Date: 5/7/2019	Beginning Section MP	0				
Paved Length (Miles): 0.06	Section Length (MI)	0.06				
Surface Type: ASPHALT	Route Summary					
Roadway Condition Information						
Pavement Condition Rating (PCR)	86	86				
Surface Condition Rating (SCR)	86	86				
Roughness Condition Index (RCI)	N/A	N/A				
Distress Index Values						
Structural Crack Index	86	86				
Alligator Crack Index	100	100				
Longitudinal Crack Index	86	86				
Transverse Cracking Index	88	88				
Patching Index	100	100				
Rutting Index	99	99				
International Roughness Index (IRI)	N/A	N/A				
Lane & Width Information						
Number of Lanes	2	2				
Paved Width (ft)	15.7	15.7				
Lane Width (ft)	8.1	8.1

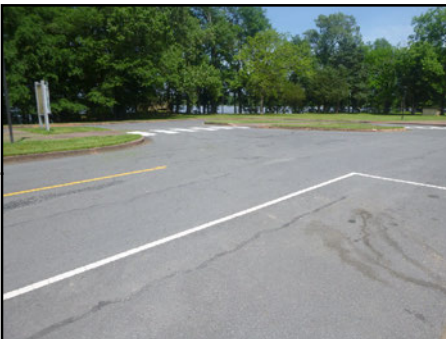
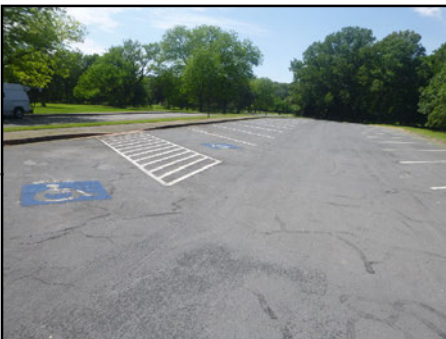
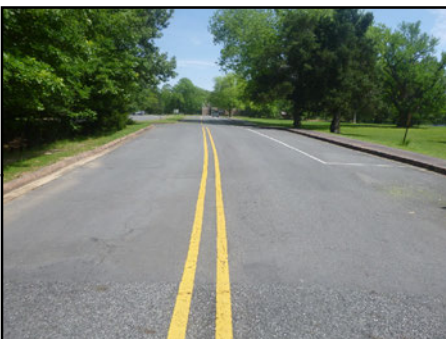
Inspection Date	FMSS Number	User Access	Surface Type
5/7/2019	76026	PUBLIC	ASPHALT
Area (Sq. Ft.)	Lane Miles (11' Widths)	Curb Reveal (Inches)	Curb Recommendation
35,056	0.604	NOT APPLICABLE	LIGHT REPAIR
Curb Type		Curb & Gutter Type	
NO CURB		CONCRETE	
Pavement Recommendation		Condition Rating / PCR	
HEAVY 3R TREATMENTS		POOR / 53	
Route Condition Legend – Pavement Condition Rating (PCR)			
Poor (0 - 60)	Fair (61- 84)	Good (85 - 94)	Excellent (95 - 100)
Not Rated			
See Appendix for definitions and formulas

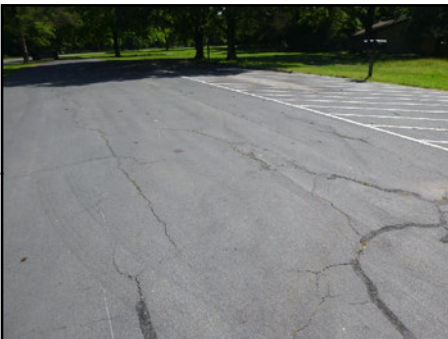
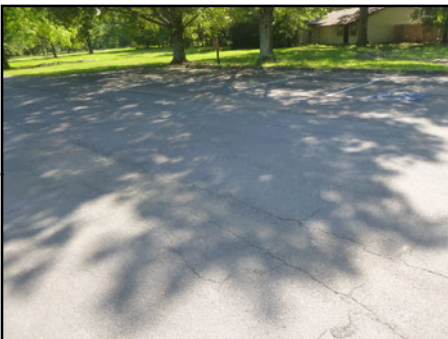
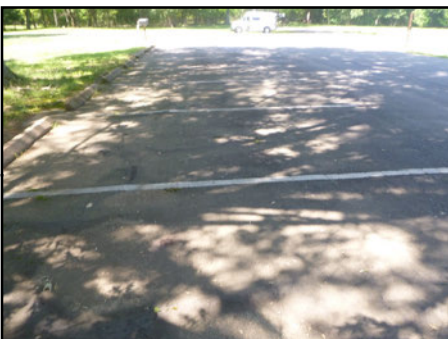
ROUTE 0901: PUBLIC ACCESS PARKING

Inspection Date	FMSS Number	User Access	Surface Type
5/7/2019	75772	PUBLIC	ASPHALT
Area (Sq. Ft.)	Lane Miles (11' Widths)	Curb Reveal (Inches)	Curb Recommendation
8,634	0.149	NOT APPLICABLE	NOT APPLICABLE
Curb Type		Curb & Gutter Type	
NO CURB		NO CURB AND GUTTER	
Pavement Recommendation		Condition Rating / PCR	
LIGHT 3R TREATMENTS		FAIR / 73

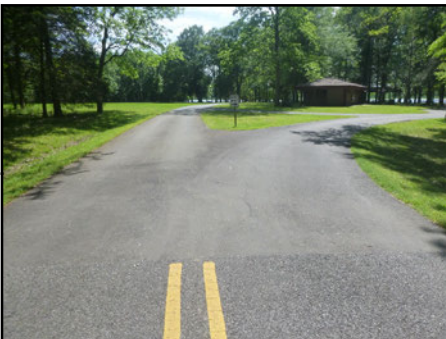
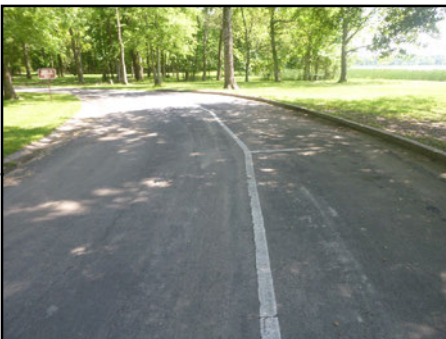
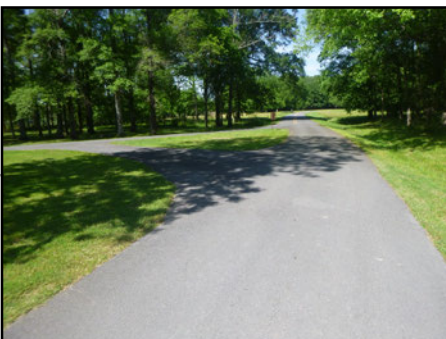
ROUTE 0904: PICNIC AREA LOOP AND PARKING

Inspection Date	FMSS Number	User Access	Surface Type
5/7/2019	75903	PUBLIC	ASPHALT
Area (Sq. Ft.)	Lane Miles (11' Widths)	Curb Reveal (Inches)	Curb Recommendation
22,630	0.39	NOT APPLICABLE	LIGHT REPAIR
Curb Type		Curb & Gutter Type	
NO CURB		CONCRETE	
Pavement Recommendation		Condition Rating / PCR	
PREVENTIVE MAINTENANCE		GOOD / 90

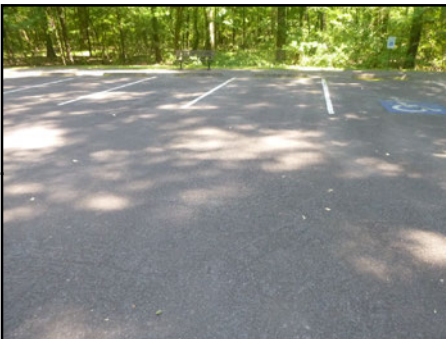
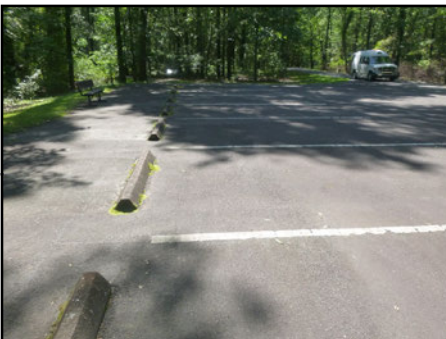
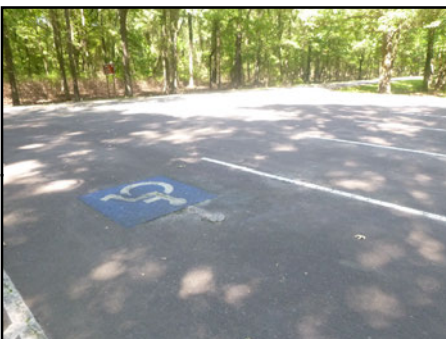
ROUTE 0905: CIVIL WAR RIFLE PITS PARKING

Inspection Date	FMSS Number	User Access	Surface Type
5/7/2019	75902	PUBLIC	ASPHALT
Area (Sq. Ft.)	Lane Miles (11' Widths)	Curb Reveal (Inches)	Curb Recommendation
5,189	0.089	NOT APPLICABLE	NOT APPLICABLE
Curb Type		Curb & Gutter Type	
NO CURB		NO CURB AND GUTTER	
Pavement Recommendation		Condition Rating / PCR	
PREVENTIVE MAINTENANCE		GOOD / 90

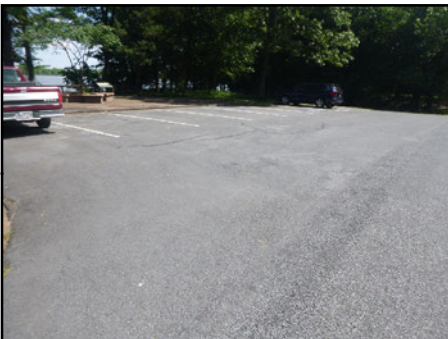
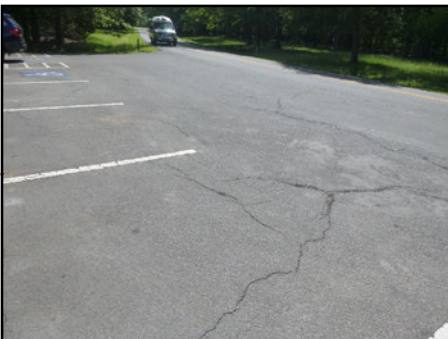
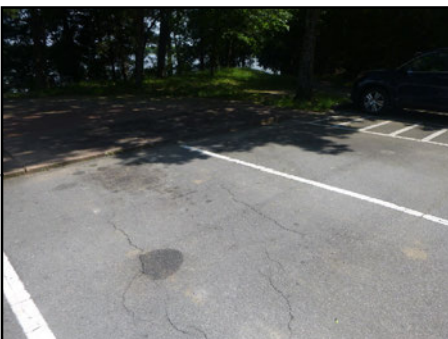
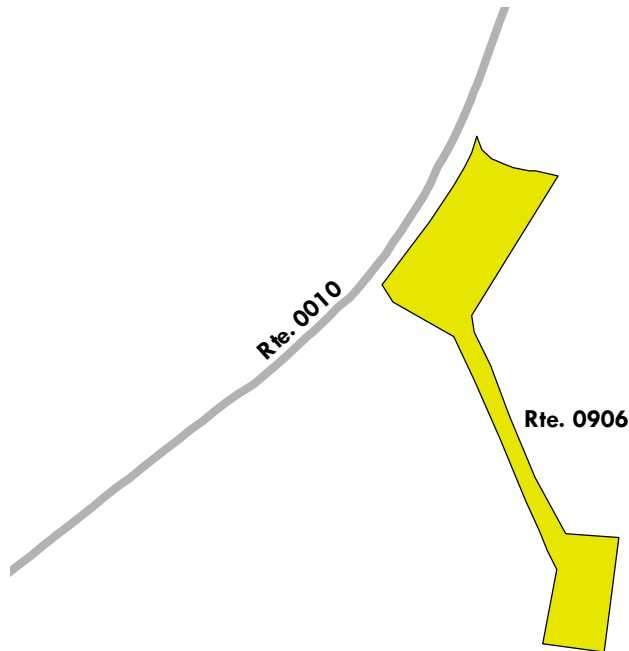
ROUTE 0906: FORT HINDMAN EXHIBIT PARKING

Inspection Date	FMSS Number	User Access	Surface Type
5/7/2019	75899	PUBLIC	ASPHALT
Area (Sq. Ft.)	Lane Miles (11' Widths)	Curb Reveal (Inches)	Curb Recommendation
6,444	0.111	0	DO NOTHING
Curb Type		Curb & Gutter Type	
CONCRETE		NO CURB AND GUTTER	
Pavement Recommendation		Condition Rating / PCR	
LIGHT 3R TREATMENTS		FAIR / 73
