BIHO Cycle 6

Final Report

Road Inventory and Condition Assessment of Paved Routes Big Hole National Battlefield

Report Date: November 2016

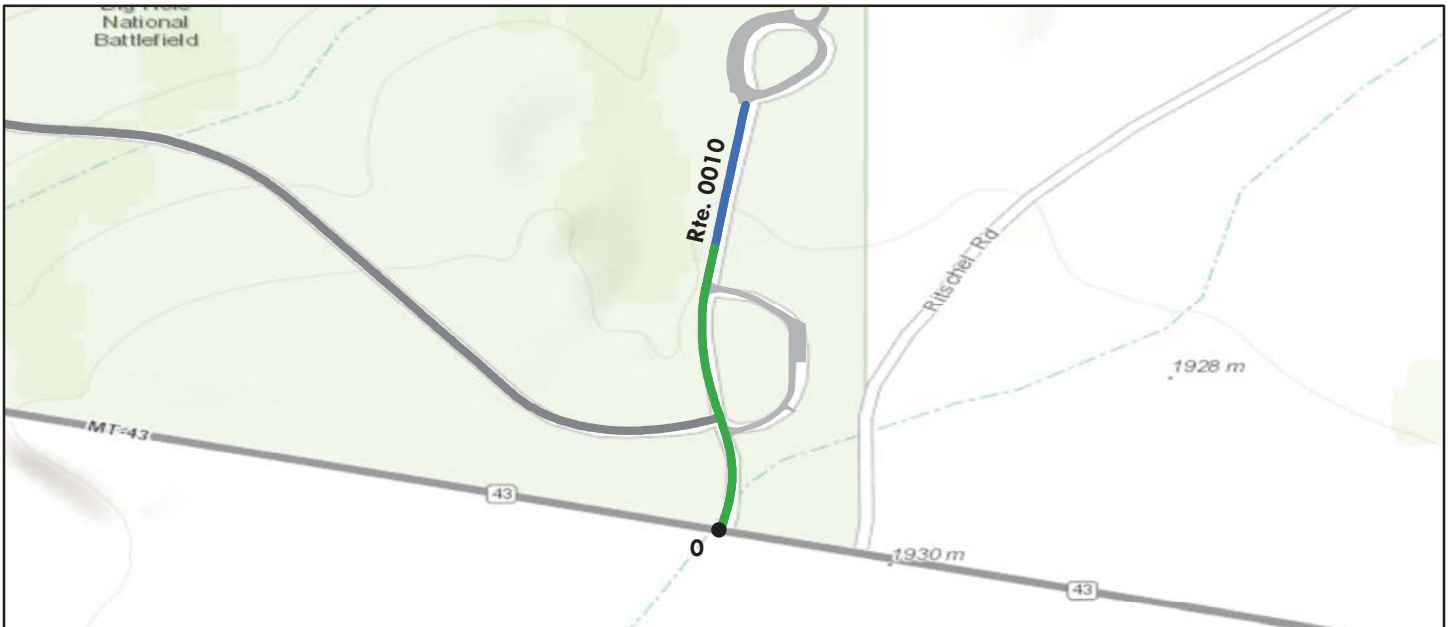
ROUTE 0010: ENTRANCE ROAD

Data Collection Vehicle (DCV) Rating

Route Condition Legend – Pavement Condition Rating (PCR)						
Poor (0 - 60)	Fair (61- 84)	Good (85 - 94)	Excellent (95 - 100)	Not Rated		
See Appendix for definitions and formulas						
Inspection Date: 8/16/2016	Beginning Section MP	0				
Paved Length (Miles): 0.3	Section Length (MI)	0.3				
Surface Type: ASPHALT	Route Summary					
Roadway Condition Information						
Pavement Condition Rating (PCR)	93	93				
Surface Condition Rating (SCR)	93	93				
Roughness Condition Index (RCI)	N/A	N/A				
Distress Index Values						
Structural Crack Index	100	100				
Alligator Crack Index	100	100				
Longitudinal Crack Index	100	100				
Transverse Cracking Index	93	93				
Patching Index	100	100				
Rutting Index	100	100				
International Roughness Index (IRI)	N/A	N/A				
Lane & Width Information						
Number of Lanes	2	2				
Paved Width (ft)	22.6	22.6				
Lane Width (ft)	10.3	10.3

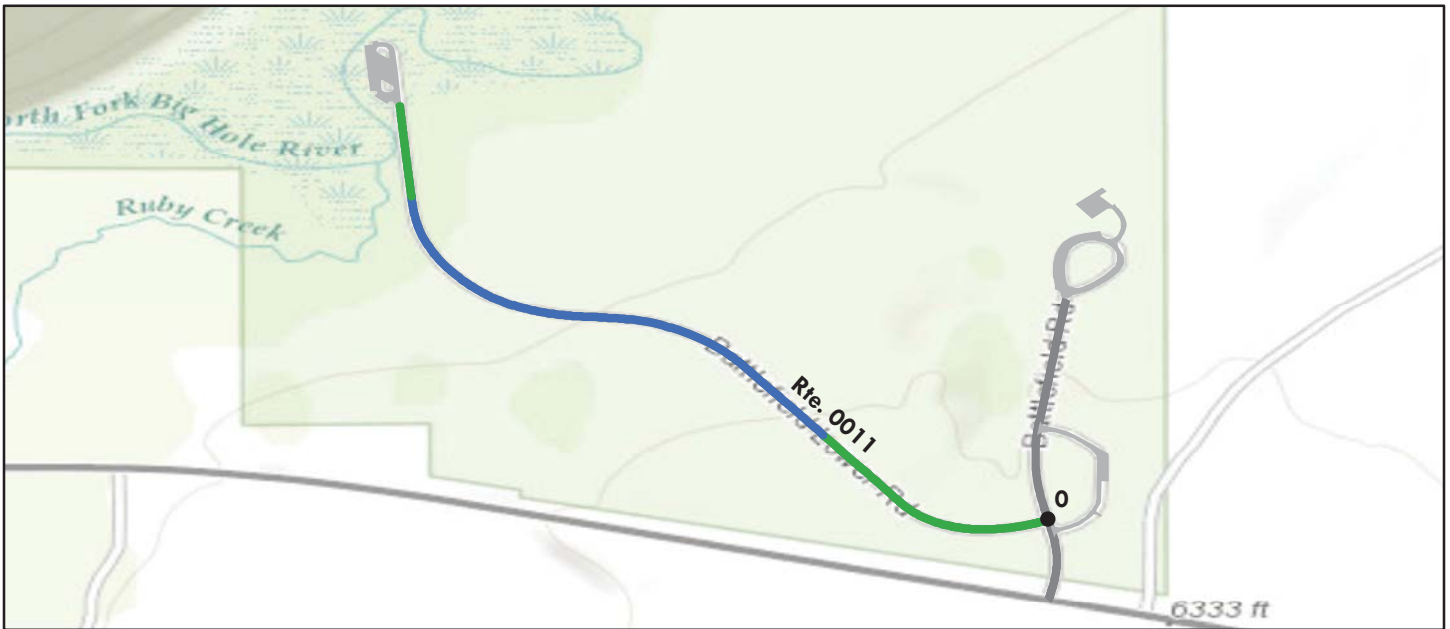
ROUTE 0011: LOWER PARKING ACCESS ROAD

Data Collection Vehicle (DCV) Rating

Route Condition Legend – Pavement Condition Rating (PCR)						
Poor (0 - 60)	Fair (61- 84)	Good (85 - 94)	Excellent (95 - 100)	Not Rated		
See Appendix for definitions and formulas						
Inspection Date:	8/16/2016	Beginning Section MP	0			
Paved Length (Miles):	0.69	Section Length (MI)	0.69			
Surface Type:	ASPHALT	Route Summary				
Roadway Condition Information						
Pavement Condition Rating (PCR)	94	94				
Surface Condition Rating (SCR)	100	100				
Roughness Condition Index (RCI)	86	86				
Distress Index Values						
Structural Crack Index	100	100				
Alligator Crack Index	100	100				
Longitudinal Crack Index	100	100				
Transverse Cracking Index	100	100				
Patching Index	100	100				
Rutting Index	100	100				
International Roughness Index (IRI)	153	153				
Lane & Width Information						
Number of Lanes	2	2				
Paved Width (ft)	20.4	20.4				
Lane Width (ft)	9.4	9.4

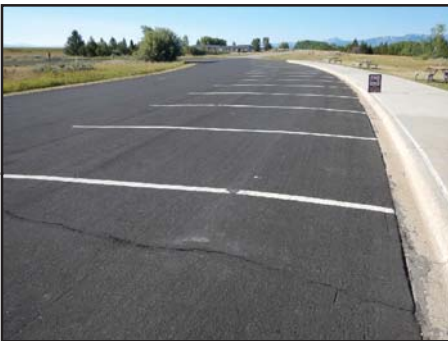
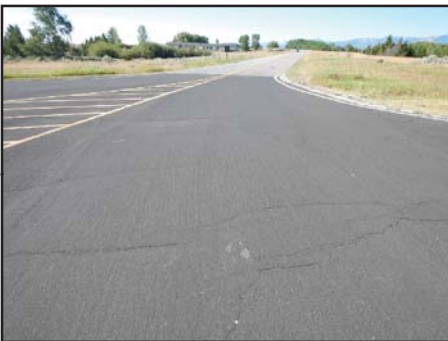
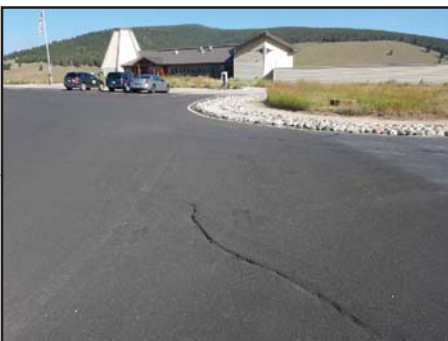
Inspection Date	FMSS Number	User Access	Surface Type
7/25/2016	31519	PUBLIC	ASPHALT
Area (Sq. Ft.)	Lane Miles (11' Widths)	Curb Reveal (Inches)	Curb Recommendation
29,557	0.509	NOT APPLICABLE	DO NOTHING
Curb Type		Curb & Gutter Type	
NO CURB		CONCRETE	
Pavement Recommendation		Condition Rating / PCR	
LIGHT 3R TREATMENTS		FAIR / 73

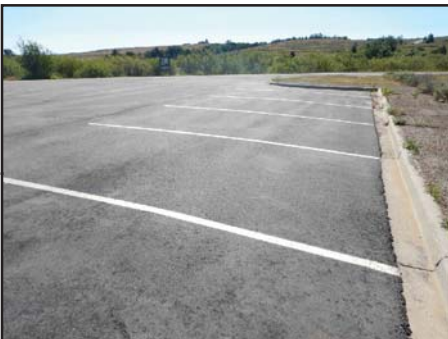
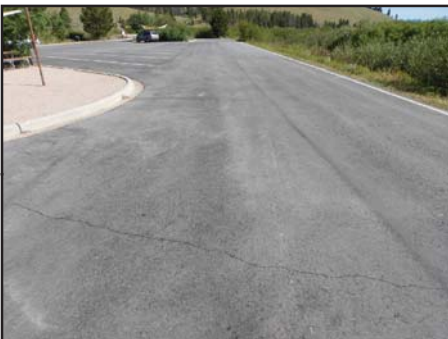
ROUTE 0901: BATTLEFIELD PARKING LOT

Inspection Date	FMSS Number	User Access	Surface Type
7/25/2016	31537	PUBLIC	ASPHALT
Area (Sq. Ft.)	Lane Miles (11' Widths)	Curb Reveal (Inches)	Curb Recommendation
28,030	0.483	NOT APPLICABLE	DO NOTHING
Curb Type		Curb & Gutter Type	
NO CURB		CONCRETE	
Pavement Recommendation		Condition Rating / PCR	
PREVENTIVE MAINTENANCE		GOOD / 90

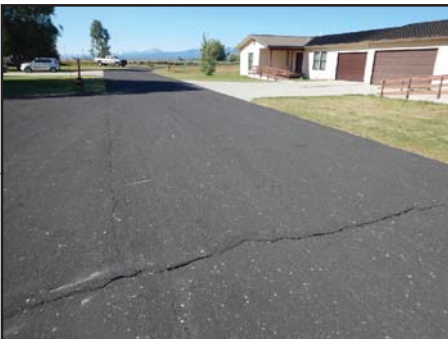
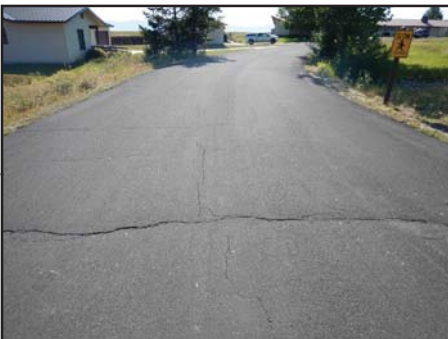
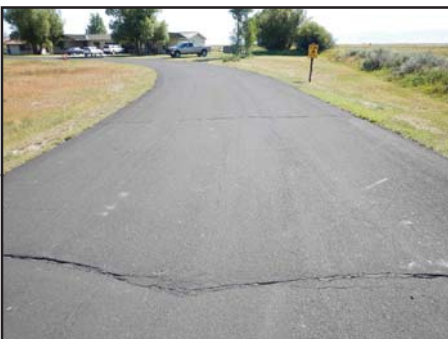
ROUTE 0902: HOUSING ACCESS AND PARKING

Inspection Date	FMSS Number	User Access	Surface Type
7/25/2016	31492	NONPUBLIC	ASPHALT
Area (Sq. Ft.)	Lane Miles (11' Widths)	Curb Reveal (Inches)	Curb Recommendation
20,480	0.353	NOT APPLICABLE	DO NOTHING
Curb Type		Curb & Gutter Type	
NO CURB		CONCRETE	
Pavement Recommendation		Condition Rating / PCR	
HEAVY 3R TREATMENTS		POOR / 53

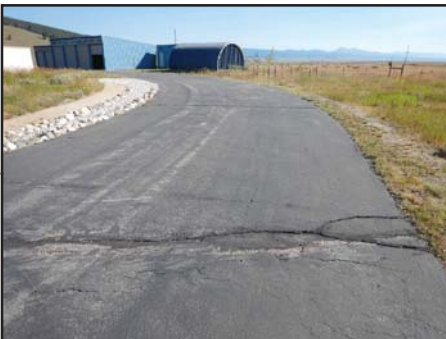
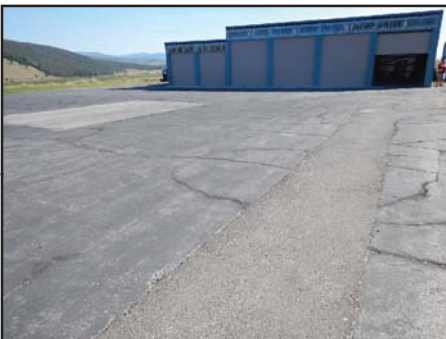
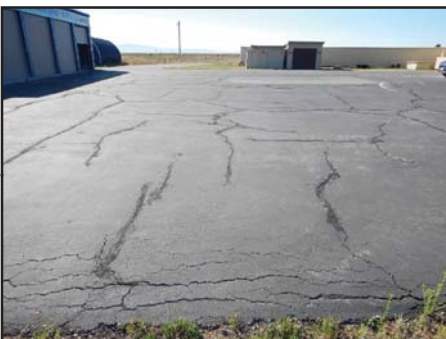
ROUTE 0903: VISITOR CENTER EMPLOYEE PARKING

Inspection Date	FMSS Number	User Access	Surface Type
7/25/2016	103171	NONPUBLIC	ASPHALT
Area (Sq. Ft.)	Lane Miles (11' Widths)	Curb Reveal (Inches)	Curb Recommendation
14,633	0.252	NOT APPLICABLE	NOT APPLICABLE
Curb Type		Curb & Gutter Type	
NO CURB		NO CURB AND GUTTER	
Pavement Recommendation		Condition Rating / PCR	
RECONSTRUCTION		POOR / 30
