BITH Cycle 6

Final Report

Road Inventory and Condition Assessment of Paved Routes Big Thicket National Preserve

Report Date: March 2017

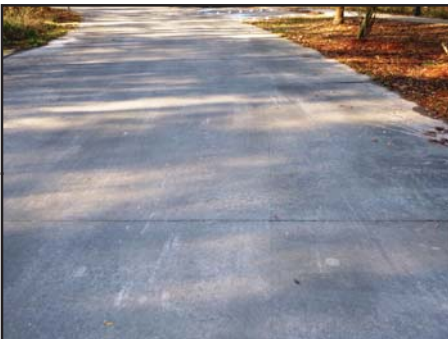
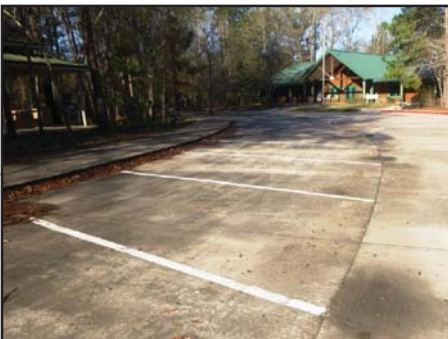
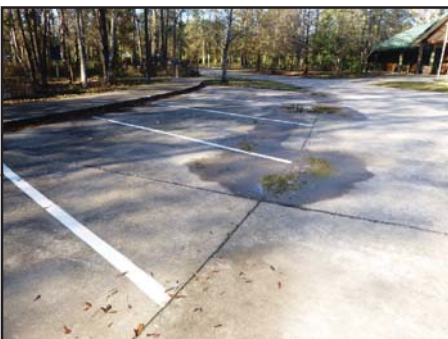
Inspection Date	FMSS Number	User Access	Surface Type
2/22/2017	28281	PUBLIC	CONCRETE
Area (Sq. Ft.)	Lane Miles (11' Widths)	Curb Reveal (Inches)	Curb Recommendation
34,606	0.596	6	DO NOTHING
Curb Type		Curb & Gutter Type	
CONCRETE		NO CURB AND GUTTER	
Pavement Recommendation		Condition Rating / PCR	
PREVENTIVE MAINTENANCE		GOOD / 90

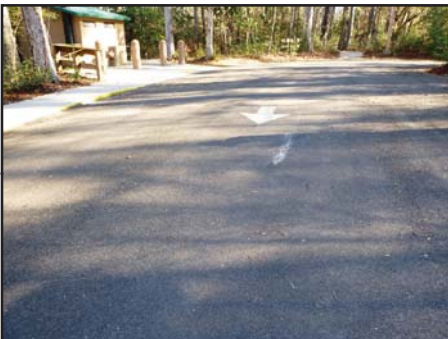
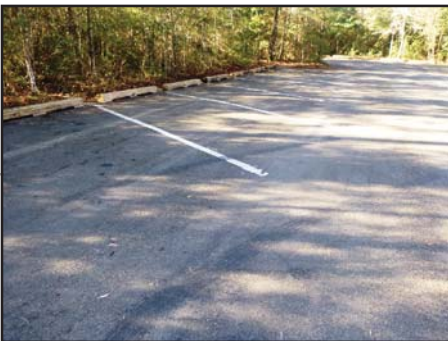
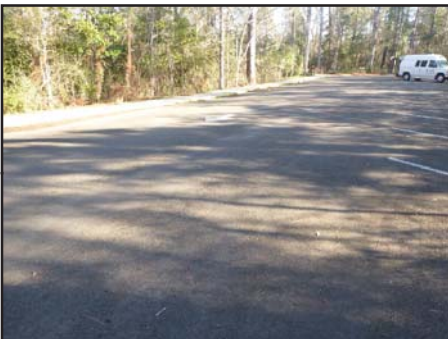
ROUTE 0904: KIRBY NATURE TRAIL PARKING

Inspection Date	FMSS Number	User Access	Surface Type
2/22/2017	28618	PUBLIC	ASPHALT
Area (Sq. Ft.)	Lane Miles (11' Widths)	Curb Reveal (Inches)	Curb Recommendation
15,740	0.271	5	DO NOTHING
Curb Type		Curb & Gutter Type	
CONCRETE		NO CURB AND GUTTER	
Pavement Recommendation		Condition Rating / PCR	
PREVENTIVE MAINTENANCE		GOOD / 90
