BRVB Cycle 6

Final Report

Road Inventory and Condition Assessment of Paved Routes Brown v. Board of Education National Historic Site

Report Date: December 2017

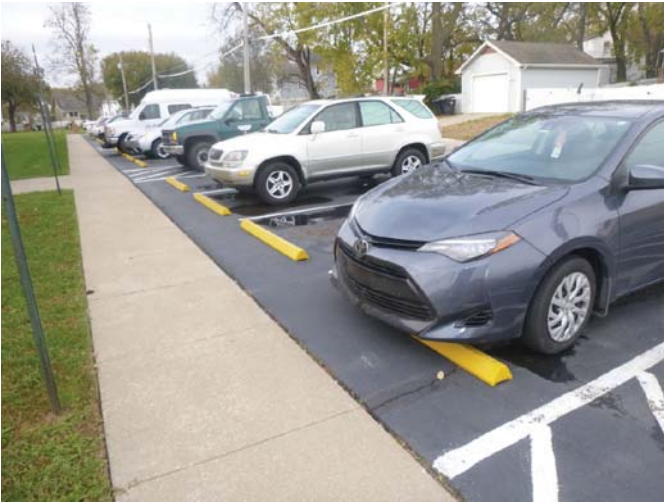
BRVB_0900_0028.JPG

ROUTE 0900: EMPLOYEE PARKING LOT

Inspection Date	FMSS Number	User Access	Surface Type
11/1/2017	80446	PUBLIC	ASPHALT
Area (Sq. Ft.)	Lane Miles (11' Widths)	Curb Reveal (Inches)	Curb Recommendation
4,901	0.084	NOT APPLICABLE	NOT APPLICABLE
Curb Type		Curb & Gutter Type	
NO CURB		NO CURB AND GUTTER	
Pavement Recommendation		Condition Rating / PCR	
PREVENTIVE MAINTENANCE		GOOD / 90
