Final Report

Road Inventory and Condition Assessment for Captain John Smith Chesapeake National Historic Trail

**Federal Highway Administration
Eastern Federal Lands Highway Division
Road Inventory Program (RIP)**

Report Date: May 2021

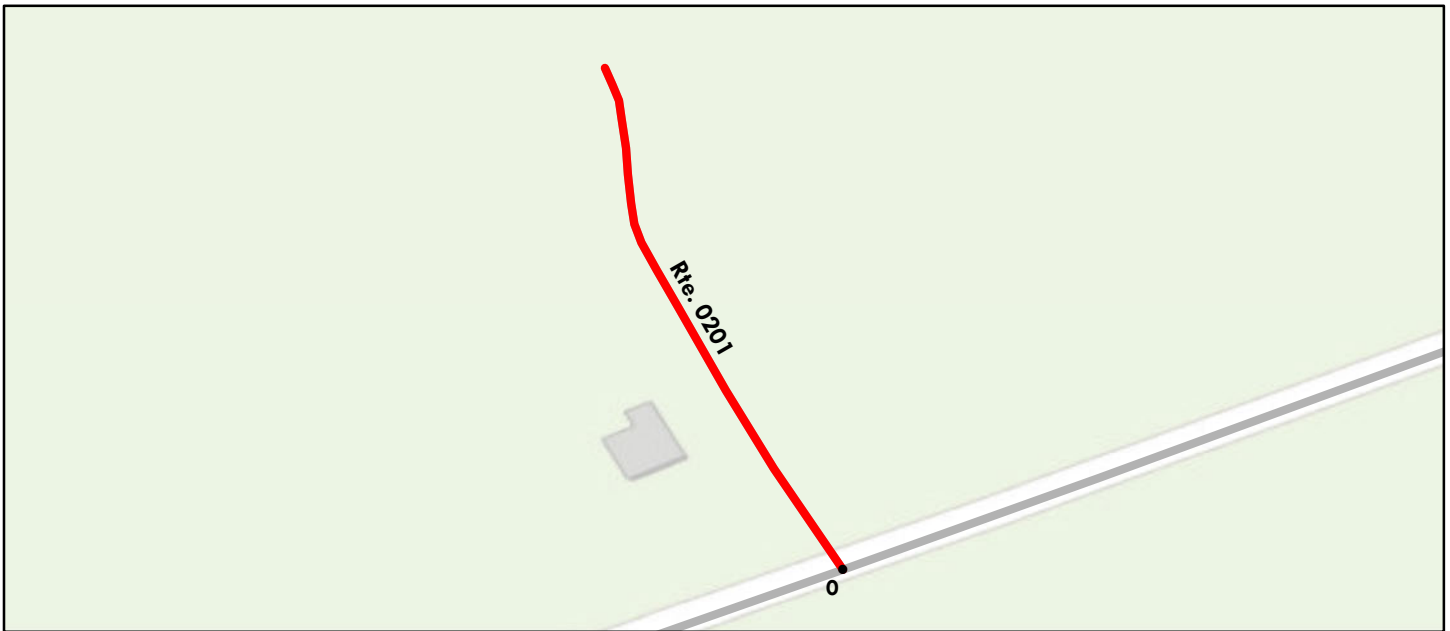
ROUTE 0201: FARM HOUSE ACCESS

Begin MP	End MP	Section Length	# of Lanes	Lane Width	Road Width	Treatment Recommendation	Treatment Cost	Unpaved Rating (Paser +)	Crown Severity	Drainage Severity	Rutting, Washboard Severity	Potholes / Loose Aggregate Severity
0.00	0.07	0.07	1	12.0	12.0	Reconstruction	\$17,500	1	High	High	Low	Med
Route Level Data:		0.07	1	12.0	12.0	Reconstruction	\$17,500	1	High	High	Low	Med

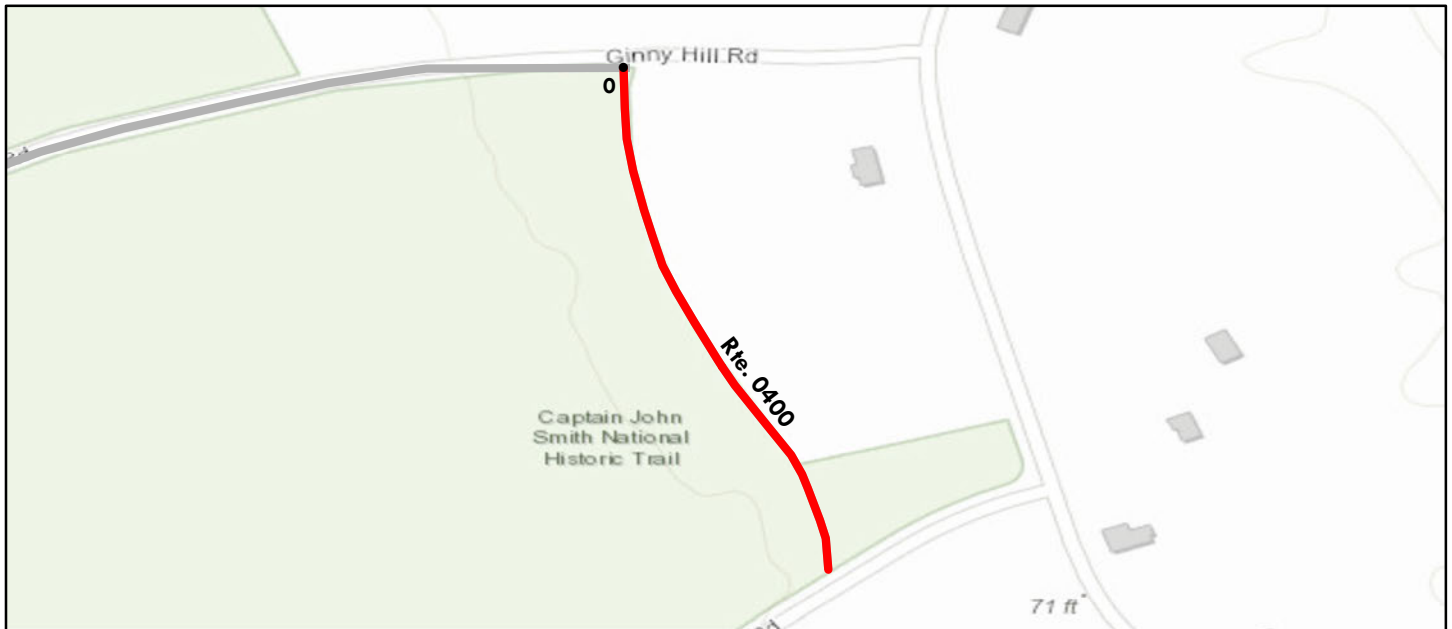
ROUTE 0400: LOVERS LANE

Begin MP	End MP	Section Length	# of Lanes	Lane Width	Road Width	Treatment Recommendation	Treatment Cost	Unpaved Rating (Paser +)	Crown Severity	Drainage Severity	Rutting, Washboard Severity	Potholes / Loose Aggregate Severity
0.00	0.17	0.17	1	9.0	9.0	Heavy Rehabilitation	\$6,920	1	High	High	Low	Med
Route Level Data:		0.17	1	9.0	9.0	Heavy Rehabilitation	\$6,920	1	High	High	Low	Med

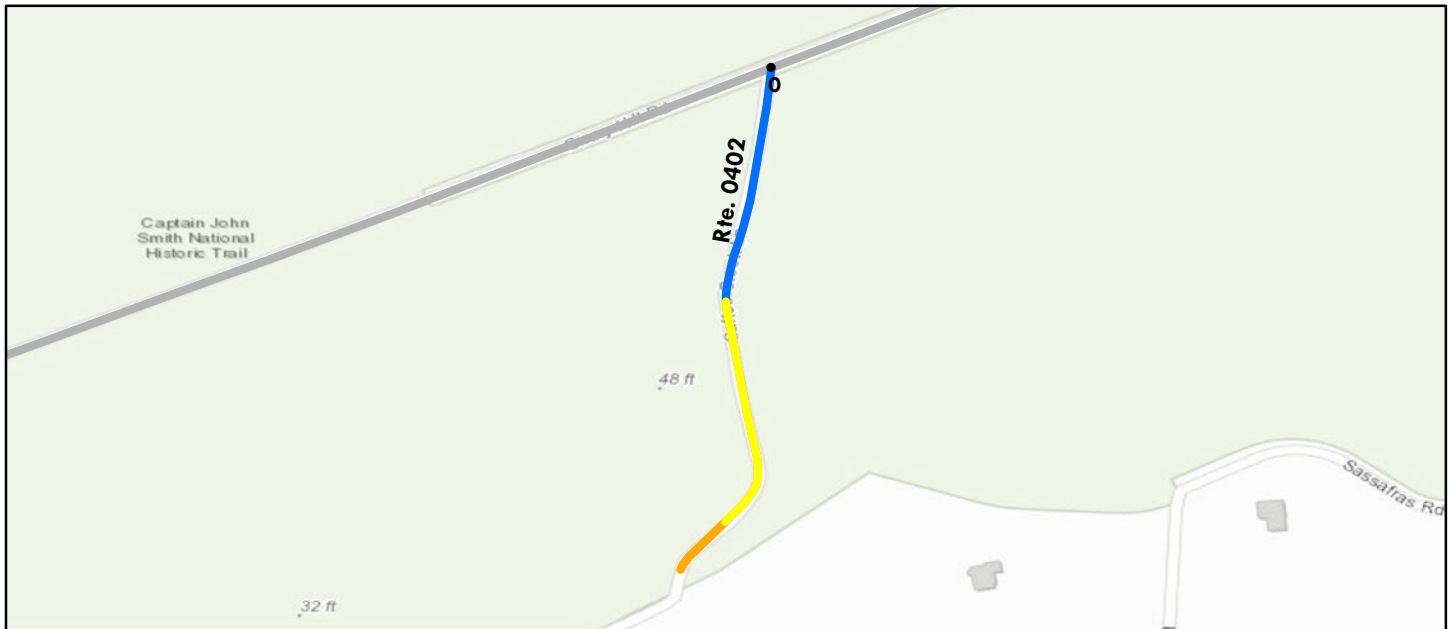
ROUTE 0402: CAFFEE CREEK LANE

Route Condition Legend					
Poor (1)	Poor (2)	Fair (3)	Good (4)	Excellent (5)	Not Rated
See Appendix for definitions and formulas					
Inspection Date: 1/29/2021		Unpaved Length (Miles): 0.228		Surface Type: GR

Begin MP	End MP	Section Length	# of Lanes	Lane Width	Road Width	Treatment Recommendation	Treatment Cost	Unpaved Rating (Paser+)	Crown Severity	Drainage Severity	Rutting, Washboard Severity	Potholes / Loose Aggregate Severity
0.00	0.23	0.23	2	7.0	14.0	Routine Maintenance	\$2,280	4	Low	Low	Low	High
Route Level Data:		0.23	2	7.0	14.0	Routine Maintenance	\$2,280	4	Low	Low	Low	High
