CANE Cycle 6

Final Report

Road Inventory and Condition Assessment of Paved Routes Camp Nelson National Monument

Report Date: November 2021

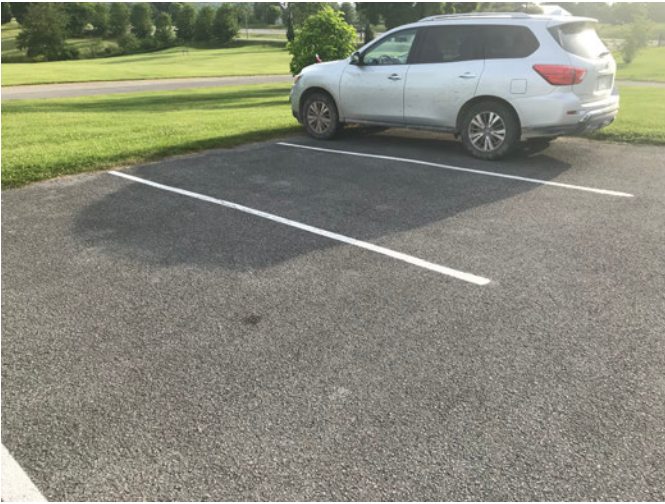
CANE_0900AZ_4

Inspection Date	FMSS Number	User Access	Surface Type
6/19/2021	252406	PUBLIC	ASPHALT
Area (Sq. Ft.)	Lane Miles (11' Widths)	Curb Reveal (Inches)	Curb Recommendation
2,856	0.049	NOT APPLICABLE	NOT APPLICABLE
Curb Type		Curb & Gutter Type	
NO CURB		NO CURB AND GUTTER	
Pavement Recommendation		Condition Rating / PCR	
LIGHT 3R TREATMENTS		FAIR / 73

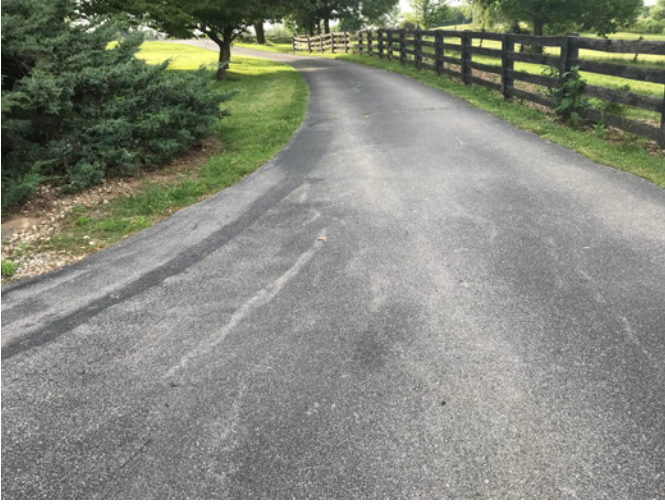
CANE_0902_4

Inspection Date	FMSS Number	User Access	Surface Type
6/19/2021	255708	NONPUBLIC	ASPHALT
Area (Sq. Ft.)	Lane Miles (11' Widths)	Curb Reveal (Inches)	Curb Recommendation
6,561	0.113	NOT APPLICABLE	NOT APPLICABLE
Curb Type		Curb & Gutter Type	
NO CURB		NO CURB AND GUTTER	
Pavement Recommendation		Condition Rating / PCR	
PREVENTIVE MAINTENANCE		GOOD / 90

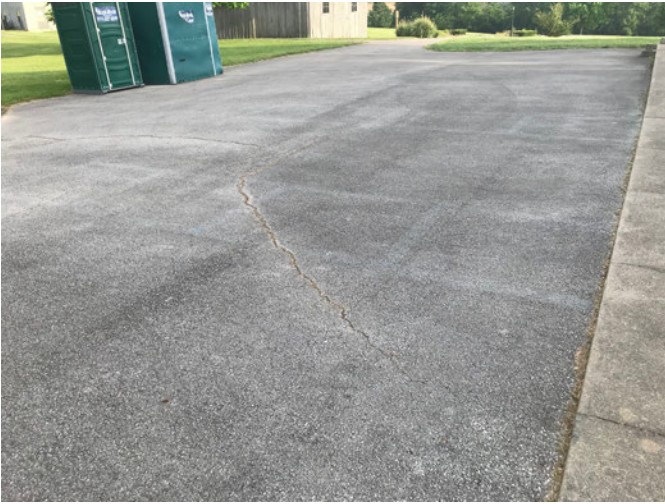
CANE_0904_4

Inspection Date	FMSS Number	User Access	Surface Type
6/19/2021		NONPUBLIC	ASPHALT
Area (Sq. Ft.)	Lane Miles (11' Widths)	Curb Reveal (Inches)	Curb Recommendation
4,330	0.075	6	DO NOTHING
Curb Type		Curb & Gutter Type	
CONCRETE		NOT APPLICABLE	
Pavement Recommendation		Condition Rating / PCR	
LIGHT 3R TREATMENTS		FAIR / 73

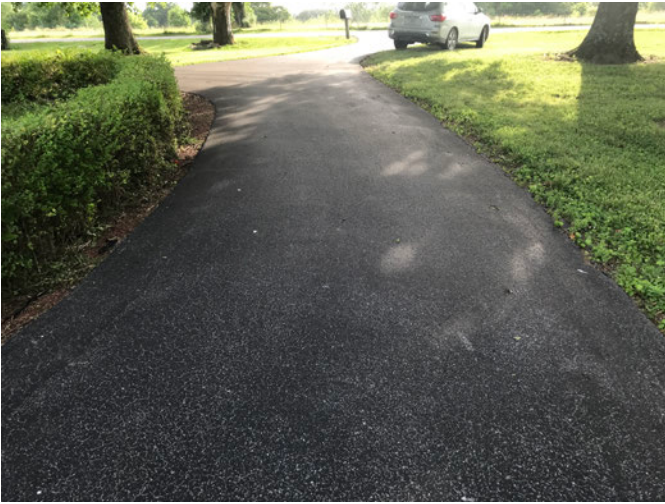
CANE_0905_4

Inspection Date	FMSS Number	User Access	Surface Type
6/19/2021	255711	NONPUBLIC	ASPHALT
Area (Sq. Ft.)	Lane Miles (11' Widths)	Curb Reveal (Inches)	Curb Recommendation
2,531	0.044	NOT APPLICABLE	NOT APPLICABLE
Curb Type		Curb & Gutter Type	
NO CURB		NO CURB AND GUTTER	
Pavement Recommendation		Condition Rating / PCR	
RECONSTRUCTION		POOR / 30
