# CARI Cycle 6

## Final Report

### Road Inventory and Condition Assessments for Cane River Creole National Historical Park

**Report Date: February 2021**

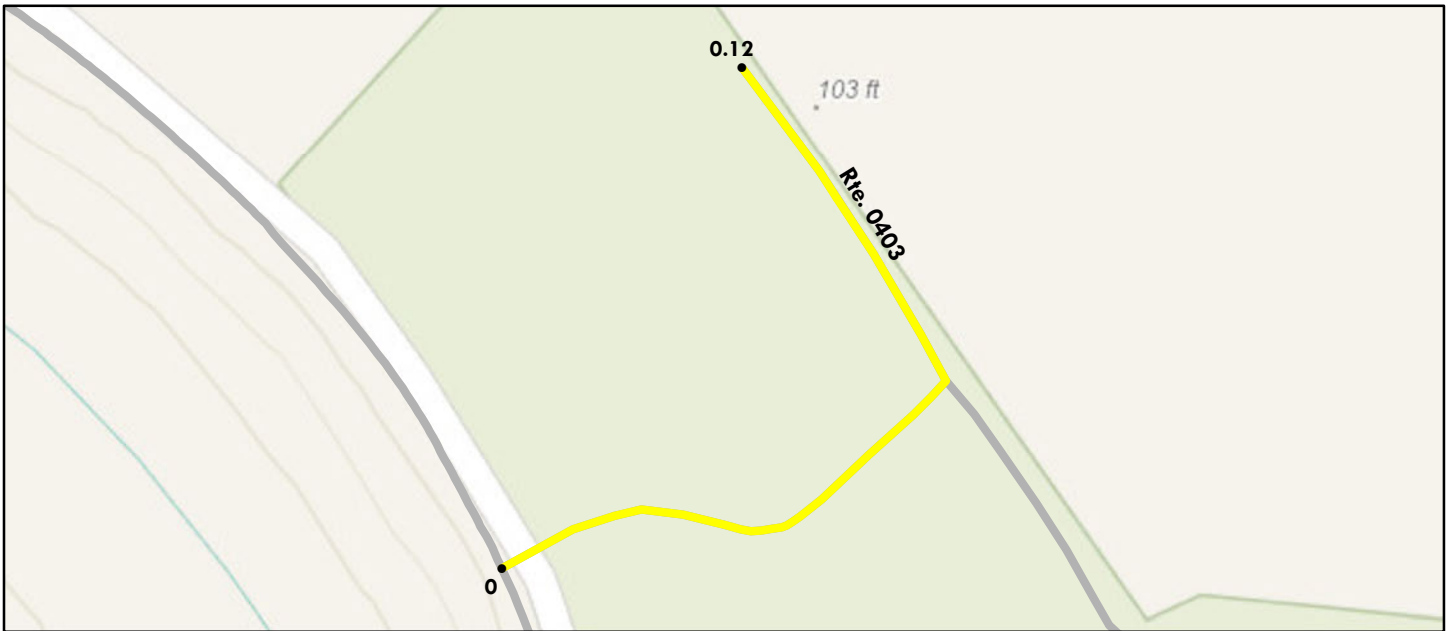
## ROUTE 0403: FARM ACCESS ROAD (MAGNOLIA)

### Condition Summary Table for CARI-0403

Begin MP	End MP	Section Length	# of Lanes	Lane Width	Road Width	Treatment Recommendation	Treatment Cost	Unpaved Rating (Paser +)	Crown Severity	Drainage Severity	Rutting, Washboard Severity	Potholes / Loose Aggregate Severity
0.00	0.12	0.12	2	5.5	11.0	Light Rehabilitation	\$12,100	3	Med	Med	Low	Low
<b>Route Level Data:</b>		0.12	2	5.5	11.0	Light Rehabilitation	\$12,100	3	Med	Med	Low	Low

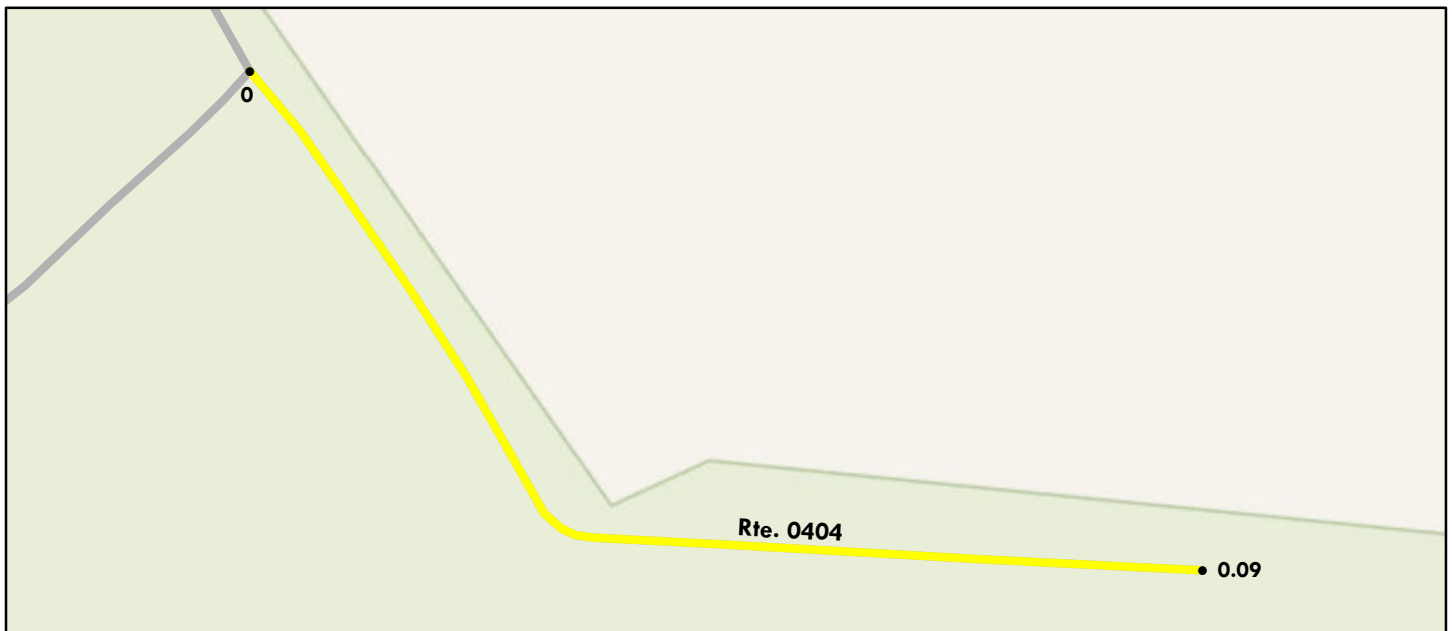
## ROUTE 0404: SLAVE TENANT QUARTERS ACCESS ROAD

Route Condition Legend					
Poor (1)	Poor (2)	Fair (3)	Good (4)	Excellent (5)	Not Rated
See Appendix for definitions and formulas					
Inspection Date: 2/22/2020		Unpaved Length (Miles): 0.09		Surface Type: GR

### Condition Summary Table for CARI-0404

Begin MP	End MP	Section Length	# of Lanes	Lane Width	Road Width	Treatment Recommendation	Treatment Cost	Unpaved Rating (Paser +)	Crown Severity	Drainage Severity	Rutting, Washboard Severity	Potholes / Loose Aggregate Severity	
0.00	0.09	0.09	2	5.5	11.0	Light Rehabilitation	\$9,100	3	Med	Med	Low	Low	
<b>Route Level Data:</b>			0.09	2	5.5	11.0	Light Rehabilitation	\$9,100	3	Med	Med	Low	Low

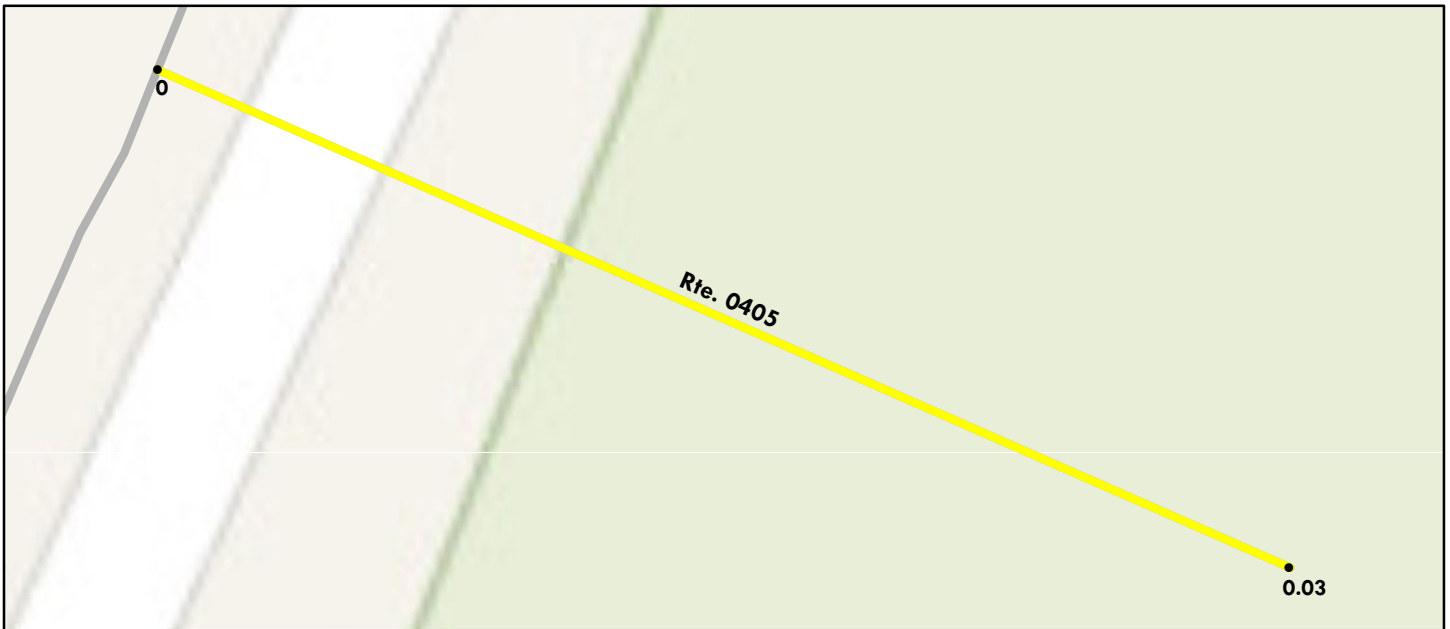
## ROUTE 0405: GIN ACCESS ROAD

Route Condition Legend					
Poor (1)	Poor (2)	Fair (3)	Good (4)	Excellent (5)	Not Rated
See Appendix for definitions and formulas					
Inspection Date: 2/22/2020		Unpaved Length (Miles): 0.03		Surface Type: GR

### Condition Summary Table for CARI-0405

Begin MP	End MP	Section Length	# of Lanes	Lane Width	Road Width	Treatment Recommendation	Treatment Cost	Unpaved Rating (Paser +)	Crown Severity	Drainage Severity	Rutting, Washboard Severity	Potholes / Loose Aggregate Severity	
0.00	0.03	0.03	2	8.0	16.0	Light Rehabilitation	\$2,600	3	Med	Med	Low	Low	
<b>Route Level Data:</b>			0.02	2	8.0	16.0	Light Rehabilitation	\$2,600	3	Med	Med	Low	Low
