# CEBE Cycle 6

## Final Report

### Road Inventory and Condition Assessment of Paved Routes Cedar Creek and Belle Grove National Historical Park

**Report Date: November 2021**

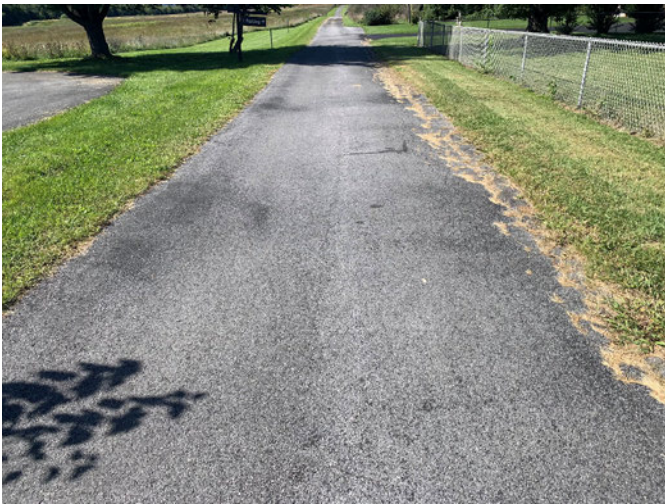
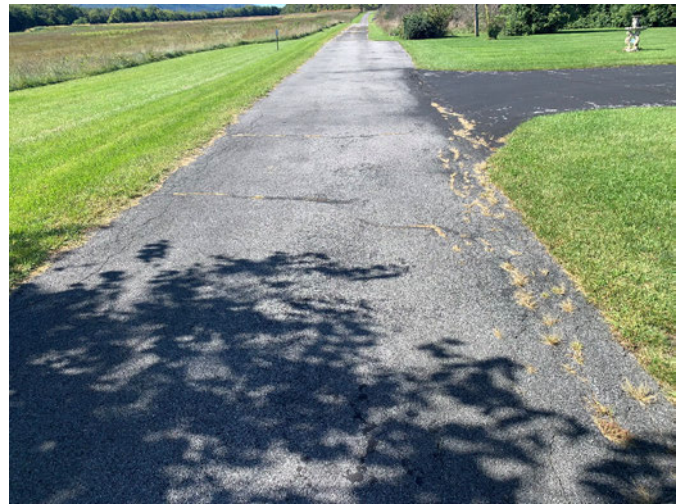
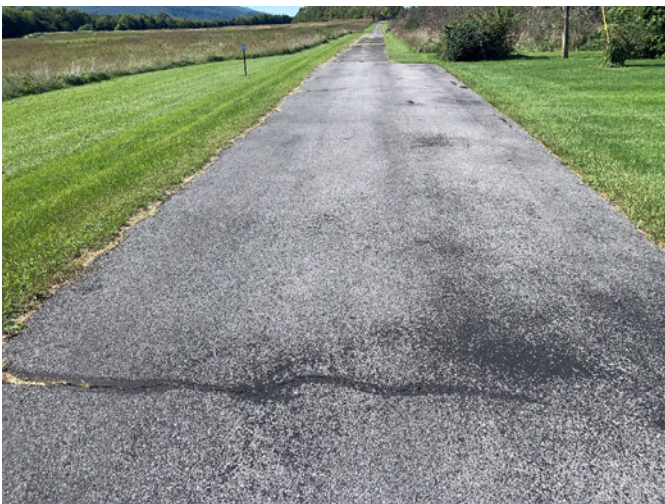
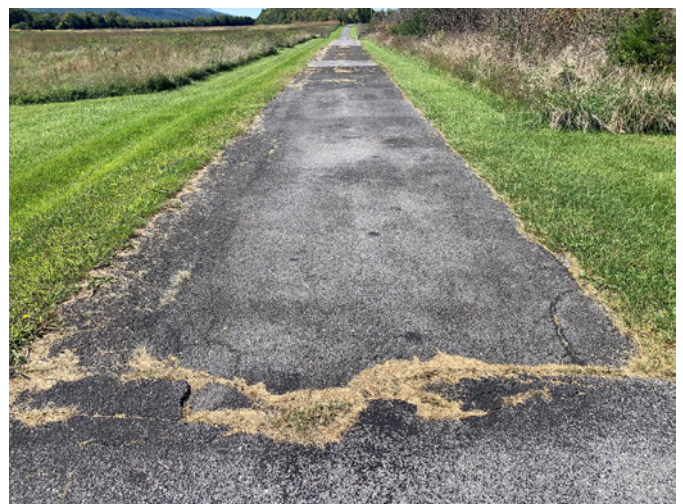
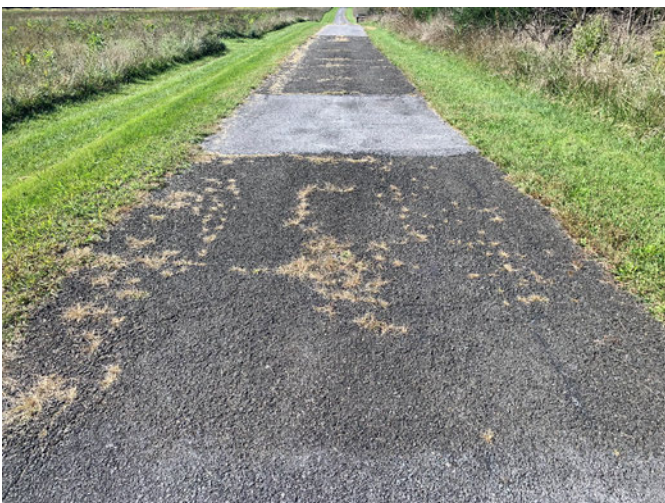
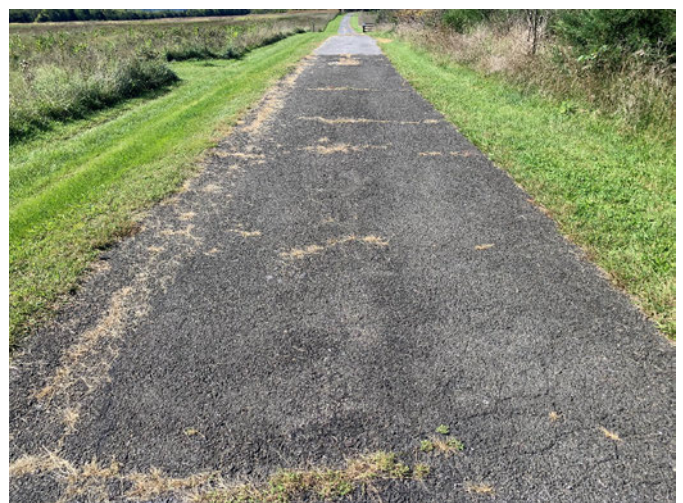
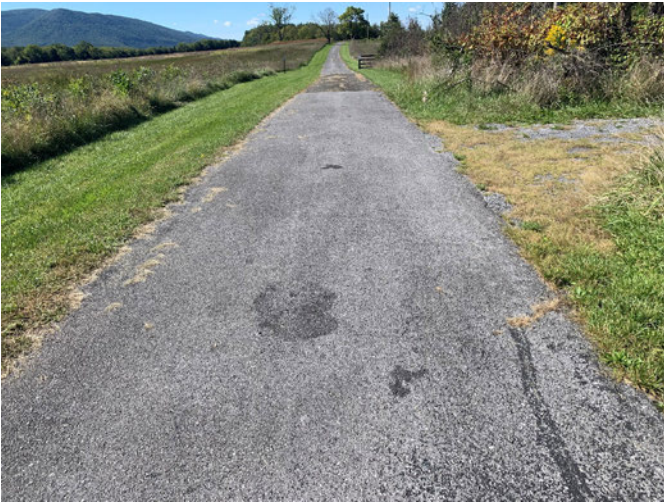
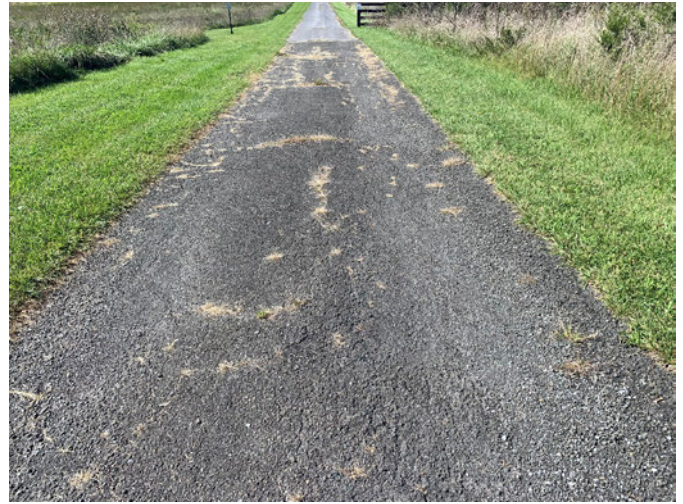
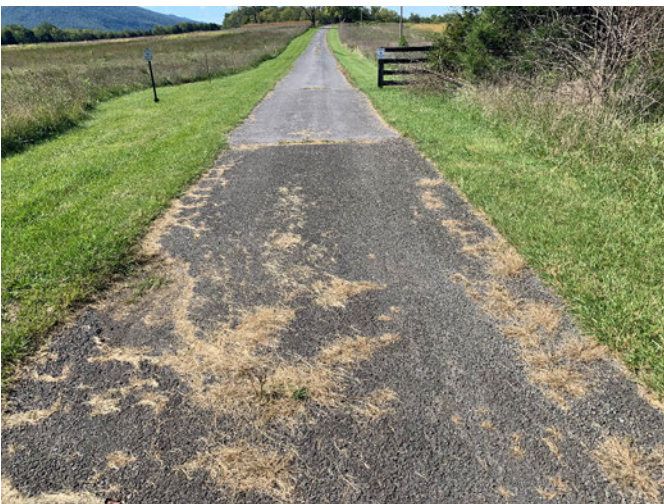
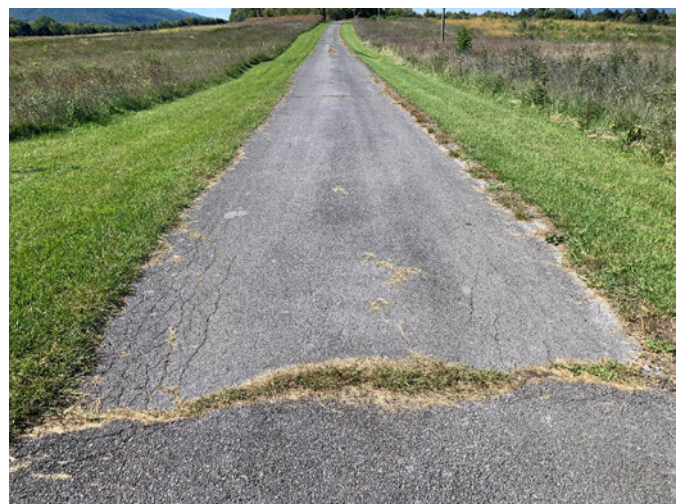
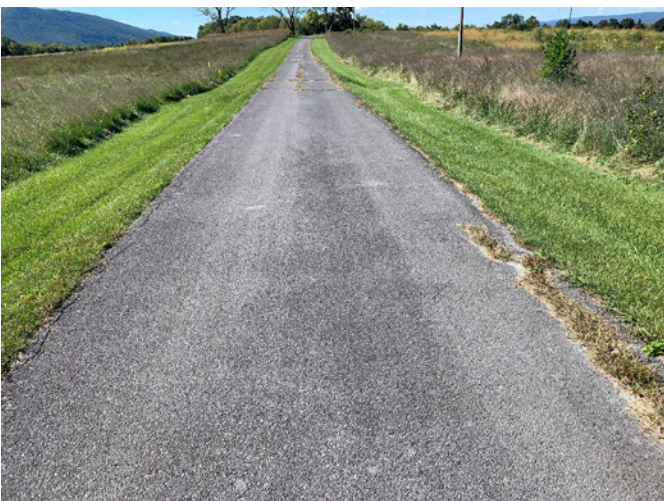
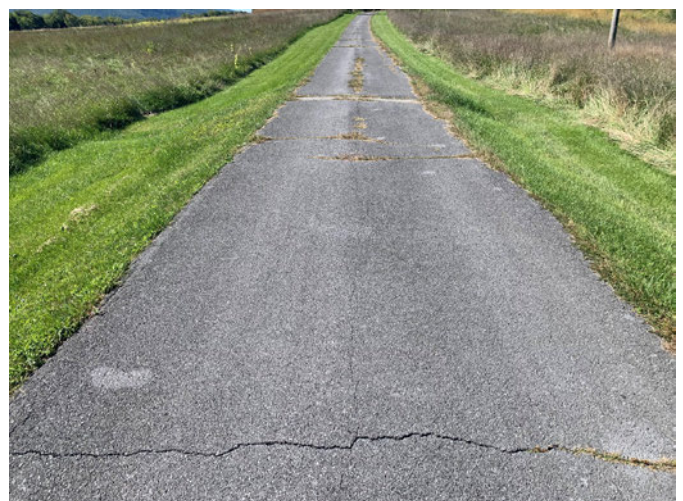
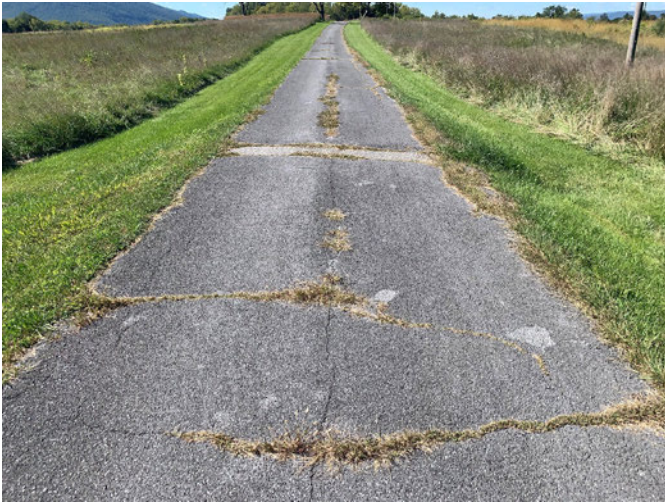
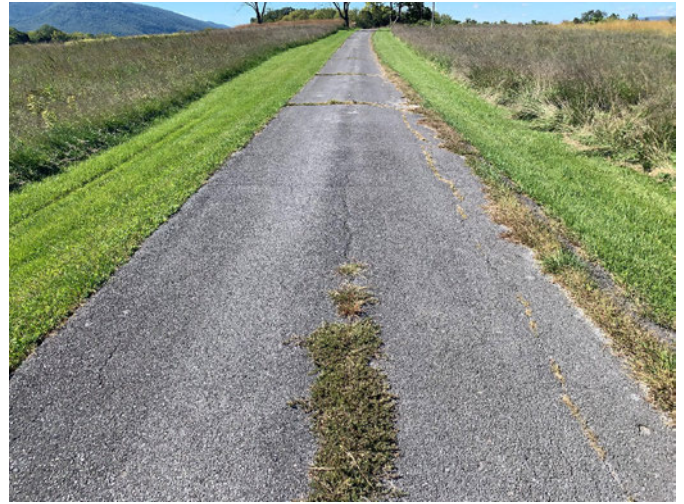
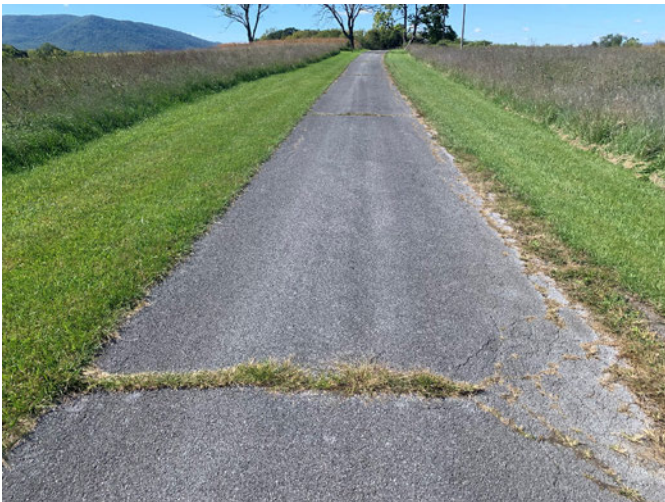
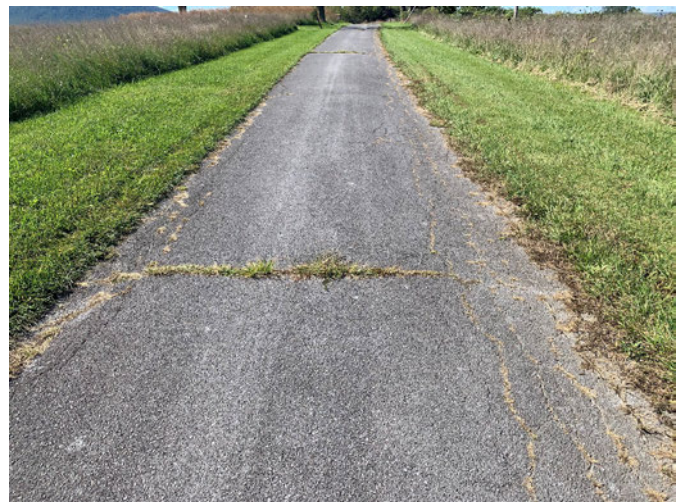
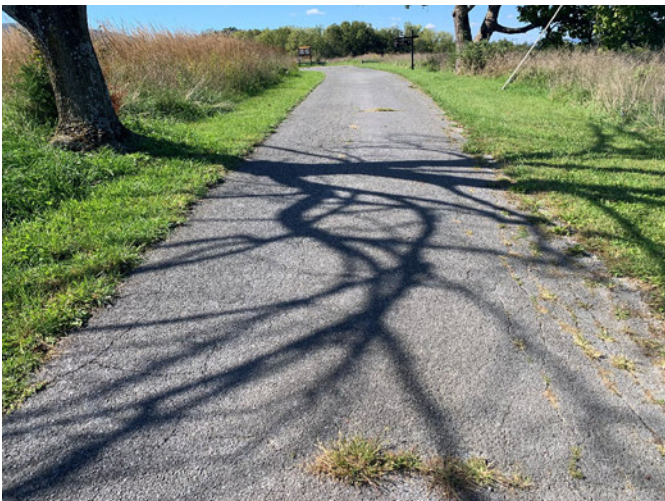
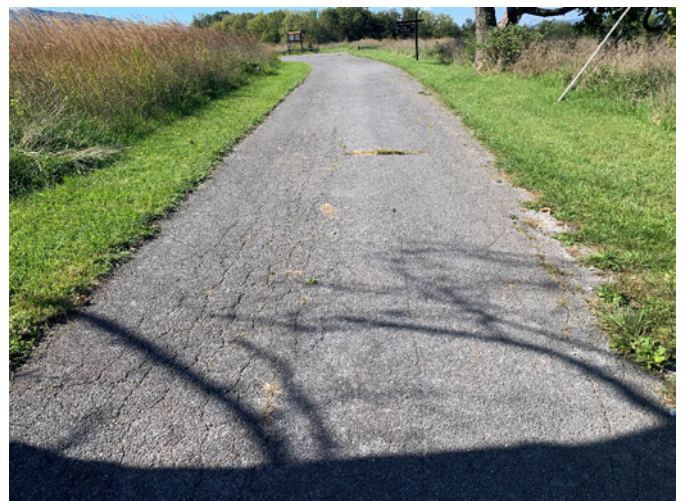
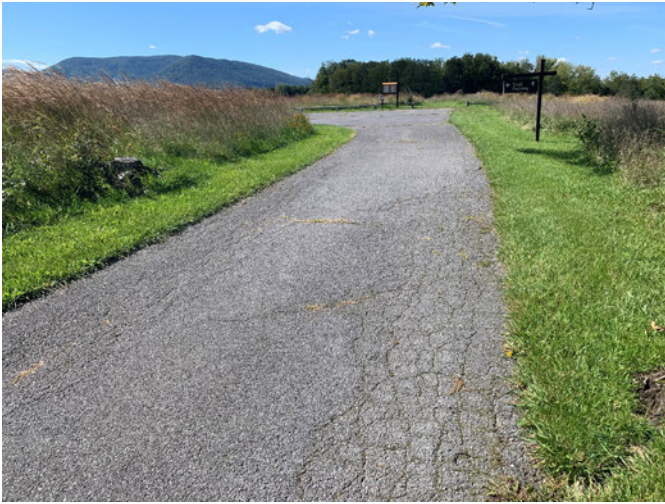
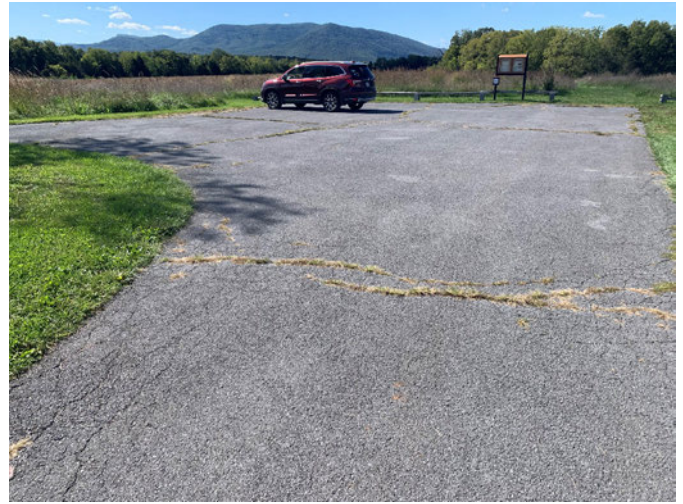
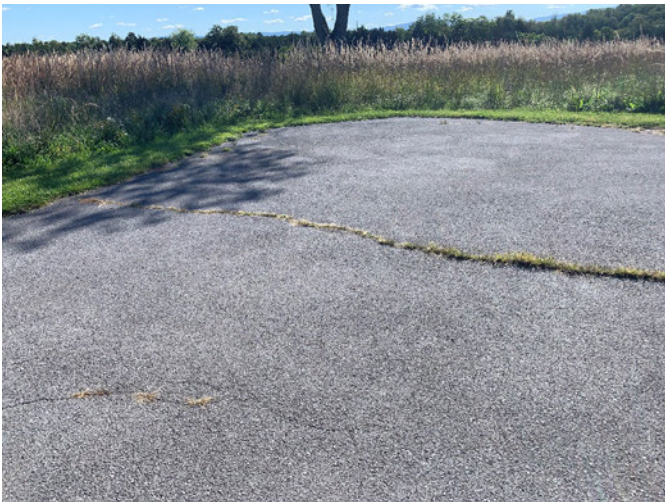
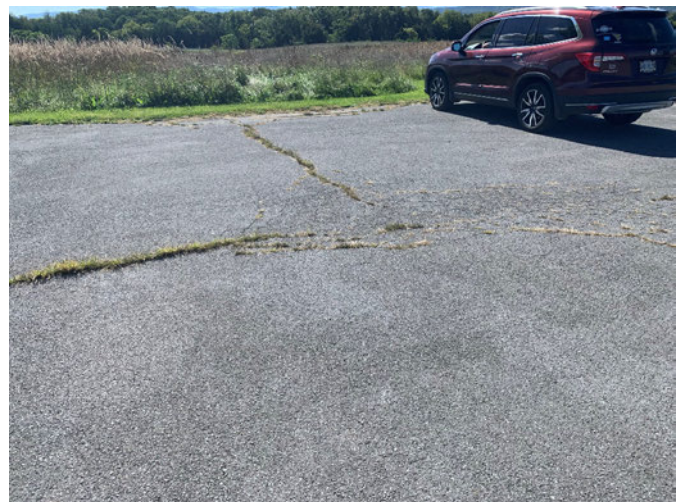
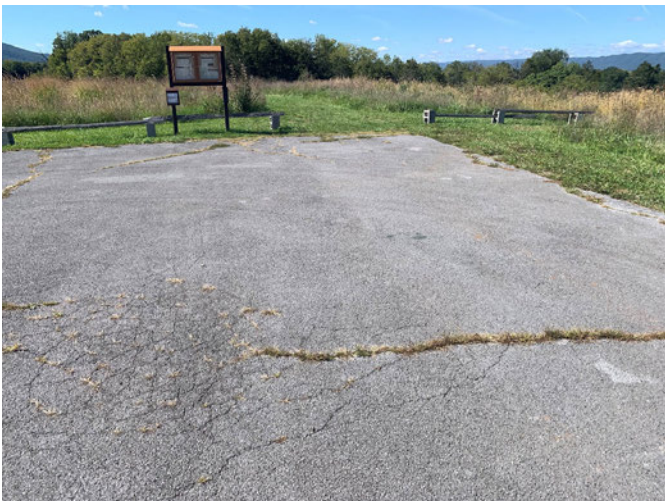
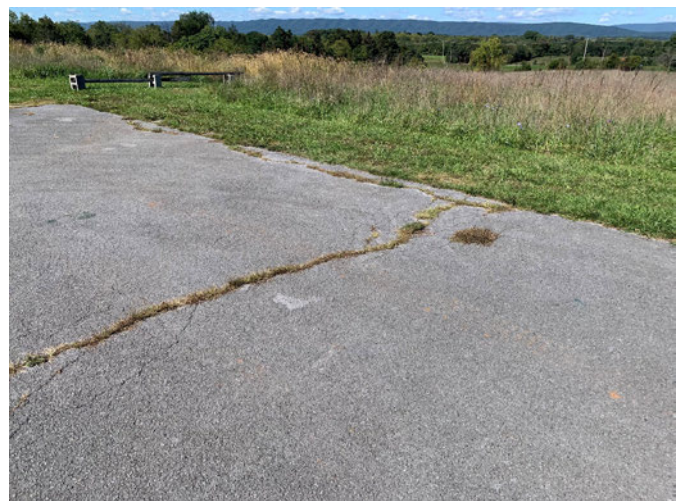
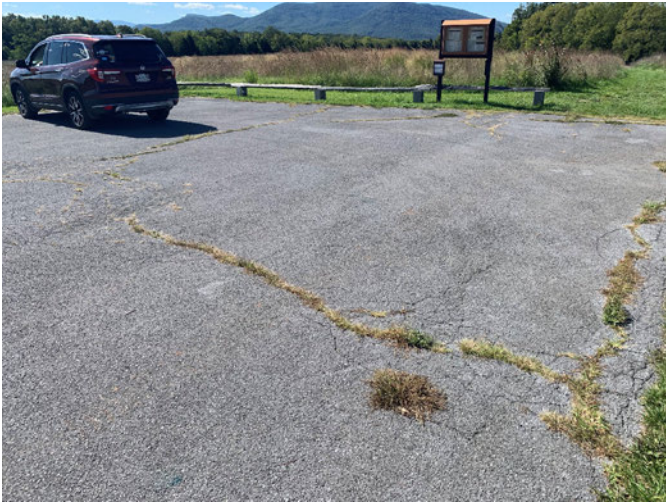
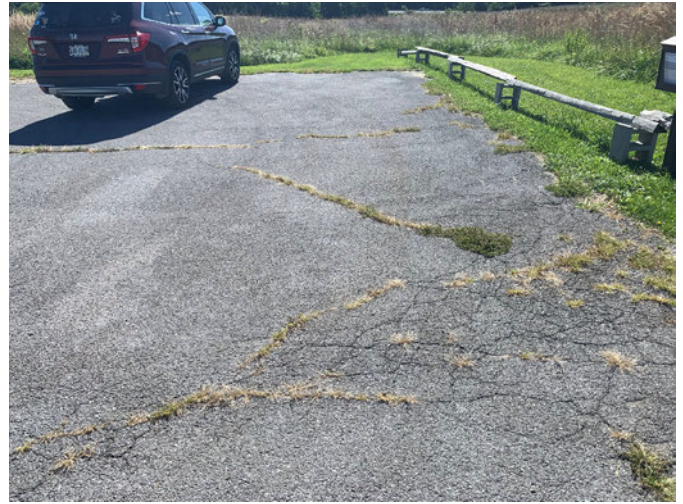
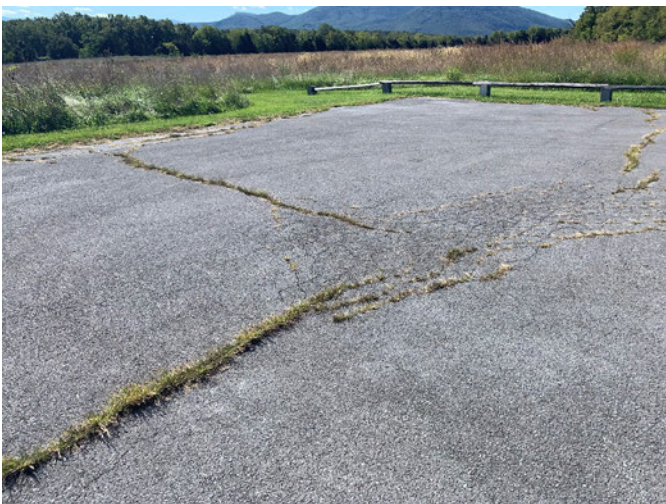
## ROUTE 0900: CLAVEN LANE PARKING

Inspection Date	FMSS Number	User Access	Surface Type
9/26/2021	251200	PUBLIC	ASPHALT
Area (Sq. Ft.)	Lane Miles (11' Widths)	Curb Reveal (Inches)	Curb Recommendation
16,455	0.283	NOT APPLICABLE	NOT APPLICABLE
Curb Type		Curb & Gutter Type	
NO CURB		NO CURB AND GUTTER	
Pavement Recommendation		Condition Rating / PCR	
HEAVY 3R TREATMENTS		POOR / 53
