Road Inventory and Condition Assessment of Paved Routes César E. Chávez National Monument

**Federal Lands Highway
Road Inventory Program**

**Federal Highway Administration
Eastern Federal Lands Highway Division
Road Inventory Program (RIP)**

**Data Collection Date: September 2014
Report Date: January 2015**

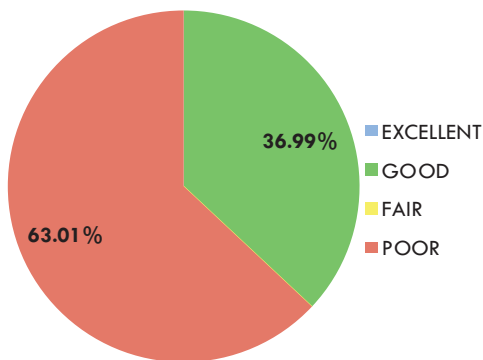
Figure 1: Pavement Condition Rating Breakdown for Roads

Parkwide Condition Rating for Paved Park Roads

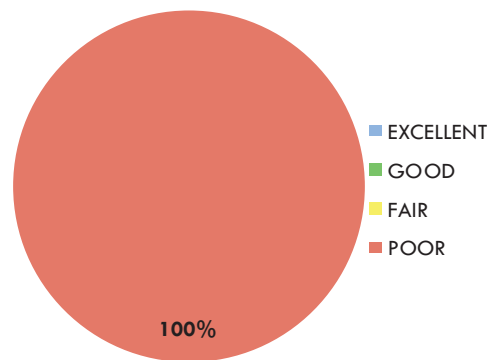
Figure 2: Pavement Condition Rating Breakdown for Parking Areas

Parkwide Condition Rating for Paved Parking Areas

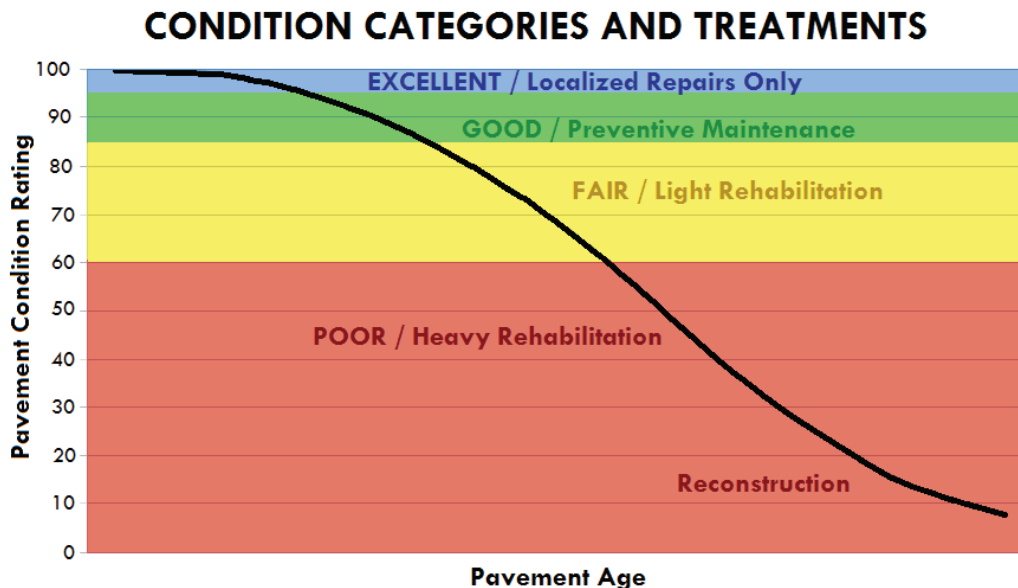
Figure 3: Pavement condition degradation and general treatment descriptions

- Excellent / New: PCR of 95-100
 - Pavements in this range will require only spot repairs
- Good: PCR of 85-94
 - Pavements in this range will likely be candidates for Preventive Maintenance. Examples include Chip and Slurry Seals, Micro Surfacing and Thin Overlays.
- Fair: PCR of 61-84
 - Pavements in this range will likely be candidates of Light Rehabilitation (L3R). Examples include single-lift overlays up to 2.5 inches in total thickness, milling and overlays.
- Poor: PCR of 0-60
 - Pavements in this range will likely be candidates of Heavy Rehabilitation or Reconstruction (H3R or 4R). Examples include Pulverization, Multiple Lift Overlays, and Reconstruction.

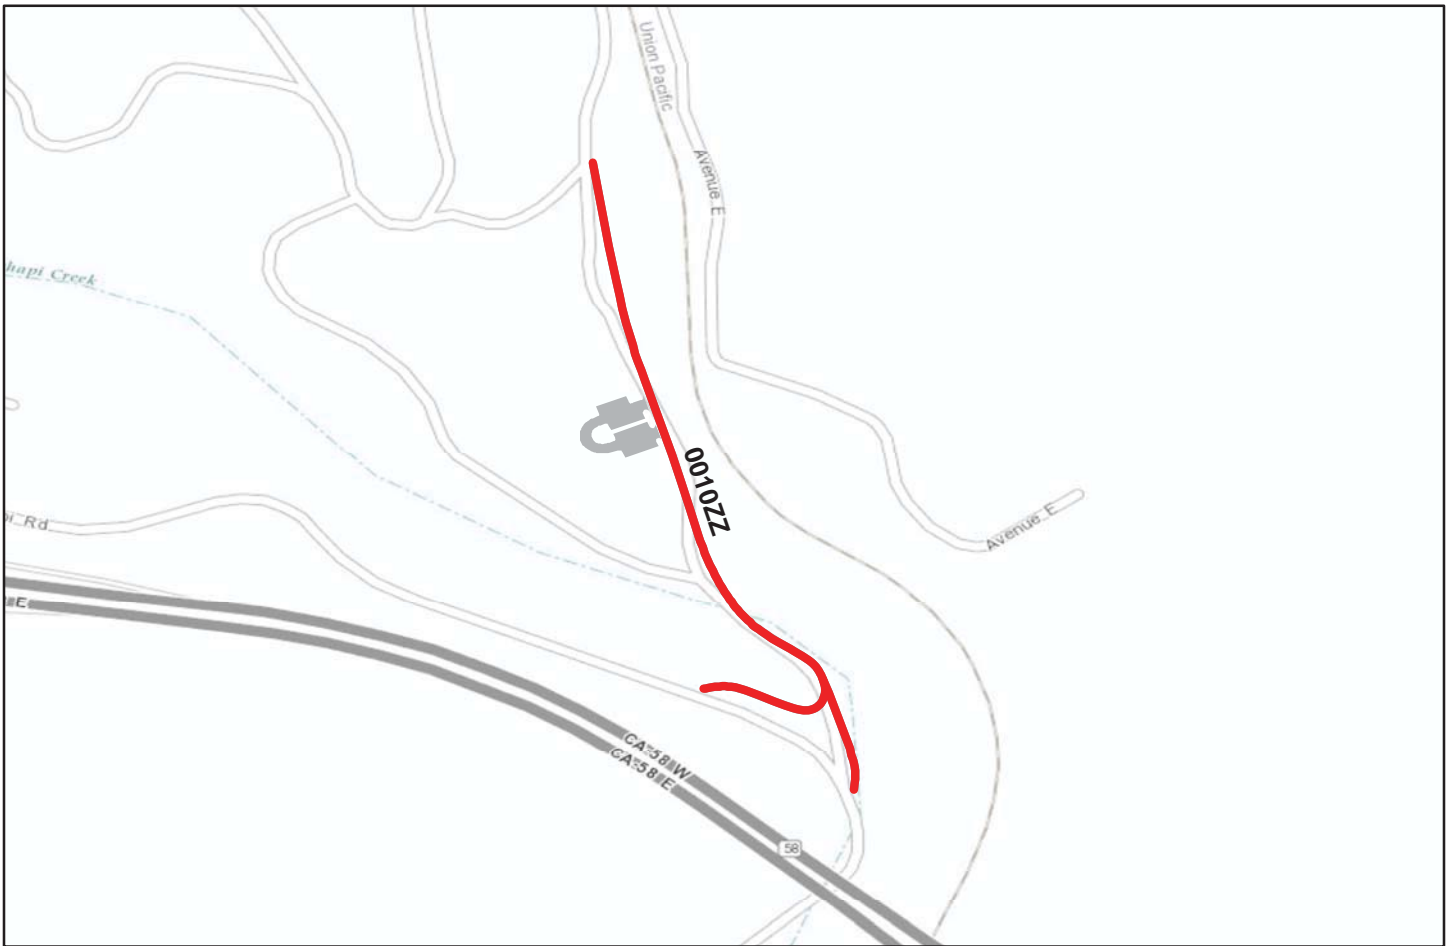
ROUTE 0010ZZ: LA PAZ ROAD

The condition shown on this page reflects the overall route condition; it might not reflect individual subcomponent ratings.

Inspection Date:	9/23/2014					
Paved Length (Miles):	0.37					
Surface Type:	CONCRETE					
Roadway Condition Information						
Pavement Condition Rating (PCR)	56					
Lane & Width Information						
Number of Lanes	2					
Paved Width (ft)	19					
Lane Width (ft)	9.5

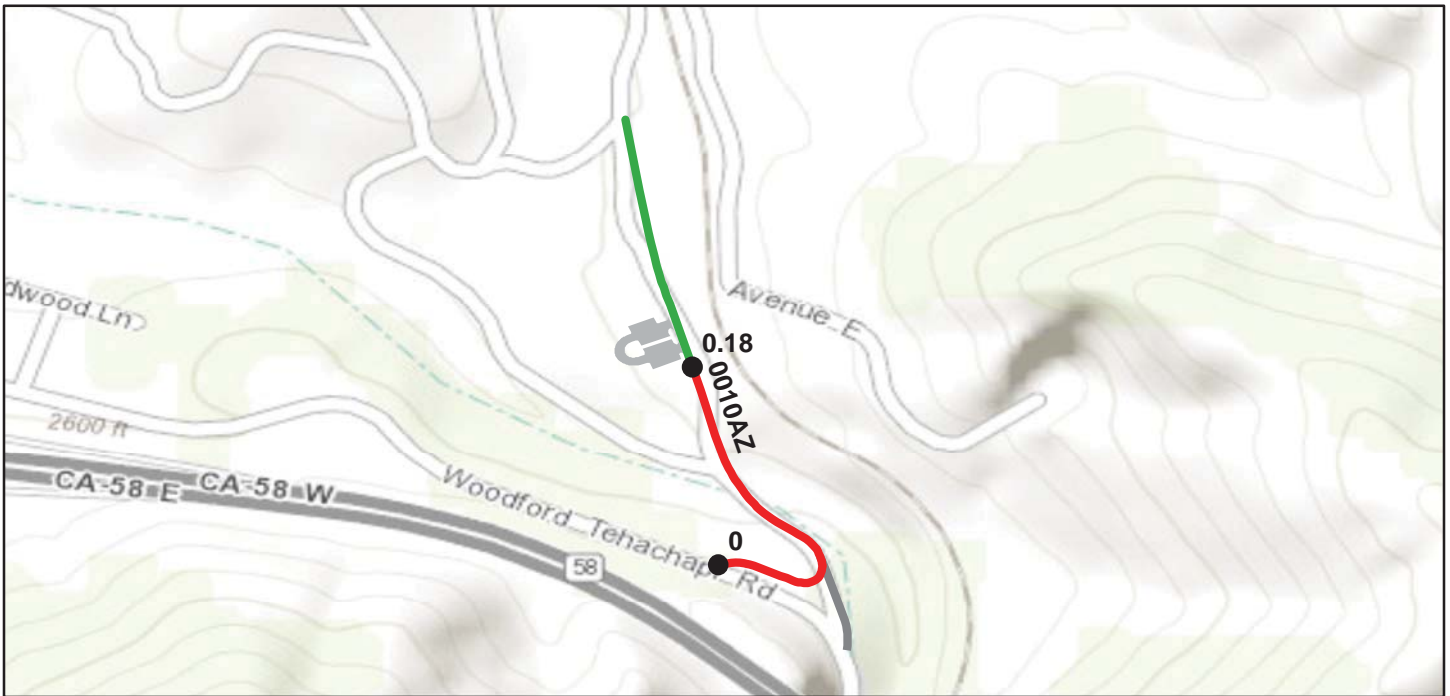
Subcomponent of Route CECH-0010ZZ

Route Condition Legend – Pavement Condition Rating (PCR)						
Poor (0 - 60)	Fair (61- 84)	Good (85 - 94)	Excellent (95 - 100)	Not Rated		
See Appendix for definitions and formulas						
Inspection Date: 9/23/2014	Beginning Section MP	0.00	0.18			
Paved Length (Miles): 0.31	Section Length (MI)	0.18	0.13			
Surface Type: CONCRETE	Route Summary					
Roadway Condition Information						
Pavement Condition Rating (PCR)	56	30	87			
Surface Condition Rating (SCR)	N/A	N/A	87			
Roughness Condition Index (RCI)	N/A	N/A	N/A			
Distress Index Values						
Structural Crack Index	N/A	N/A	87			
Transverse Cracking Index	N/A	N/A	90			
Patching Index	N/A	N/A	100			
Rutting Index	N/A	N/A	99			
International Roughness Index (IRI)	N/A	N/A	N/A			
Lane & Width Information						
Number of Lanes	2	2	2			
Paved Width (ft)	19.5	18.4	21			
Lane Width (ft)	9.8	9.2	10.5

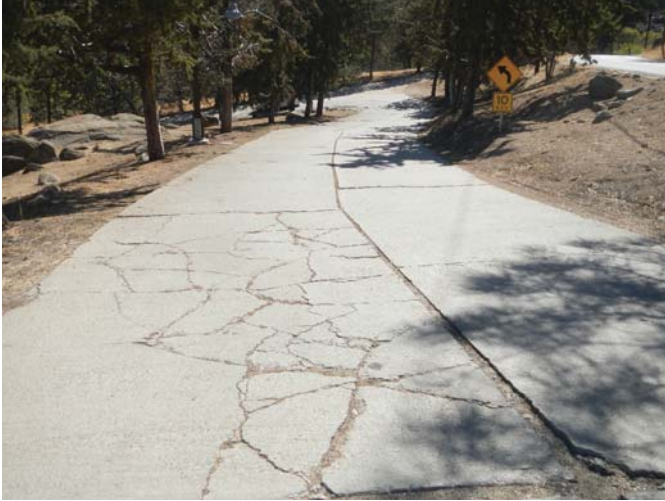
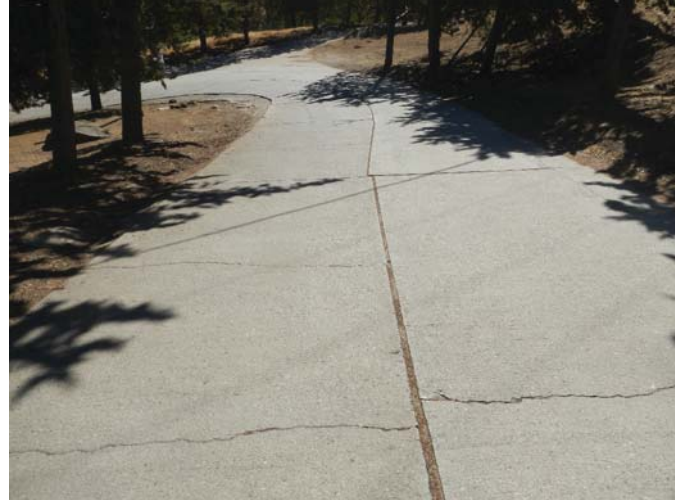
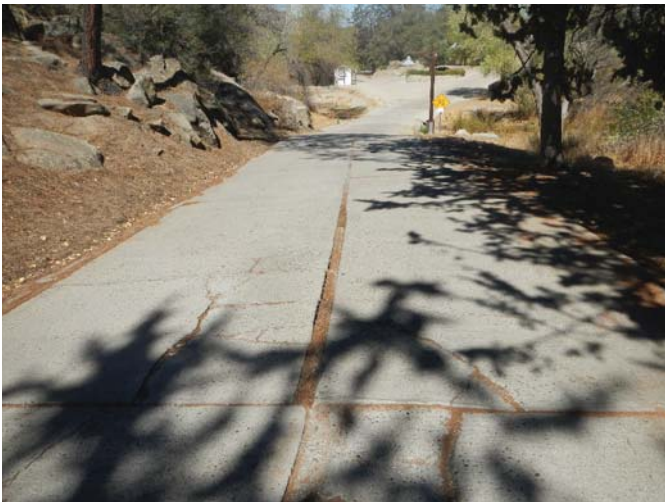
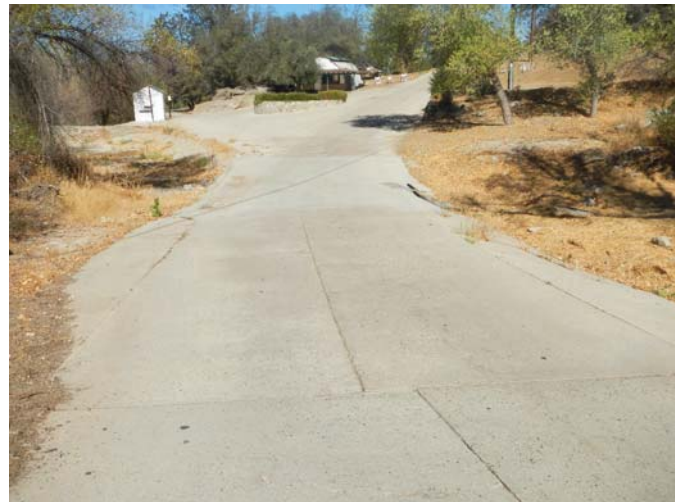
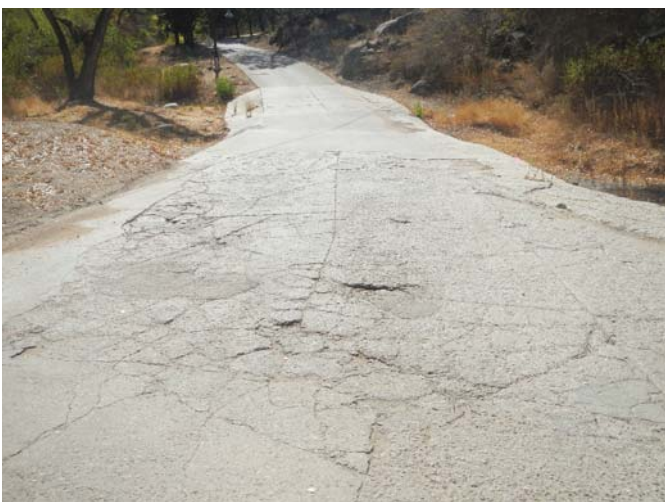
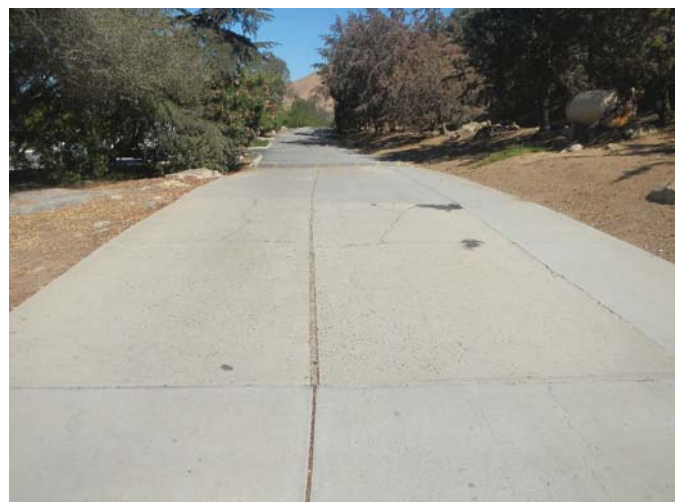
Concrete Section: Mileposts 0 - 0.18

Condition Photos

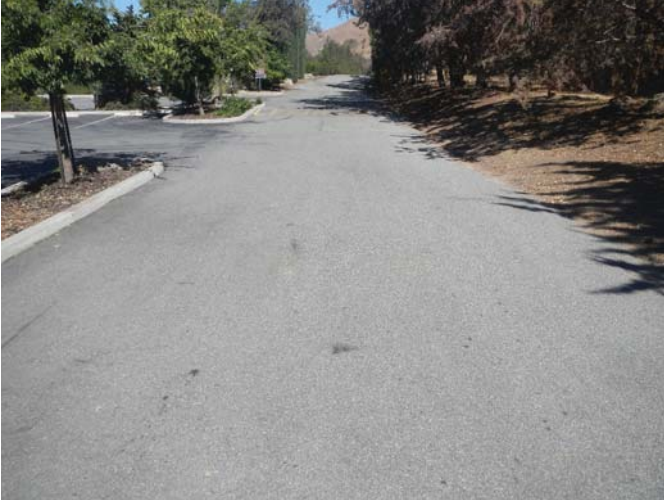
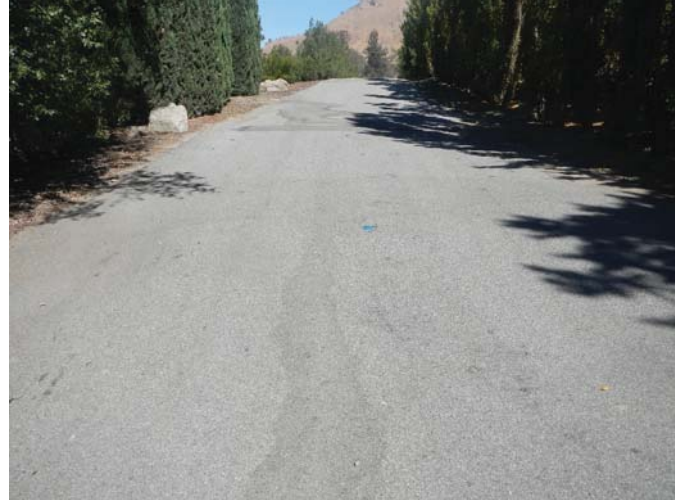
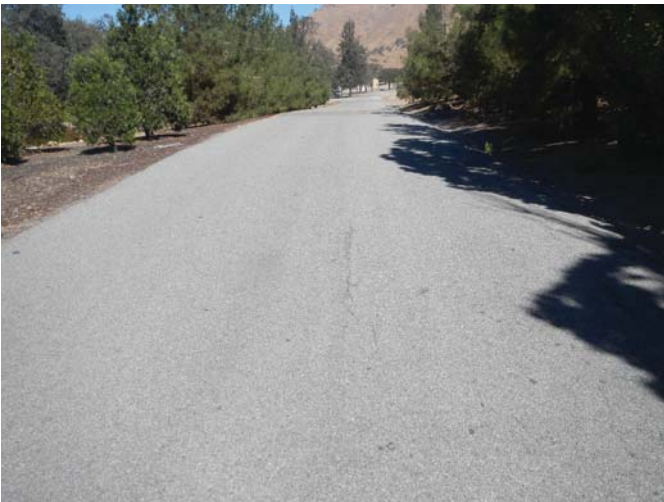
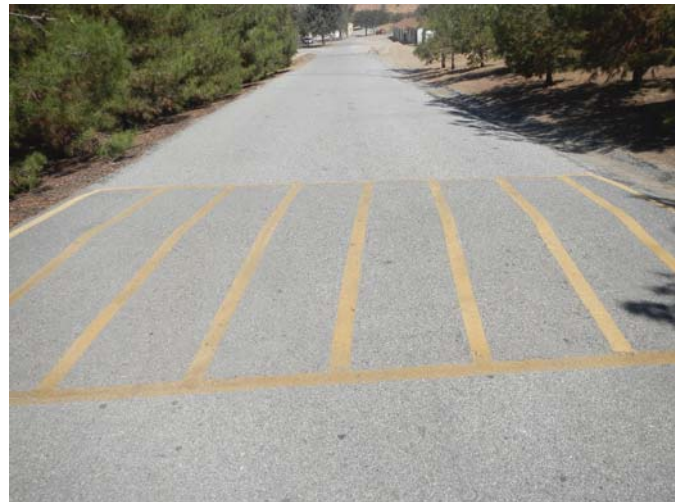
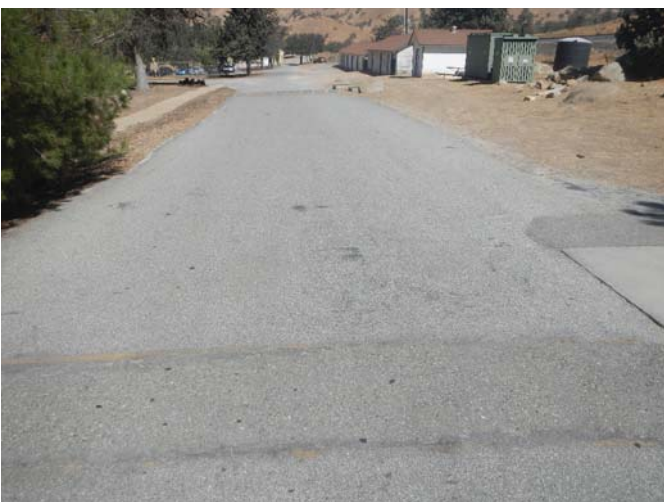
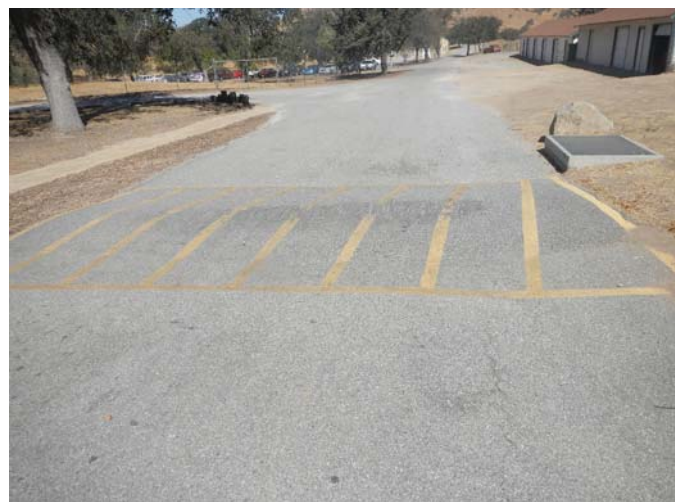
Asphalt Section: Mileposts 0.18 - 0.31

Condition Photos

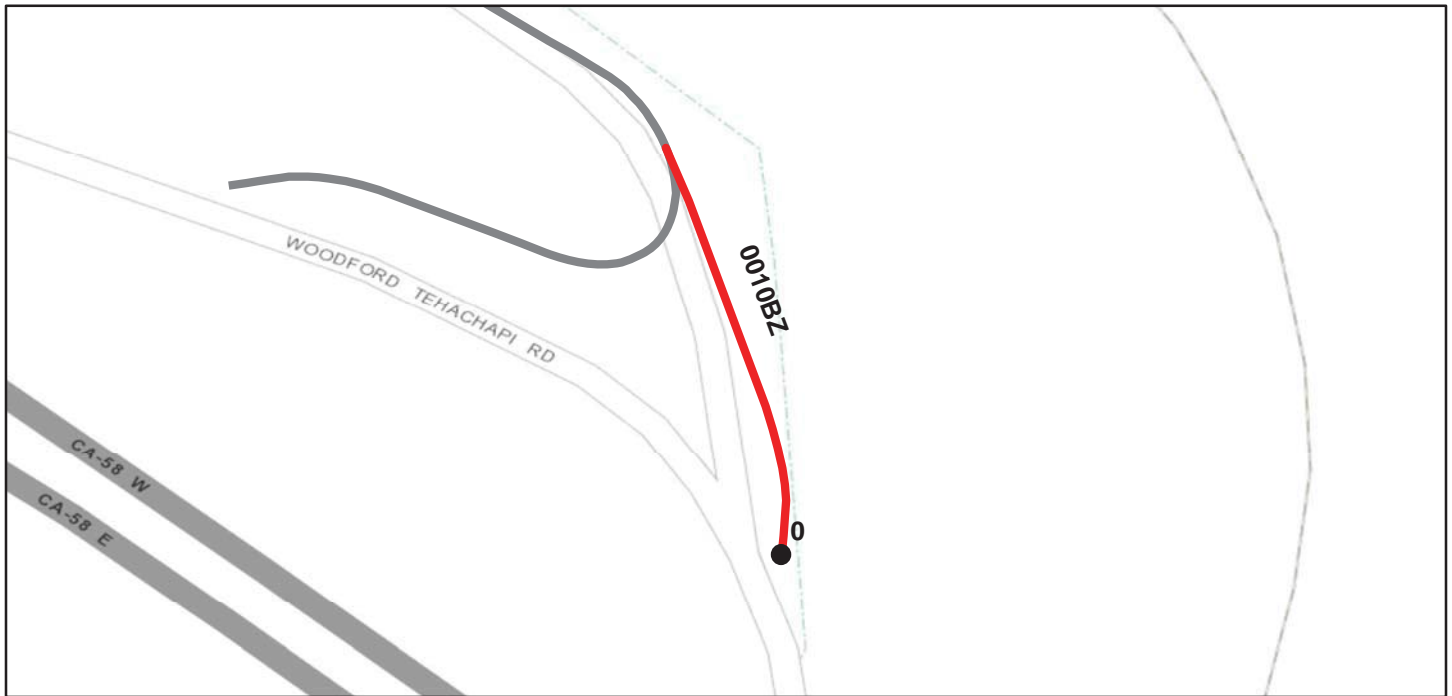
Subcomponent of Route CECH-0010ZZ

Inspection Date:	9/23/2014	Beginning Section MP	0.00				
Paved Length (Miles):	0.05	Section Length (MI)	0.05				
Surface Type:	CONCRETE	Route Summary					
Roadway Condition Information							
Pavement Condition Rating (PCR)	53	53					
Surface Condition Rating (SCR)	N/A	N/A					
Roughness Condition Index (RCI)	N/A	N/A					
Distress Index Values							
Structural Crack Index	N/A	N/A					
Transverse Cracking Index	N/A	N/A					
Patching Index	N/A	N/A					
Rutting Index	N/A	N/A					
International Roughness Index (IRI)	N/A	N/A					
Lane & Width Information							
Number of Lanes	2	2					
Paved Width (ft)	16	16					
Lane Width (ft)	8	8

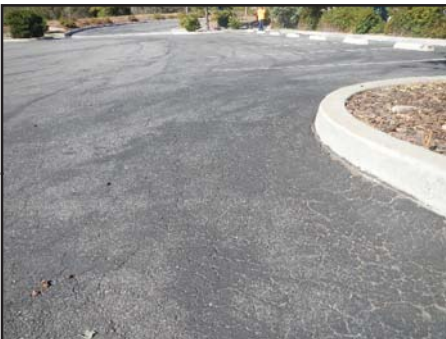
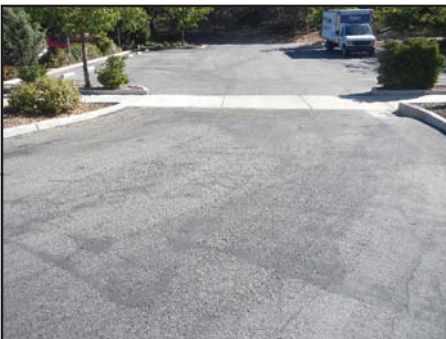
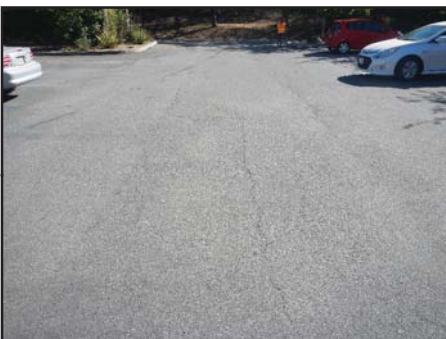
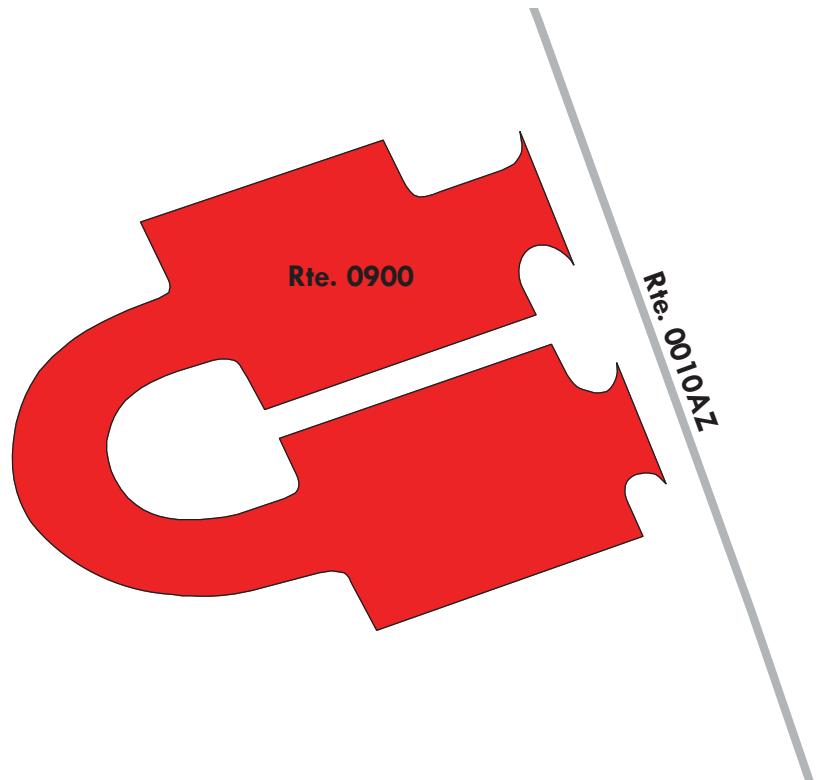
Inspection Date	FMSS Number	User Access	Surface Type
9/23/2014		PUBLIC	ASPHALT
Area (Sq. Ft.)	Lane Miles (11' Widths)	Curb Reveal (Inches)	Curb Recommendation
12,867	0.222	5	DO NOTHING
Curb Type		Curb & Gutter Type	
CONCRETE		NO CURB AND GUTTER	
Pavement Recommendation		Condition Rating / PCR	
HEAVY 3R TREATMENTS		POOR / 53

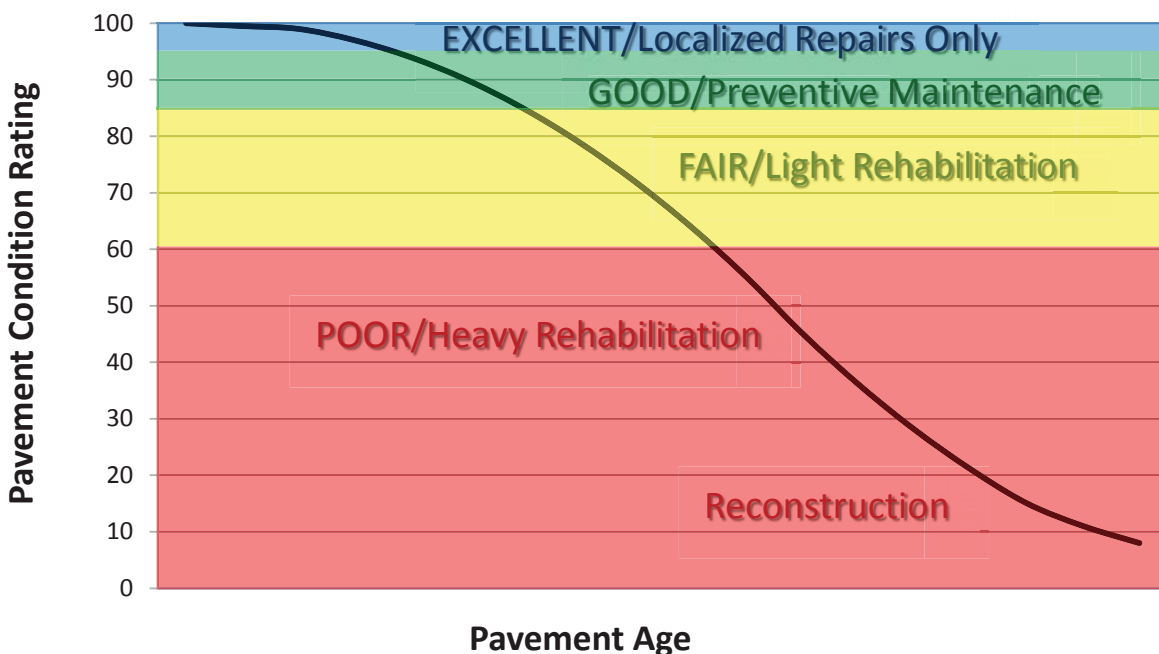
Condition Categories and Treatments

- Excellent/New: PCR of 95-100. Pavements in this range will require only spot repairs
- Good: PCR of 85-94. Pavements in this range will likely be candidates for Preventive Maintenance. Examples include Chip and Slurry Seals, Micro Surfacing and Thin Overlays.
- Fair: PCR of 61-84. Pavements in this range will likely be candidates of Light Rehabilitation (L3R).
Examples include single-lift overlays up to 2.5 inches in total thickness, milling and overlays.
- Poor: PCR of 60 or below. Pavements in this range will likely be candidates of Heavy Rehabilitation or Reconstruction (H3R or 4R). Examples include Pulverization, Multiple Lift Overlays, and Reconstruction.
