# CHAT Cycle 6

## Final Report

### Road Inventory and Condition Assessment of Paved Routes Chattahoochee River National Recreation Area

**Report Date: January 2022**

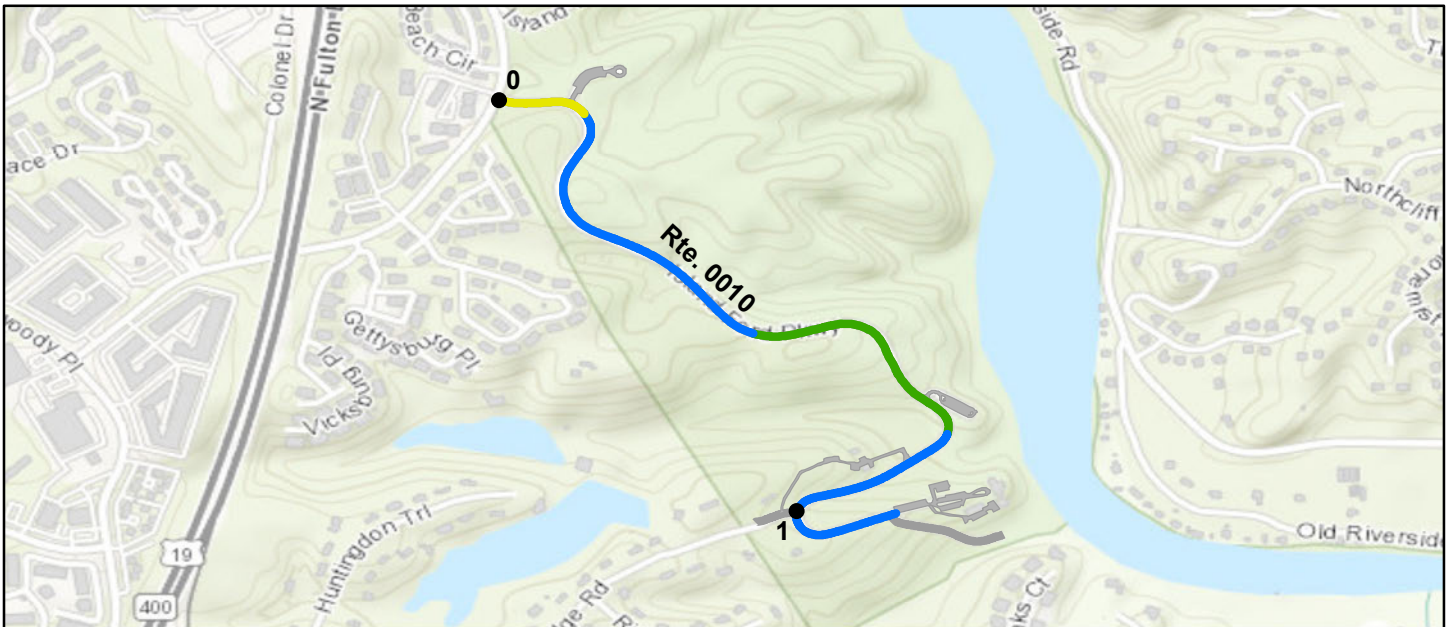
### Data Collection Vehicle (DCV) Rating

Colors on map represent condition scores at 0.10-mile intervals. See Appendix for definitions and formulas.

| Inspection Date: | 7/24/2021 | Beginning Section MP | 0 | 1 | | | |
|---|---|---|---|---|--|--|--|
| Pavement Condition Rating (PCR) | 96 | 96 | 98 | | | | |
| Surface Condition Rating (SCR) | 98 | 98 | 99 | | | | |
| Roughness Condition Index (RCI) | 93 | 93 | 96 | | | | |

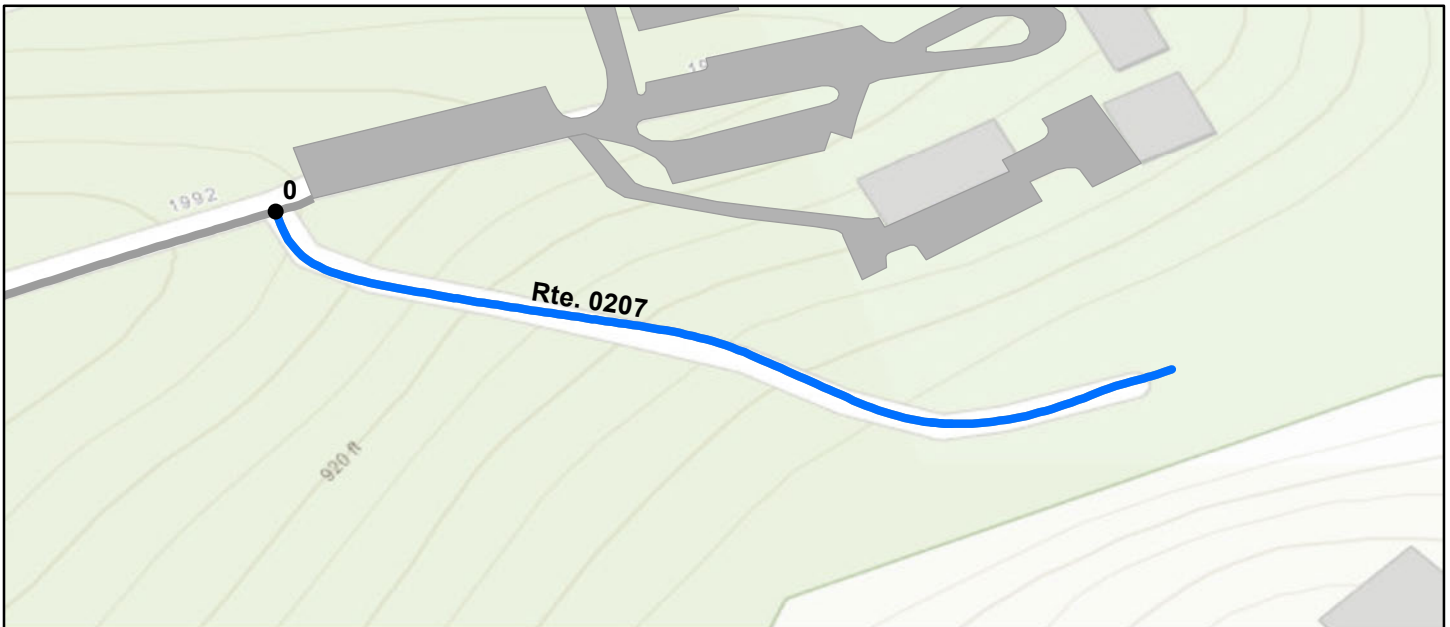
### Data Collection Vehicle (DCV) Rating

Colors on map represent condition scores at 0.10-mile intervals. See Appendix for definitions and formulas.

| Pavement Condition Rating (PCR) | 97 | 97 | | | | | |
| Surface Condition Rating (SCR) | 97 | 97 | | | | | |

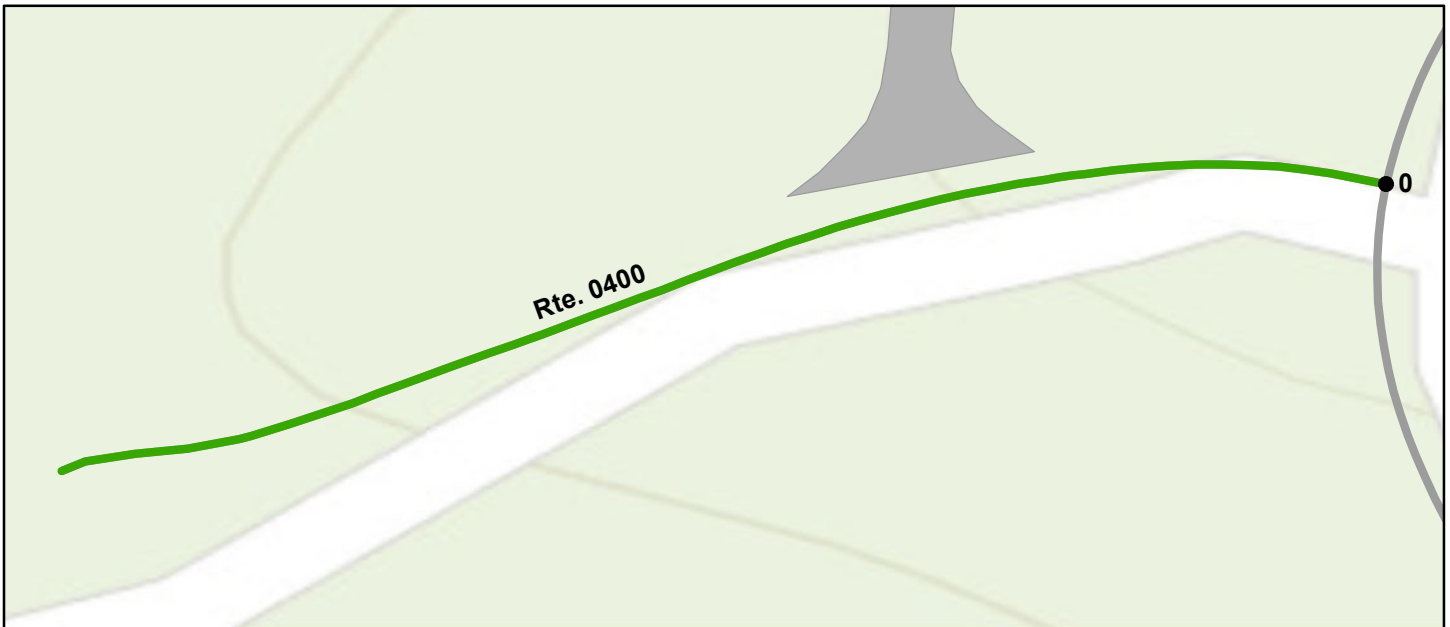
### Data Collection Vehicle (DCV) Rating

Colors on map represent condition scores at 0.10-mile intervals. See Appendix for definitions and formulas.

| Pavement Condition Rating (PCR) | 93 | 93 | | | | |
| Surface Condition Rating (SCR) | 93 | 93 | | | | |
| Structural Crack Index | 96 | 96 | | | | |
