Final Report

Road Inventory and Condition Assessment of Paved Routes Charles Young Buffalo Soldiers National Monument

**Federal Lands Highway
Road Inventory Program**

**Federal Highway Administration
Eastern Federal Lands Highway Division
Road Inventory Program (RIP)**

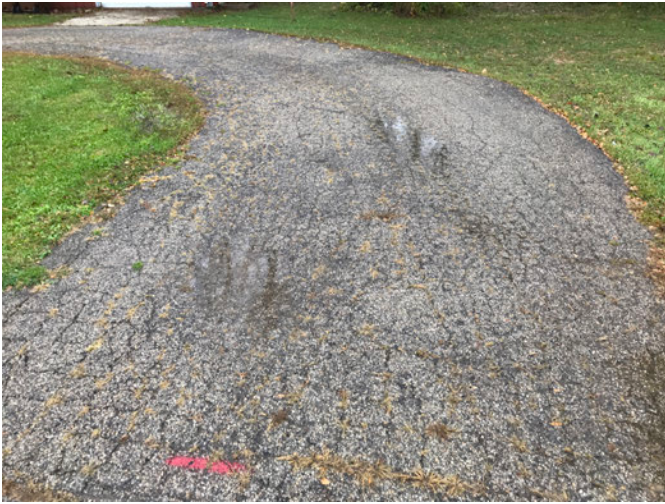
CHYO_0900_1.jpg

Inspection Date	FMSS Number	User Access	Surface Type
10/19/2020	244327	PUBLIC	ASPHALT
Area (Sq. Ft.)	Lane Miles (11' Widths)	Curb Reveal (Inches)	Curb Recommendation
9,615	0.166	6	LIGHT REPAIR
Curb Type		Curb & Gutter Type	
CONCRETE		NO CURB AND GUTTER	
Pavement Recommendation		Condition Rating / PCR	
HEAVY 3R TREATMENTS		POOR / 53
