COWP Cycle 6

Final Report

Road Inventory and Condition Assessment of Paved Routes Cowpens National Battlefield

Report Date: November 2021

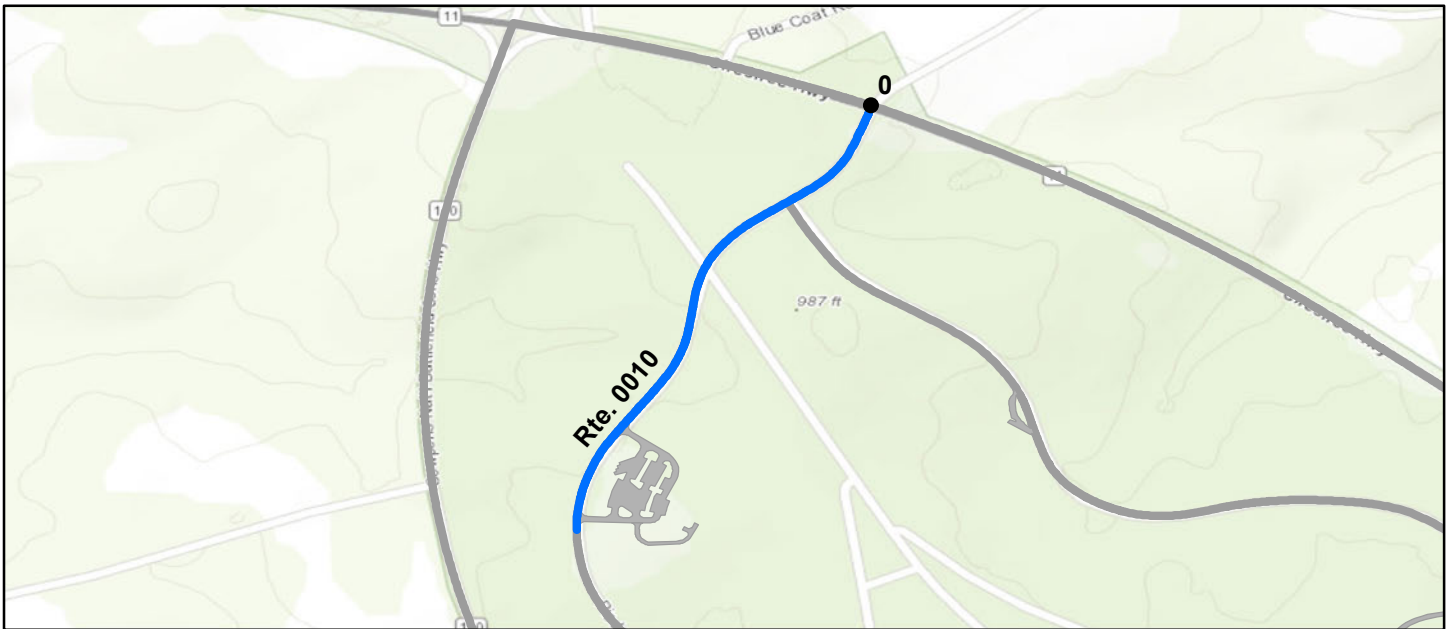
ROUTE 0010: MAIN ENTRANCE ROAD

Inspection Date: 2/8/2021	Beginning Section MP	0				
Paved Length (Miles): 0.45	Section Length (MI)	0.45				
Surface Type: ASPHALT	Route Summary					
Roadway Condition Information						
Pavement Condition Rating (PCR)	99	99				
Surface Condition Rating (SCR)	99	99				
Roughness Condition Index (RCI)	N/A	N/A				
Distress Index Values						
Structural Crack Index	100	100				
Alligator Crack Index	100	100				
Longitudinal Crack Index	100	100				
Transverse Cracking Index	99	99				
Patching Index	100	100				
Rutting Index	100	100				
International Roughness Index (IRI)	N/A	N/A				
Lane & Width Information						
Number of Lanes	2	2				
Paved Width (ft)	20	20				
Lane Width (ft)	9.4	9.4

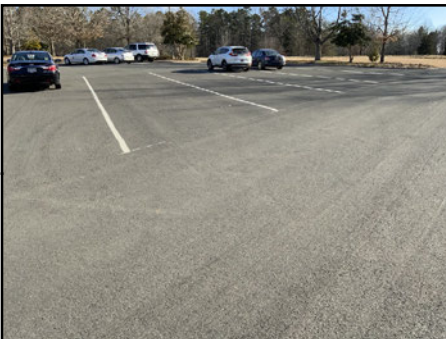
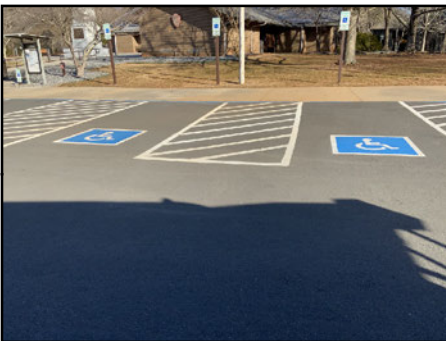
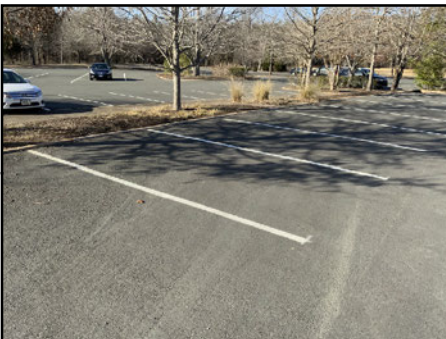
Inspection Date	FMSS Number	User Access	Surface Type
2/8/2021	75898	PUBLIC	ASPHALT
Area (Sq. Ft.)	Lane Miles (11' Widths)	Curb Reveal (Inches)	Curb Recommendation
63,085	1.086	4	LIGHT REPAIR
Curb Type		Curb & Gutter Type	
CONCRETE		NO CURB AND GUTTER	
Pavement Recommendation		Condition Rating / PCR	
PREVENTIVE MAINTENANCE		GOOD / 90

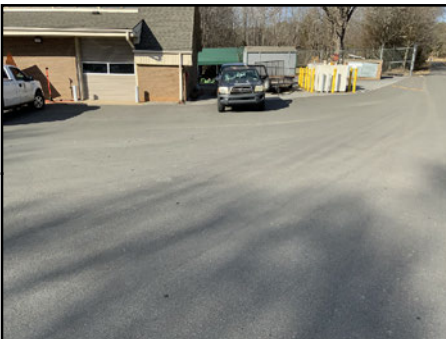
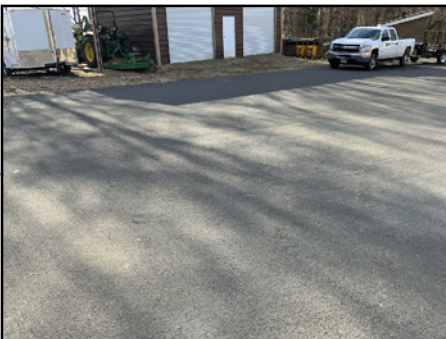
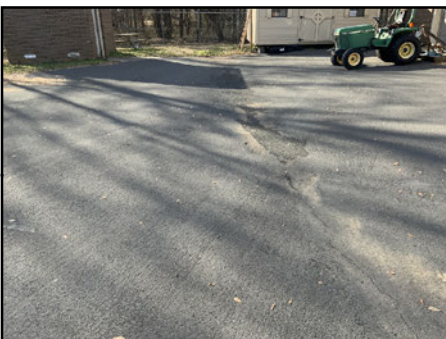
ROUTE 0902: MAINTENANCE AREA

Inspection Date	FMSS Number	User Access	Surface Type
2/8/2021	75904	NONPUBLIC	ASPHALT
Area (Sq. Ft.)	Lane Miles (11' Widths)	Curb Reveal (Inches)	Curb Recommendation
13,387	0.23	NOT APPLICABLE	NOT APPLICABLE
Curb Type		Curb & Gutter Type	
NO CURB		NO CURB AND GUTTER	
Pavement Recommendation		Condition Rating / PCR	
PREVENTIVE MAINTENANCE		GOOD / 90

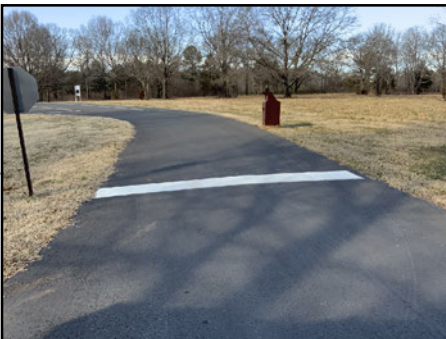
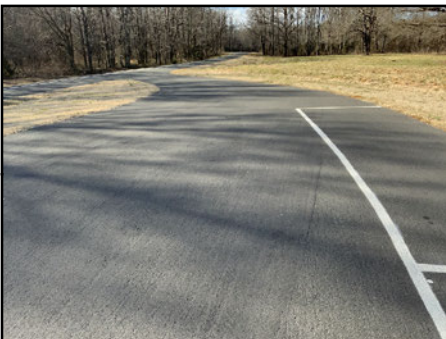
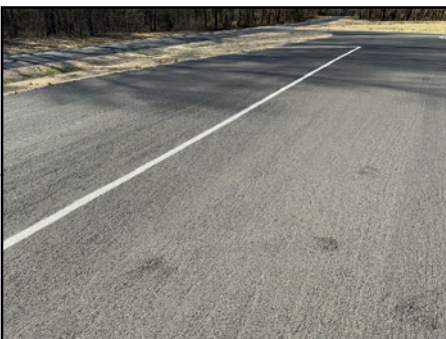
ROUTE 0903: OVERLOOK NUMBER 1 PARKING

Inspection Date	FMSS Number	User Access	Surface Type
2/8/2021	75906	PUBLIC	ASPHALT
Area (Sq. Ft.)	Lane Miles (11' Widths)	Curb Reveal (Inches)	Curb Recommendation
7,001	0.121	NOT APPLICABLE	NOT APPLICABLE
Curb Type		Curb & Gutter Type	
NO CURB		NO CURB AND GUTTER	
Pavement Recommendation		Condition Rating / PCR	
PREVENTIVE MAINTENANCE		GOOD / 90

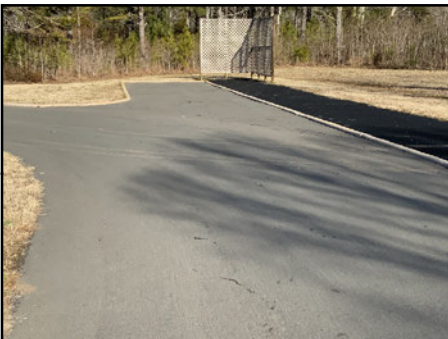
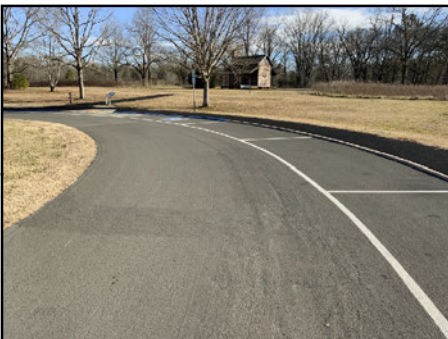
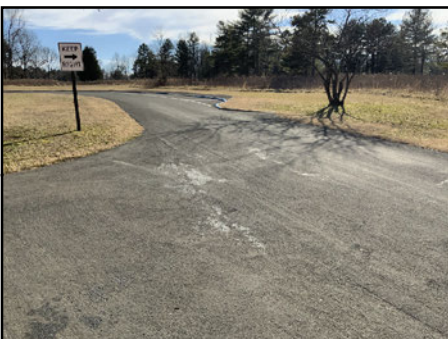
ROUTE 0904: SCRUGGS HOUSE PARKING

Inspection Date	FMSS Number	User Access	Surface Type
2/8/2021	75907	PUBLIC	ASPHALT
Area (Sq. Ft.)	Lane Miles (11' Widths)	Curb Reveal (Inches)	Curb Recommendation
19,631	0.338	3	LIGHT REPAIR
Curb Type		Curb & Gutter Type	
CONCRETE		NO CURB AND GUTTER	
Pavement Recommendation		Condition Rating / PCR	
PREVENTIVE MAINTENANCE		GOOD / 90

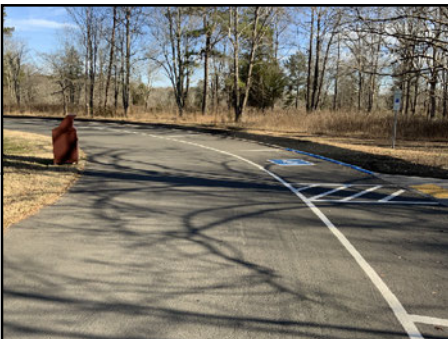
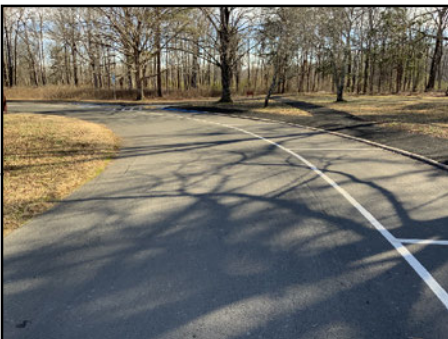
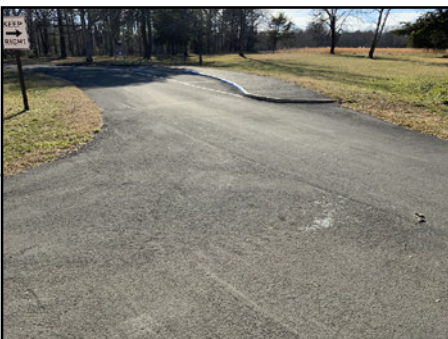
ROUTE 0905: BATTLEFIELD PARKING NUMBER 1

Inspection Date	FMSS Number	User Access	Surface Type
2/8/2021	75909	PUBLIC	ASPHALT
Area (Sq. Ft.)	Lane Miles (11' Widths)	Curb Reveal (Inches)	Curb Recommendation
21,623	0.372	3	LIGHT REPAIR
Curb Type		Curb & Gutter Type	
CONCRETE		NO CURB AND GUTTER	
Pavement Recommendation		Condition Rating / PCR	
PREVENTIVE MAINTENANCE		GOOD / 90

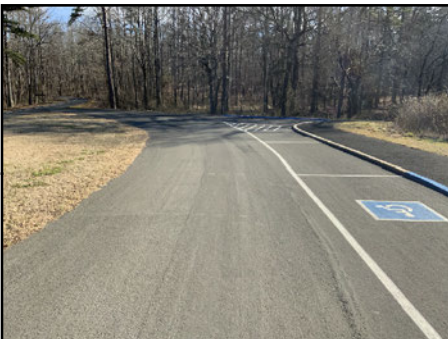
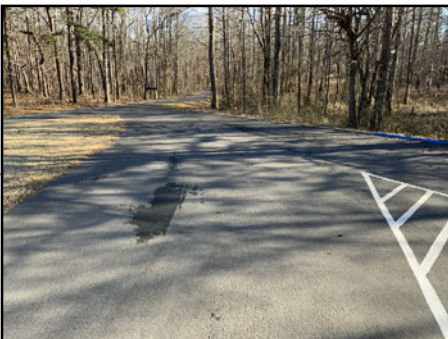
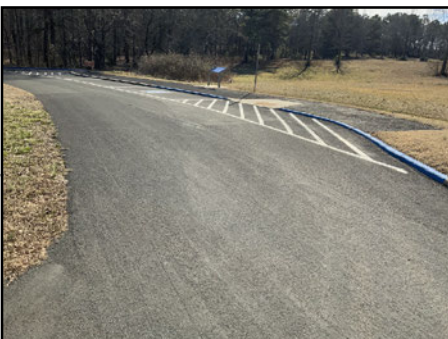
ROUTE 0906: BATTLEFIELD PARKING NUMBER 2

Inspection Date	FMSS Number	User Access	Surface Type
2/8/2021	75911	PUBLIC	ASPHALT
Area (Sq. Ft.)	Lane Miles (11' Widths)	Curb Reveal (Inches)	Curb Recommendation
6,051	0.104	4	DO NOTHING
Curb Type		Curb & Gutter Type	
CONCRETE		NO CURB AND GUTTER	
Pavement Recommendation		Condition Rating / PCR	
DO NOTHING		EXCELLENT / 97

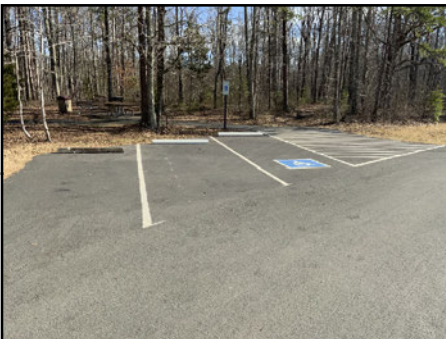
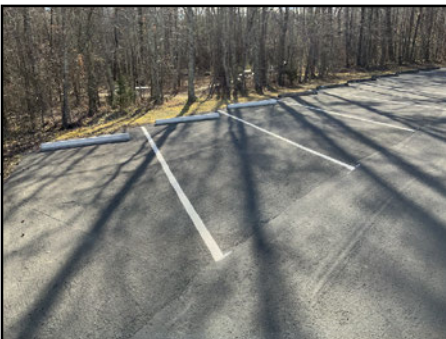
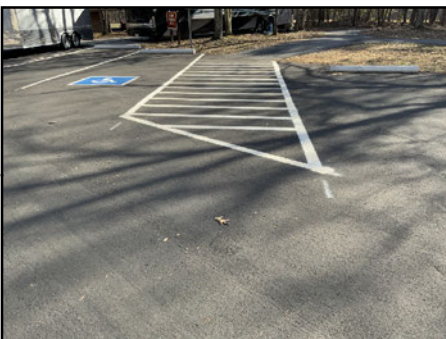
ROUTE 0907: PICNIC AREA LOOP

Inspection Date	FMSS Number	User Access	Surface Type
2/8/2021	75896	PUBLIC	ASPHALT
Area (Sq. Ft.)	Lane Miles (11' Widths)	Curb Reveal (Inches)	Curb Recommendation
41,114	0.708	NOT APPLICABLE	NOT APPLICABLE
Curb Type		Curb & Gutter Type	
NO CURB		NO CURB AND GUTTER	
Pavement Recommendation		Condition Rating / PCR	
DO NOTHING		EXCELLENT / 97

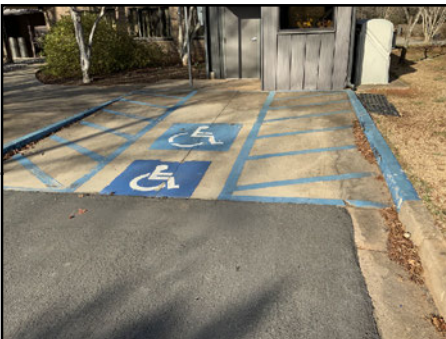
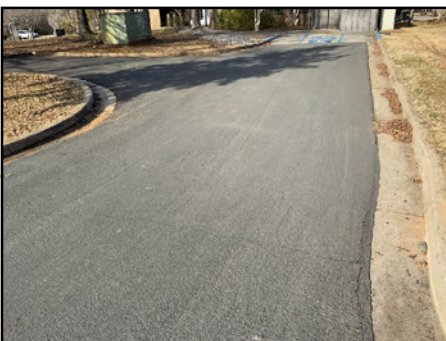
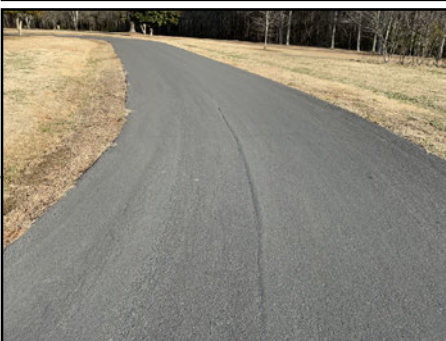
ROUTE 0913: GOV PARKING

Inspection Date	FMSS Number	User Access	Surface Type
2/8/2021	75924	NONPUBLIC	ASPHALT
Area (Sq. Ft.)	Lane Miles (11' Widths)	Curb Reveal (Inches)	Curb Recommendation
6,303	0.109	NOT APPLICABLE	LIGHT REPAIR
Curb Type		Curb & Gutter Type	
NO CURB		CONCRETE	
Pavement Recommendation		Condition Rating / PCR	
PREVENTIVE MAINTENANCE		GOOD / 90

MULTIPLE SURFACE TYPES: ASPHALT = 6002 SQ FT; CONCRETE = 301 SQ FT.

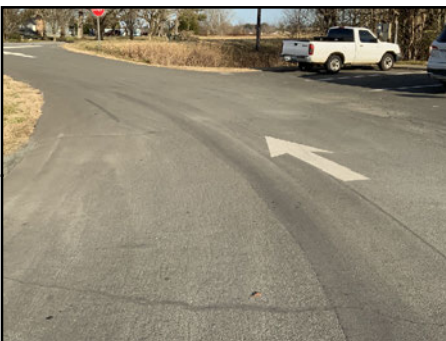
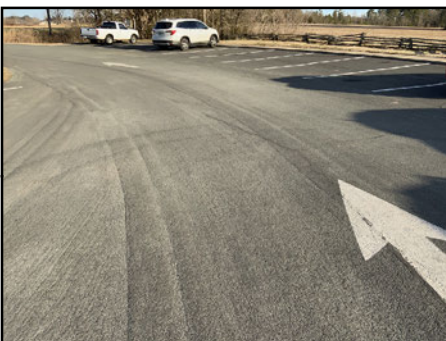
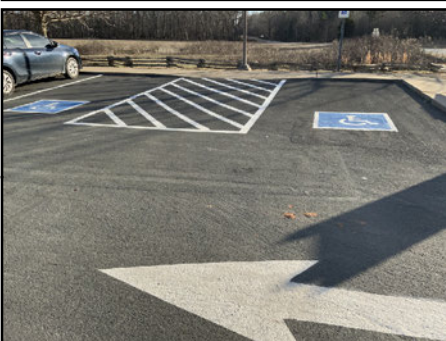
ROUTE 0914: TRAILHEAD PARKING

Inspection Date	FMSS Number	User Access	Surface Type
2/8/2021	113293	PUBLIC	ASPHALT
Area (Sq. Ft.)	Lane Miles (11' Widths)	Curb Reveal (Inches)	Curb Recommendation
18,190	0.313	NOT APPLICABLE	NOT APPLICABLE
Curb Type		Curb & Gutter Type	
NO CURB		NO CURB AND GUTTER	
Pavement Recommendation		Condition Rating / PCR	
LIGHT 3R TREATMENTS		FAIR / 73
