DESO Cycle 6

Final Report

Road Inventory and Condition Assessment of Paved Routes De Soto National Memorial

Report Date: May 2019

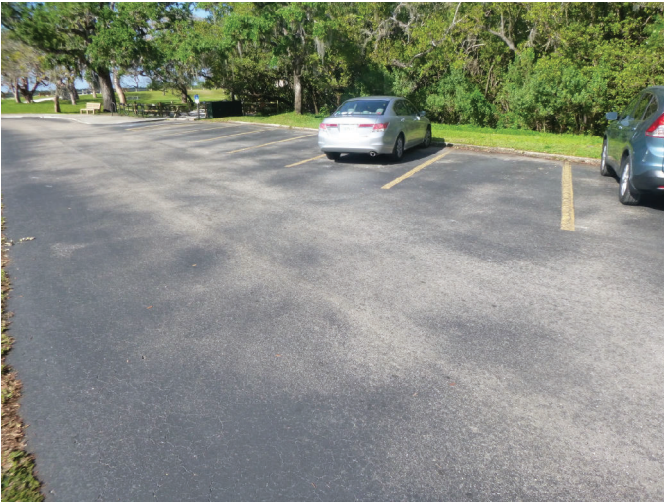
DESO_0900_0277.JPG

Inspection Date	FMSS Number	User Access	Surface Type
4/10/2019	50413	PUBLIC	ASPHALT
Area (Sq. Ft.)	Lane Miles (11' Widths)	Curb Reveal (Inches)	Curb Recommendation
27,336	0.471	3	LIGHT REPAIR
Curb Type		Curb & Gutter Type	
CONCRETE		NO CURB AND GUTTER	
Pavement Recommendation		Condition Rating / PCR	
HEAVY 3R TREATMENTS		POOR / 53
