ELRO Cycle 6

Road Inventory and Condition Assessment of Paved Routes Eleanor Roosevelt National Historic Site

**Federal Lands Highway
Road Inventory Program**

Report Date: May 2021

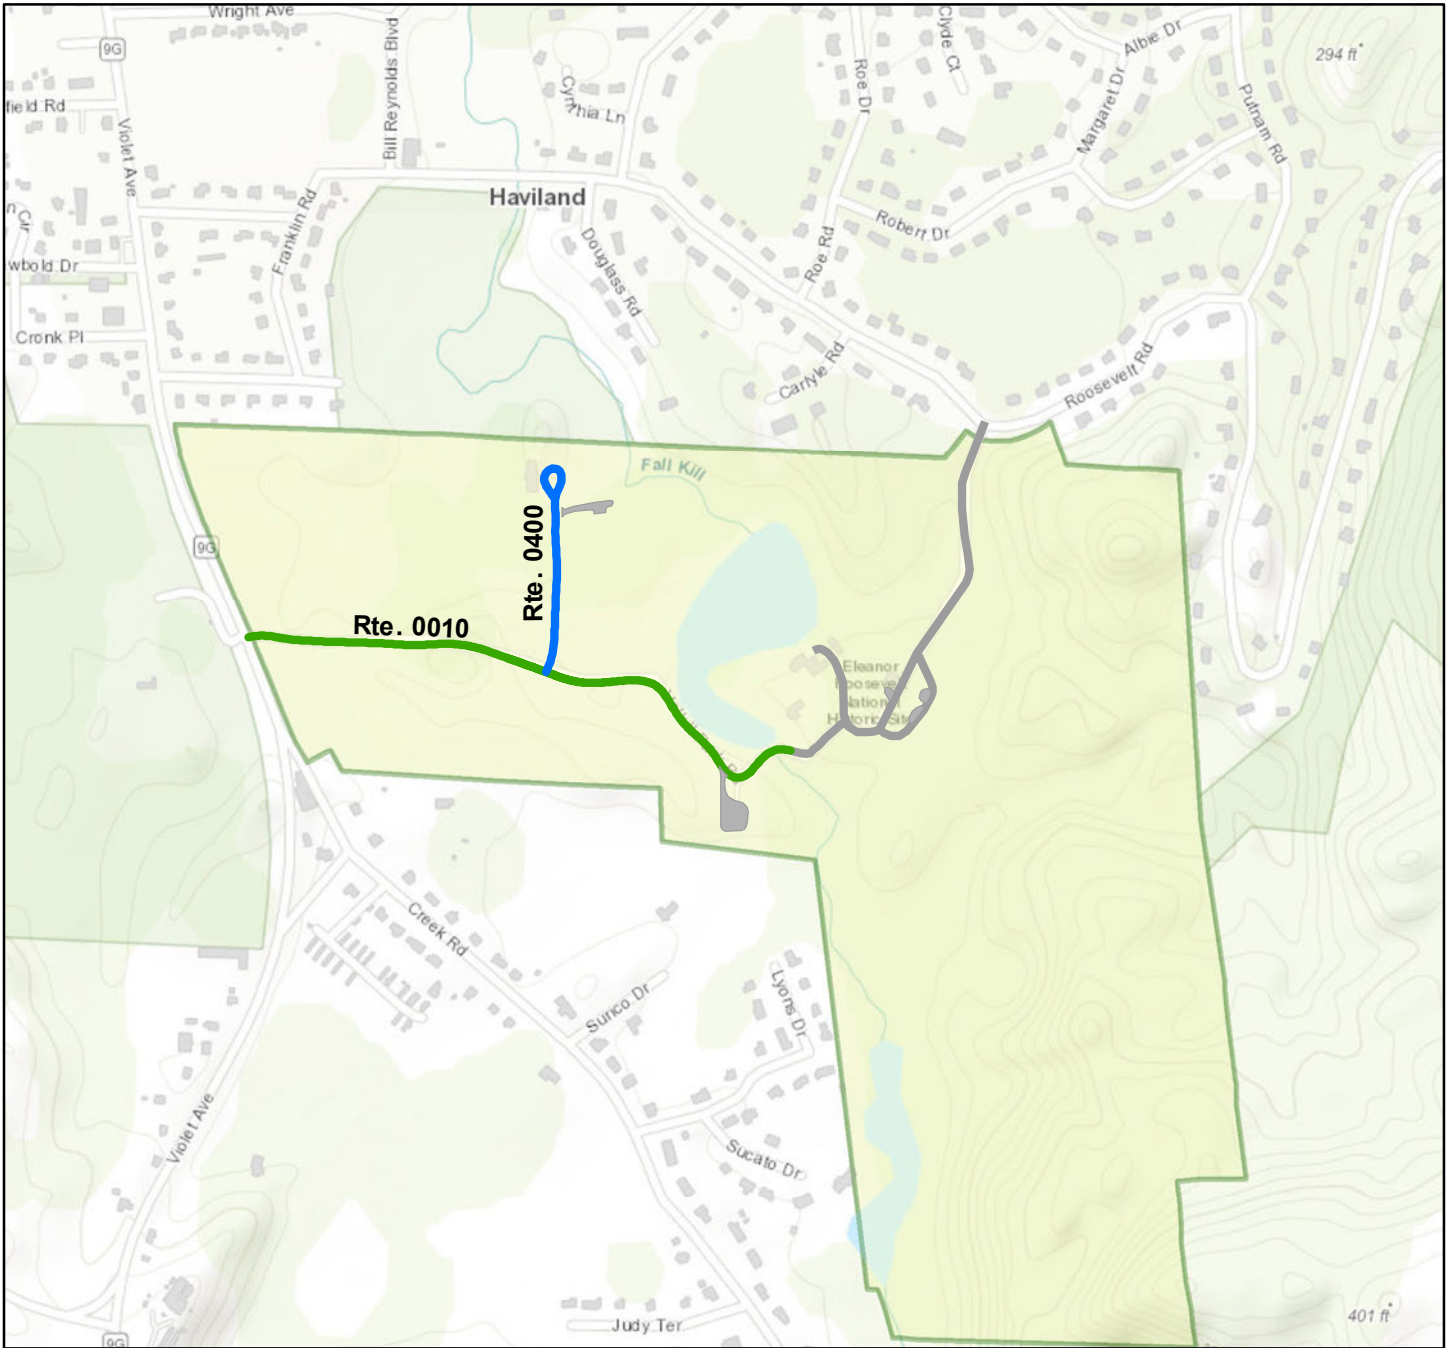
Area Map 1

ROUTE CONDITION MAP

PCR - MILE BY MILE

Colors on map represent condition scores at 1-mile intervals. See Appendix for definitions and formulas
Only Data Collection Vehicle and Manually Rated Roads are displayed

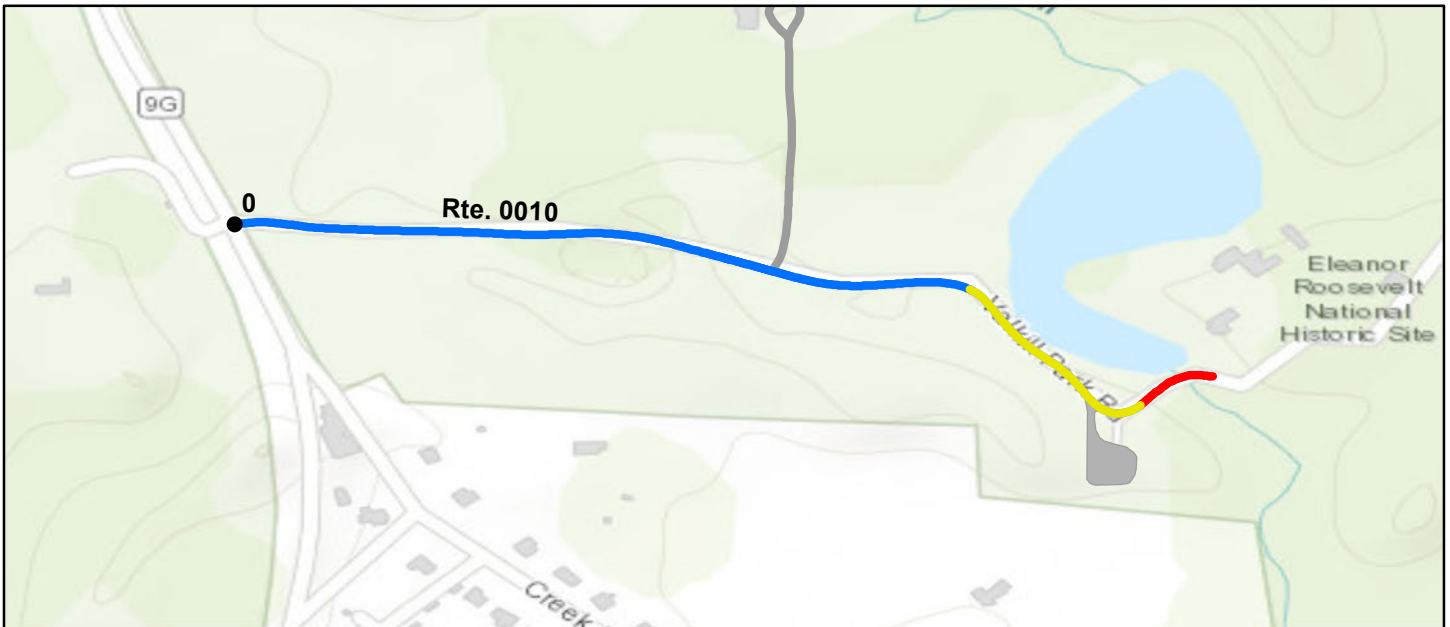
ROUTE 0010: MAIN ENTRANCE ROAD

Colors on map represent condition scores at 0.10-mile intervals. See Appendix for definitions and formulas.

Inspection Date:	10/20/2020	Beginning Section MP	0				
Paved Length (Miles):	0.44	Section Length (MI)	0.44				
Surface Type:	ASPHALT	Route Summary					
Roadway Condition Information							
Pavement Condition Rating (PCR)		87	87				
Surface Condition Rating (SCR)		87	87				
Roughness Condition Index (RCI)		N/A	N/A				
Distress Index Values							
Structural Crack Index		87	87				
Alligator Crack Index		99	99				
Longitudinal Crack Index		88	88				
Transverse Cracking Index		93	93				
Patching Index		100	100				
Rutting Index		97	97				
International Roughness Index (IRI)		N/A	N/A				
Lane & Width Information							
Number of Lanes		2	2				
Paved Width (ft)		16.1	16.1				
Lane Width (ft)		8.1	8.1

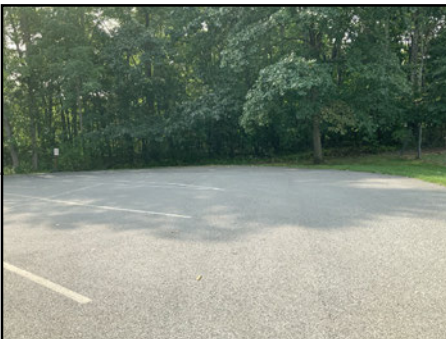
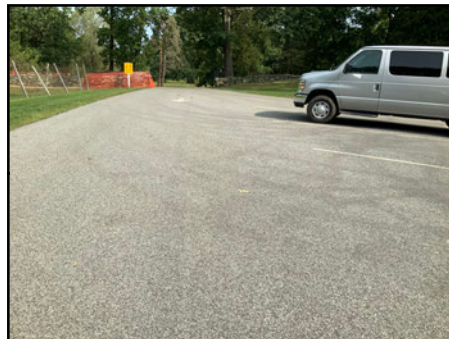
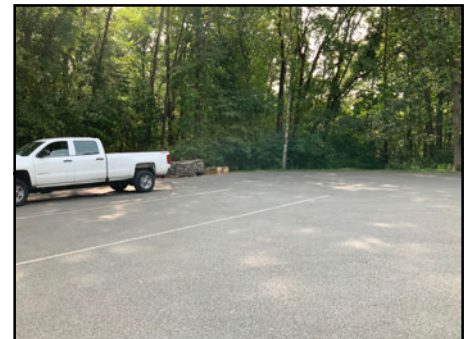
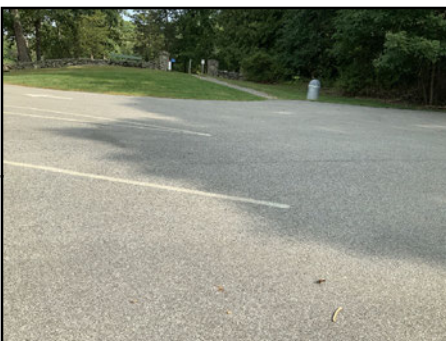
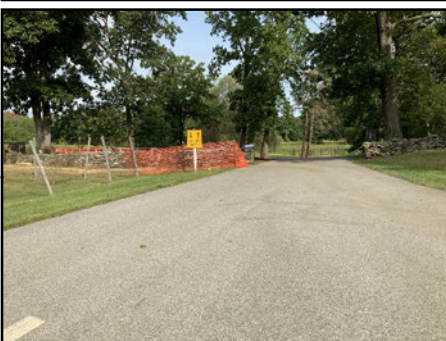
Inspection Date	FMSS Number	User Access	Surface Type
9/14/2020	103749	PUBLIC	ASPHALT
Area (Sq. Ft.)	Lane Miles (11' Widths)	Curb Reveal (Inches)	Curb Recommendation
13,375	0.23	NOT APPLICABLE	NOT APPLICABLE
Curb Type		Curb & Gutter Type	
NO CURB		NO CURB AND GUTTER	
Pavement Recommendation		Condition Rating / PCR	
PREVENTIVE MAINTENANCE		GOOD / 90
