FILA Cycle 6

Final Report

Road Inventory and Condition Assessment of Paved Routes First Ladies National Historic Site

Report Date: March 2020

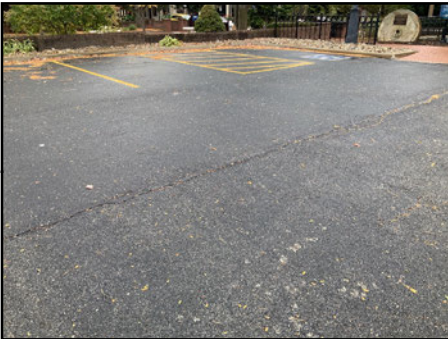
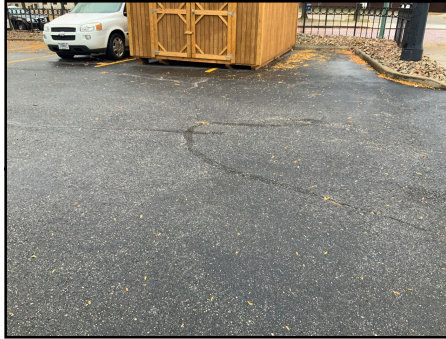
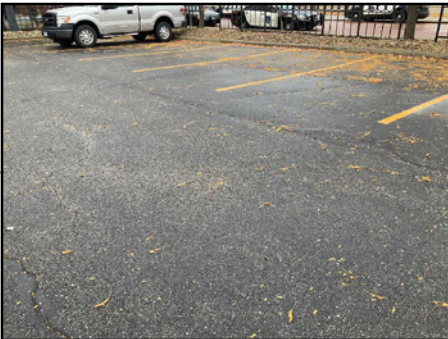
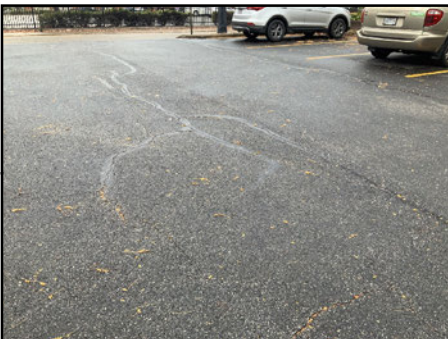
Inspection Date	FMSS Number	User Access	Surface Type
10/26/2019	78834	PUBLIC	ASPHALT
Area (Sq. Ft.)	Lane Miles (11' Widths)	Curb Reveal (Inches)	Curb Recommendation
6,152	0.106	6	DO NOTHING
Curb Type		Curb & Gutter Type	
CONCRETE		NO CURB AND GUTTER	
Pavement Recommendation		Condition Rating / PCR	
PREVENTIVE MAINTENANCE		GOOD / 90
