FLFO Cycle 6

Final Report

Road Inventory and Condition Assessment of Paved Routes Florissant Fossil Beds National Monument

Federal Highway Administration
Eastern Federal Lands Highway Division
Road Inventory Program (RIP)

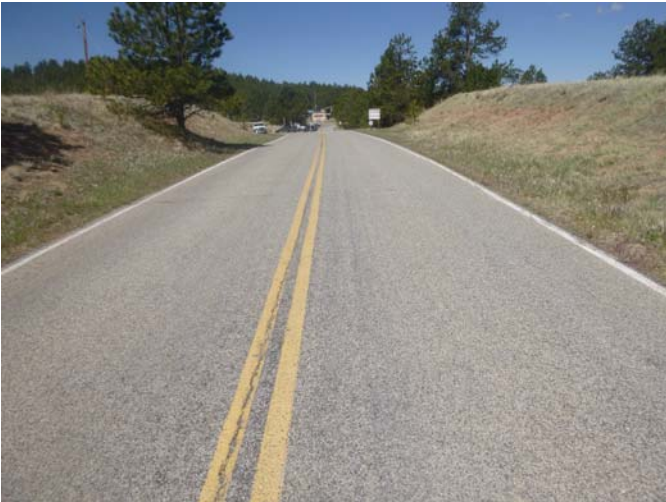
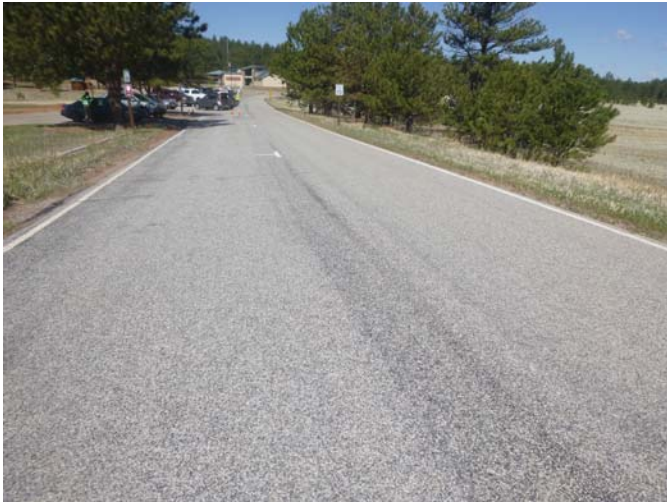
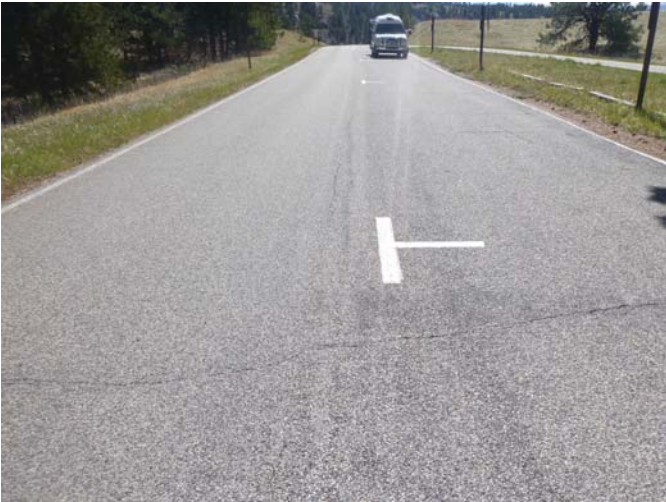
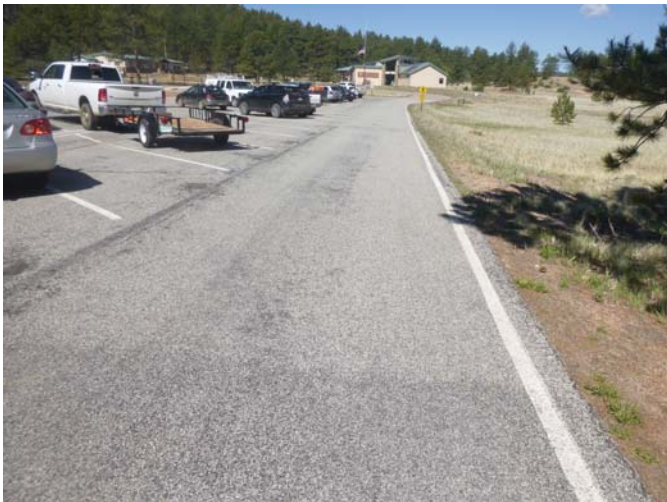
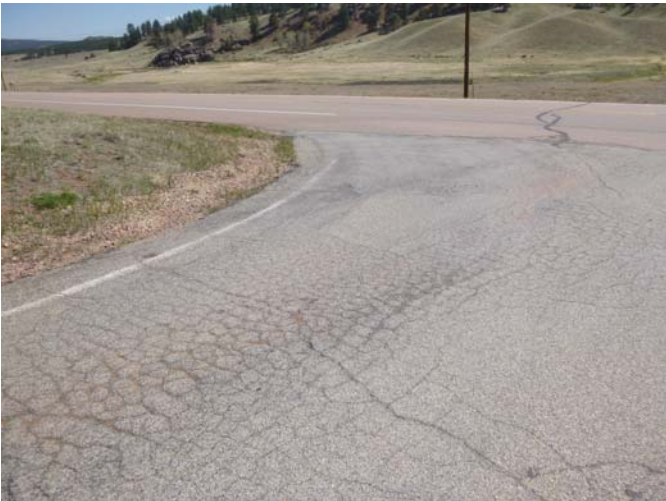
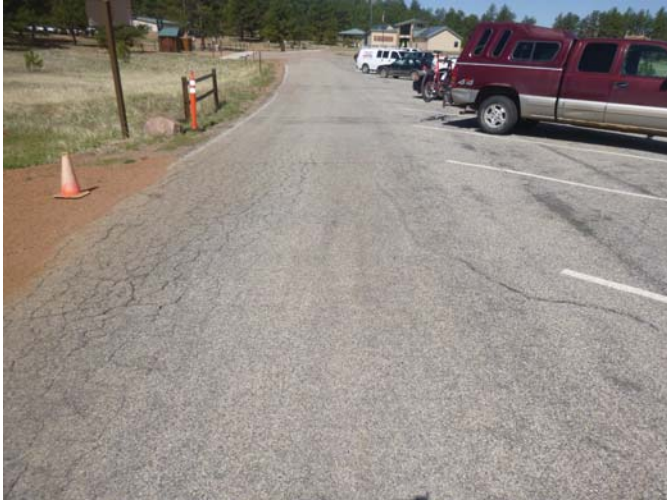
Condition Photos

Inspection Date	FMSS Number	User Access	Surface Type
5/30/2017	26224	PUBLIC	ASPHALT
Area (Sq. Ft.)	Lane Miles (11' Widths)	Curb Reveal (Inches)	Curb Recommendation
58,110	1.001	NOT APPLICABLE	NOT APPLICABLE
Curb Type		Curb & Gutter Type	
NO CURB		NO CURB AND GUTTER	
Pavement Recommendation		Condition Rating / PCR	
HEAVY 3R TREATMENTS		POOR / 53

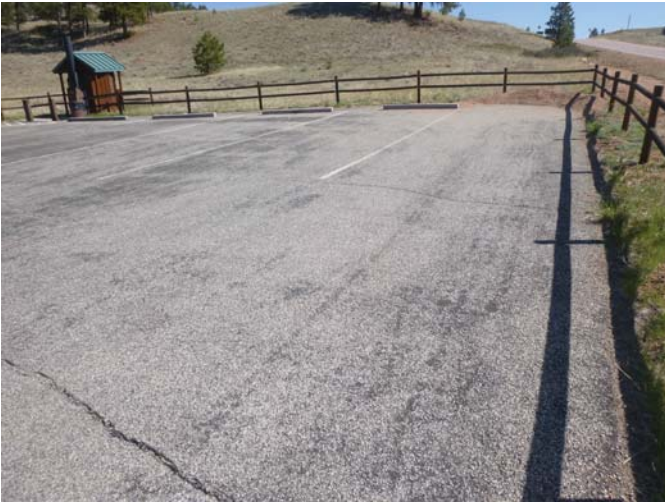
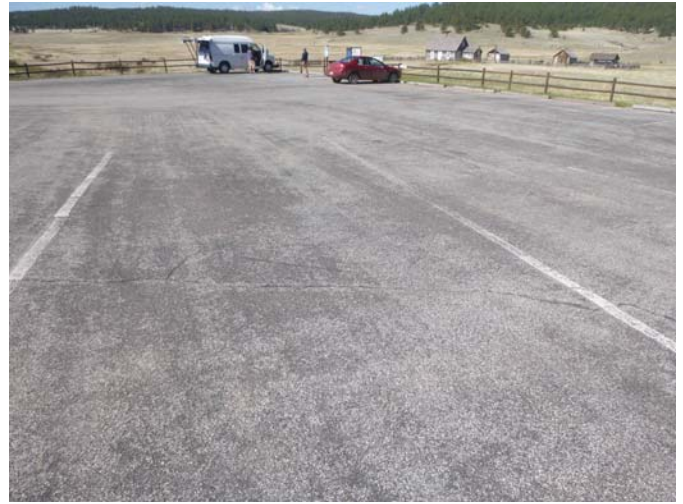
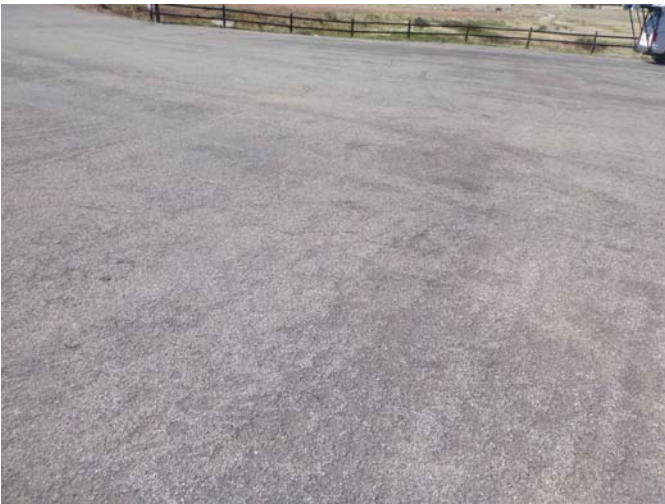
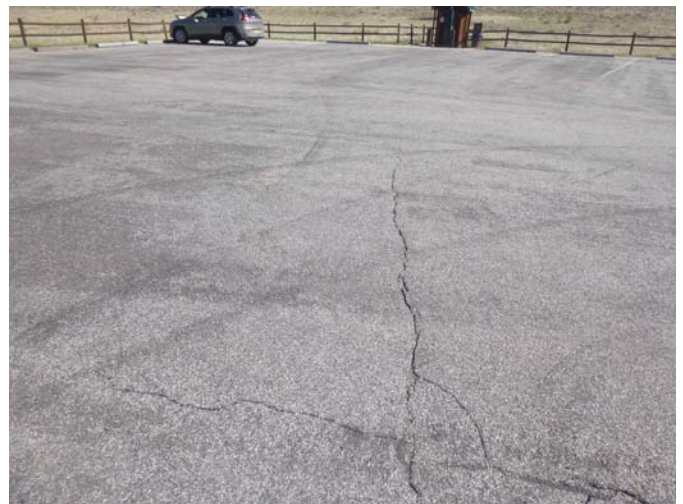
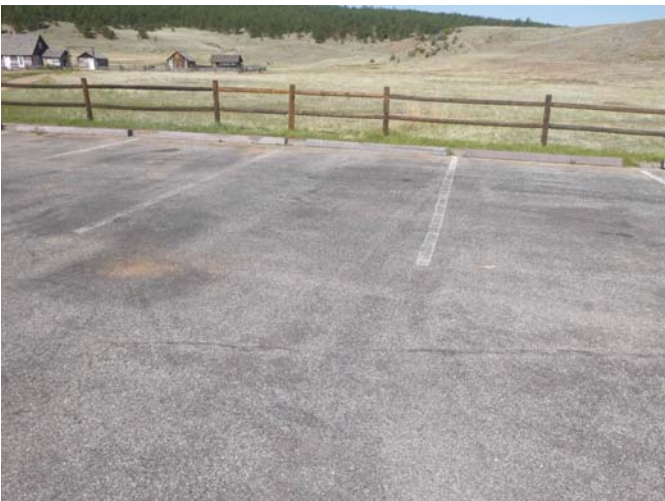
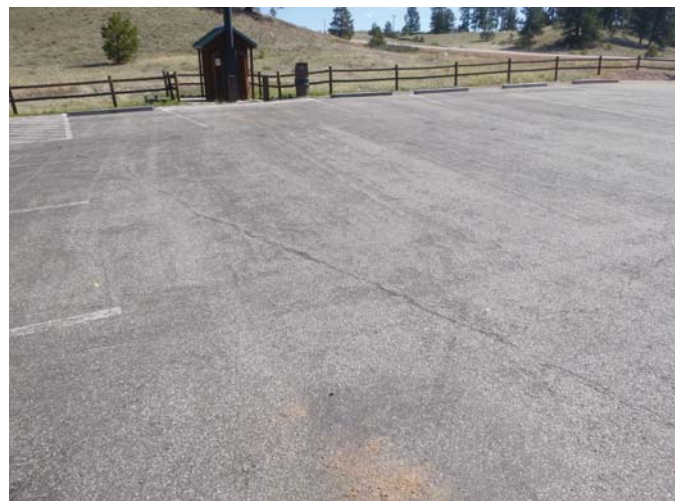
Condition Photos

Inspection Date	FMSS Number	User Access	Surface Type
5/30/2017	26254	PUBLIC	ASPHALT
Area (Sq. Ft.)	Lane Miles (11' Widths)	Curb Reveal (Inches)	Curb Recommendation
12,249	0.211	NOT APPLICABLE	NOT APPLICABLE
Curb Type		Curb & Gutter Type	
NO CURB		NO CURB AND GUTTER	
Pavement Recommendation		Condition Rating / PCR	
LIGHT 3R TREATMENTS		FAIR / 73

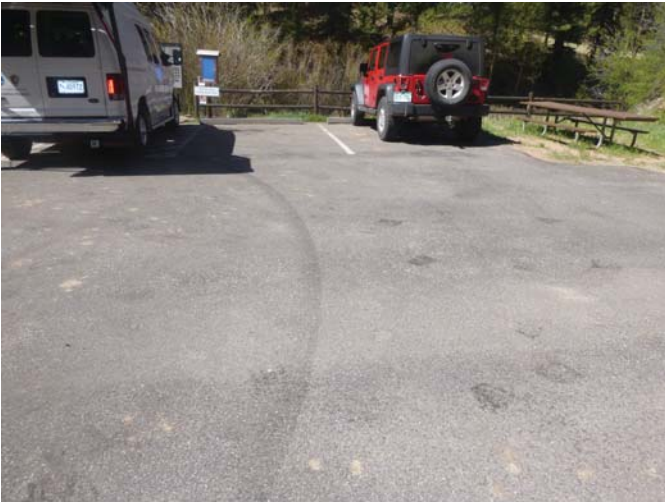
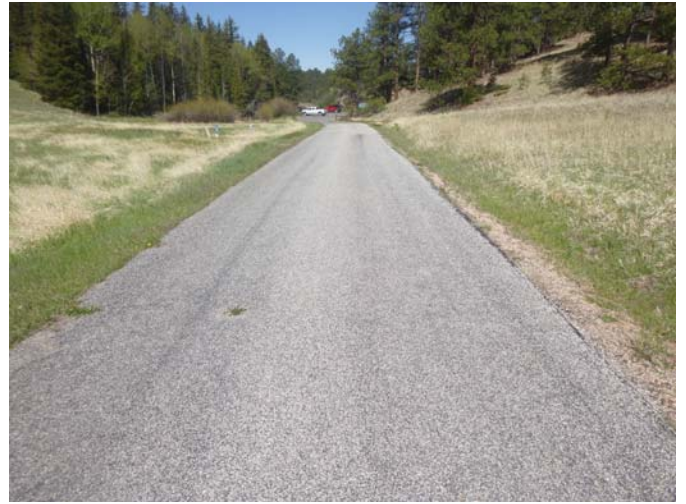
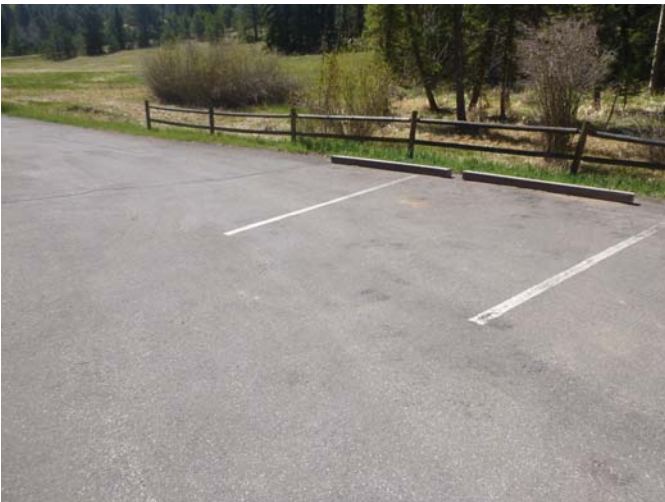
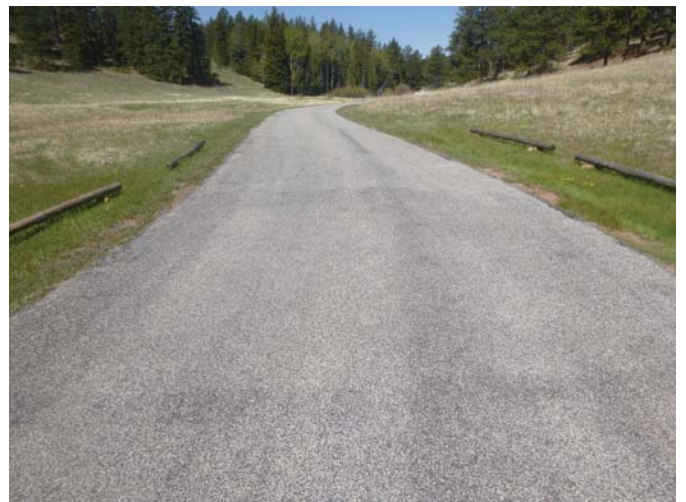
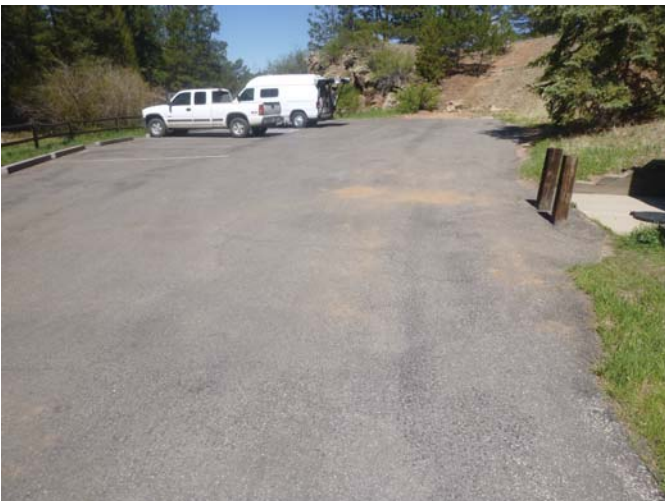
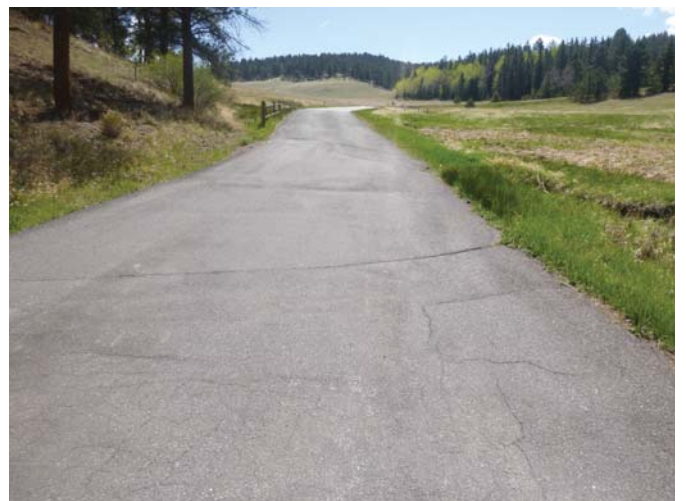
Condition Photos

Inspection Date	FMSS Number	User Access	Surface Type
5/30/2017	26263	PUBLIC	ASPHALT
Area (Sq. Ft.)	Lane Miles (11' Widths)	Curb Reveal (Inches)	Curb Recommendation
11,584	0.199	NOT APPLICABLE	NOT APPLICABLE
Curb Type		Curb & Gutter Type	
NO CURB		NO CURB AND GUTTER	
Pavement Recommendation		Condition Rating / PCR	
LIGHT 3R TREATMENTS		FAIR / 73
