FOBO Cycle 6

Final Report

Road Inventory and Condition Assessment of Paved Routes Fort Bowie National Historic Site

**Federal Lands Highway
Road Inventory Program**

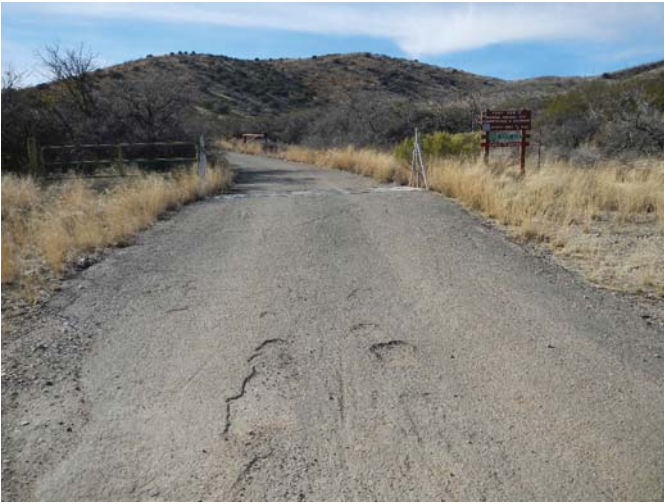
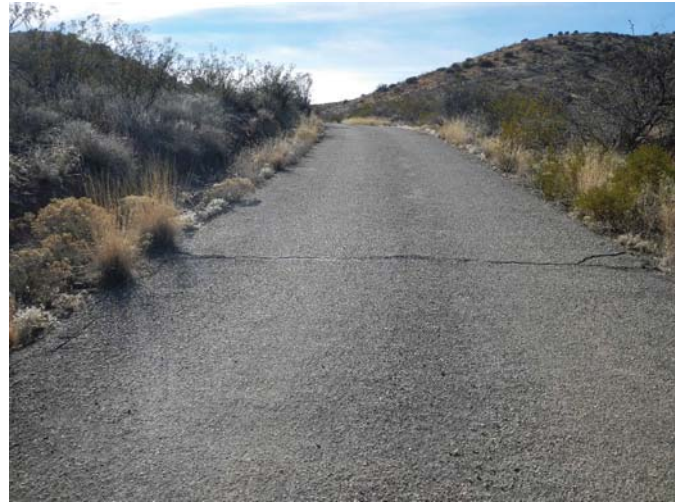
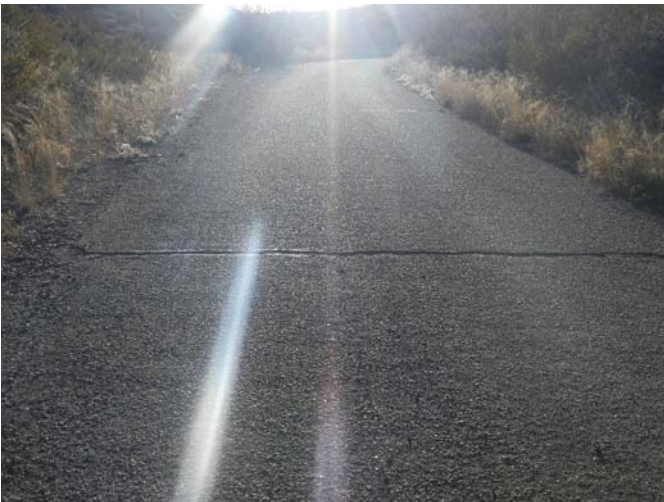
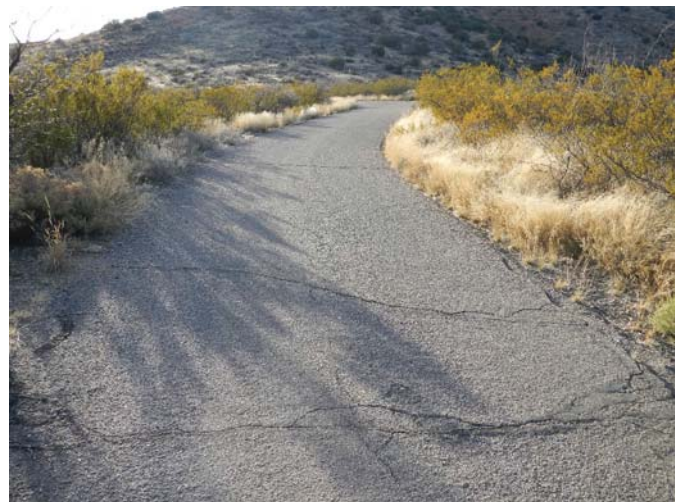
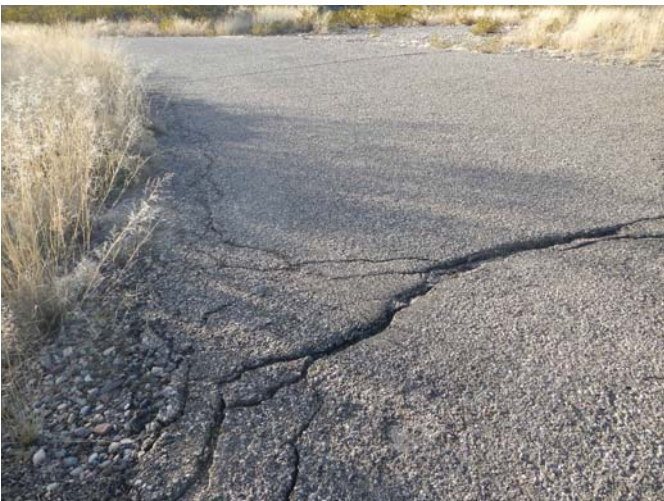
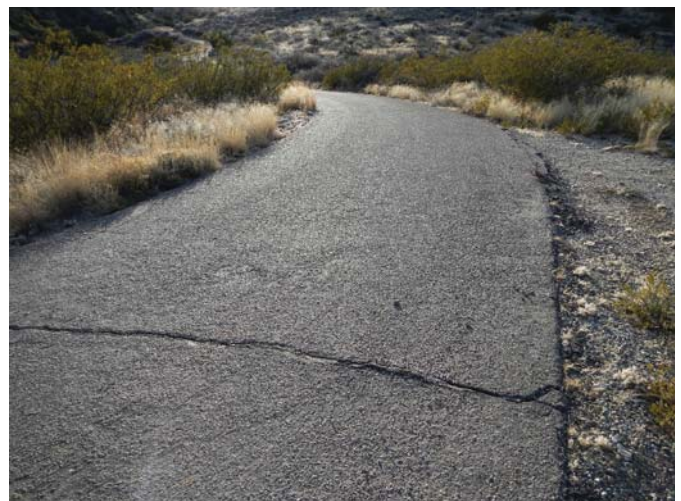
Condition Photos from MP 0.00 to 0.10

Route No.	FMSS No.	Route Name	Functional Class	Surf. Type	Paved Length (Miles)	Pavement Condition Rating (PCR)	Roughness Condition Index (RCI)	Surface Condition Rating (SCR)	Structural Crack Index	Alligator Crack Index	Longitudinal Cracking Index	Transverse Cracking Index	Patch / Pothole Index	Rutting Index
FOBO-0400	91022	ADMINISTRATIVE ROAD	5	AS	0.48	53	NR	53	NR	73	73	53	97	97

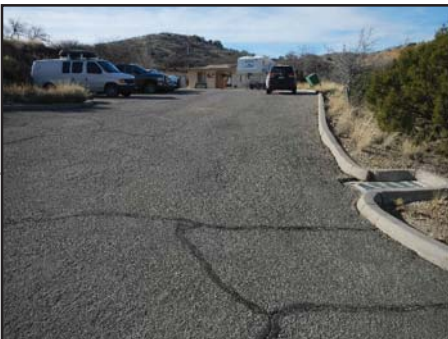
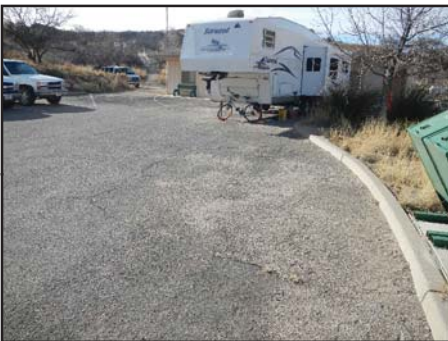
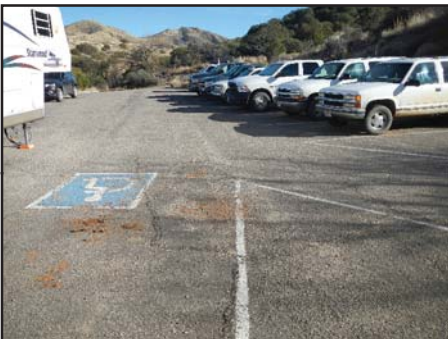
Inspection Date	FMSS Number	User Access	Surface Type
1/22/2016	93675	PUBLIC	ASPHALT
Area (Sq. Ft.)	Lane Miles (11' Widths)	Curb Reveal (Inches)	Curb Recommendation
6,522	0.112	4	DO NOTHING
Curb Type		Curb & Gutter Type	
CONCRETE		NO CURB AND GUTTER	
Pavement Recommendation		Condition Rating / PCR	
LIGHT 3R TREATMENTS		FAIR / 73
