# FODA Cycle 6

## Final Report

### Road Inventory and Condition Assessment of Paved Routes Fort Davis National Historic Site

**Report Date: July 2017**

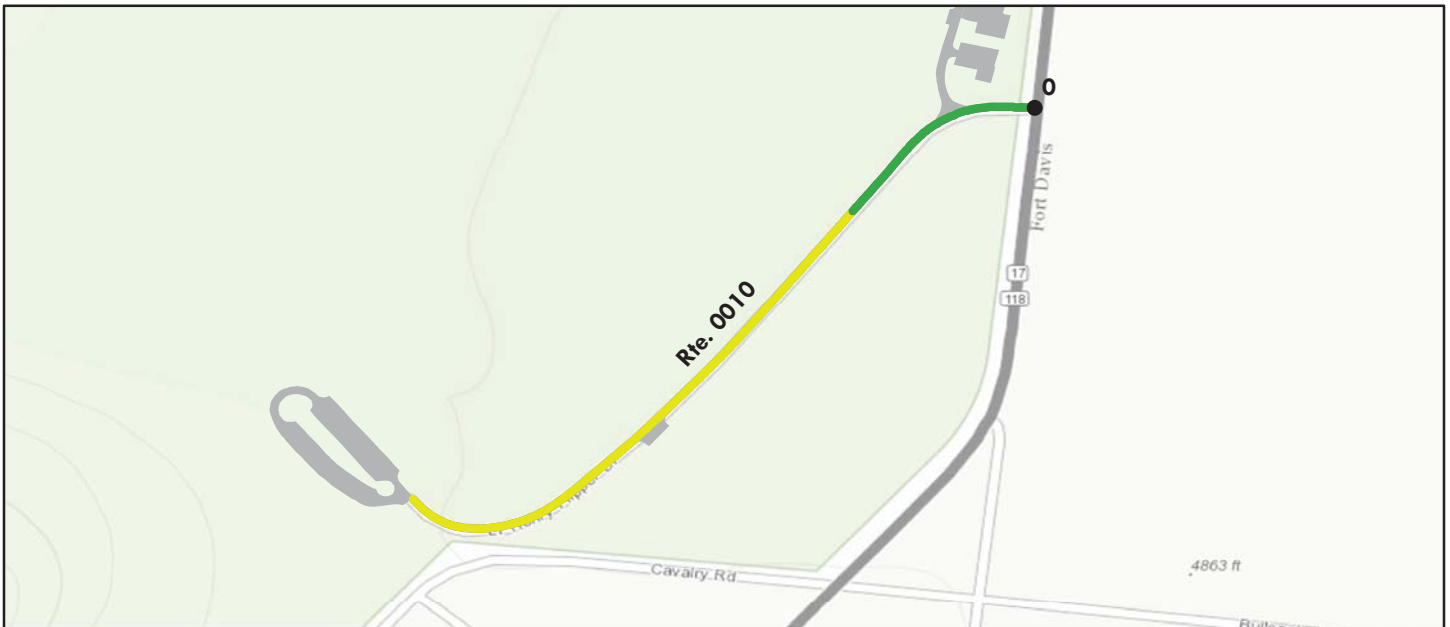
## ROUTE 0010: ENTRANCE ROAD

Route Condition Legend – Pavement Condition Rating (PCR)						
Poor (0 - 60)	Fair (61- 84)	Good (85 - 94)	Excellent (95 - 100)	Not Rated		
See Appendix for definitions and formulas						
<b>Inspection Date:</b>	3/21/2017	<b>Beginning Section MP</b>	0			
<b>Paved Length (Miles):</b>	0.36	<b>Section Length (MI)</b>	0.36			
<b>Surface Type:</b>	ASPHALT	<b>Route Summary</b>				
<b>Roadway Condition Information</b>						
Pavement Condition Rating (PCR)	83	83				
Surface Condition Rating (SCR)	83	83				
Roughness Condition Index (RCI)	N/A	N/A				
<b>Distress Index Values</b>						
Structural Crack Index	90	90				
Alligator Crack Index	100	100				
Longitudinal Crack Index	90	90				
Transverse Cracking Index	83	83				
Patching Index	100	100				
Rutting Index	97	97				
International Roughness Index (IRI)	N/A	N/A				
<b>Lane &amp; Width Information</b>						
Number of Lanes	2	2				
Paved Width (ft)	19	19				
Lane Width (ft)	9.5	9.5

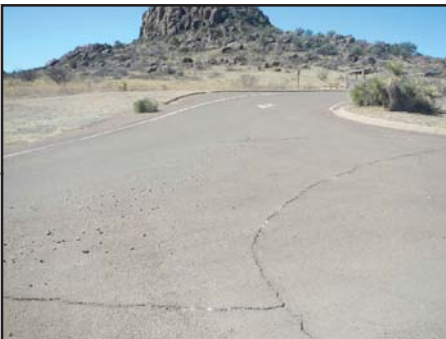
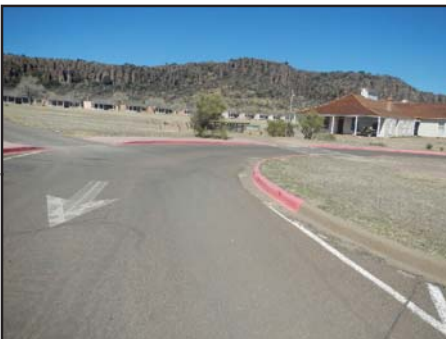
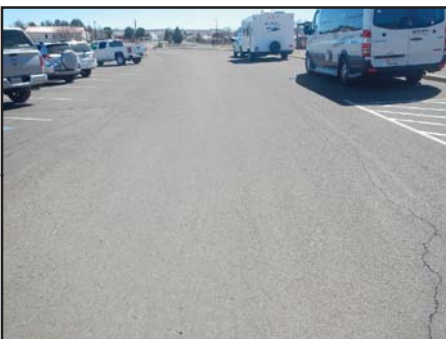
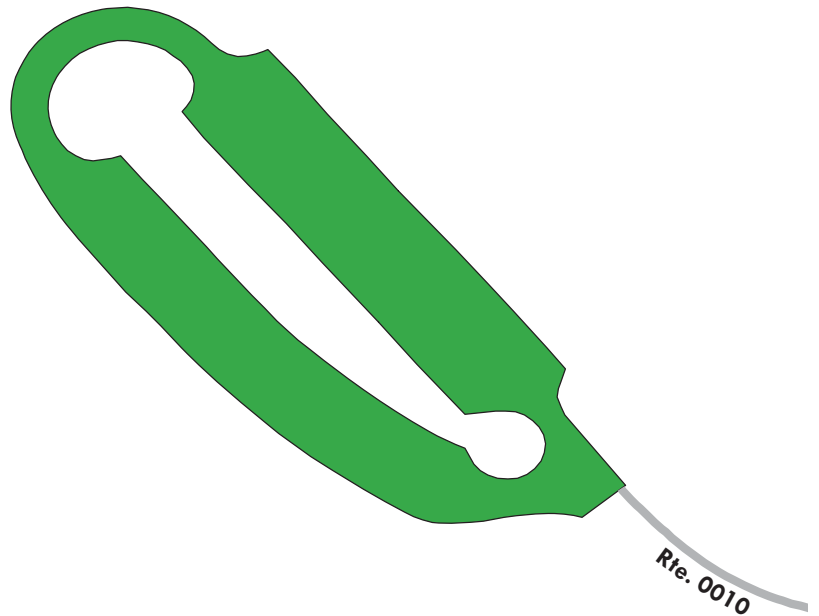
Rte. 0900

Inspection Date	FMSS Number	User Access	Surface Type
2/25/2017	55266	PUBLIC	ASPHALT
Area (Sq. Ft.)	Lane Miles (11' Widths)	Curb Reveal (Inches)	Curb Recommendation
35,697	0.615	NOT APPLICABLE	DO NOTHING
Curb Type		Curb & Gutter Type	
NO CURB		CONCRETE	
Pavement Recommendation		Condition Rating / PCR	
PREVENTIVE MAINTENANCE		GOOD / 90

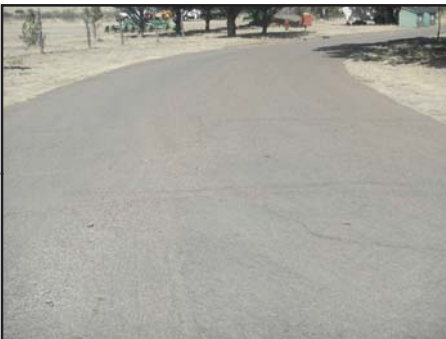
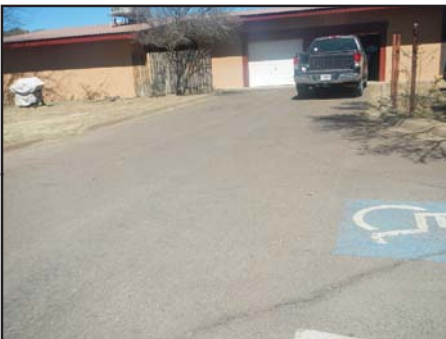
## ROUTE 0901: MAINTENANCE ROAD AND PAVED HOUSING PARKING AREA

Inspection Date	FMSS Number	User Access	Surface Type
2/25/2017	55269	NONPUBLIC	ASPHALT
Area (Sq. Ft.)	Lane Miles (11' Widths)	Curb Reveal (Inches)	Curb Recommendation
16,157	0.278	NOT APPLICABLE	DO NOTHING
Curb Type		Curb & Gutter Type	
NO CURB		CONCRETE	
Pavement Recommendation		Condition Rating / PCR	
PREVENTIVE MAINTENANCE		GOOD / 90

Note: Parking area consists of multiple surface types: 1 part asphalt at 15,939 square feet, 1 part concrete at 218 square feet.

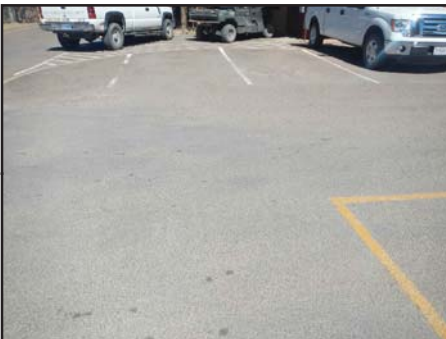
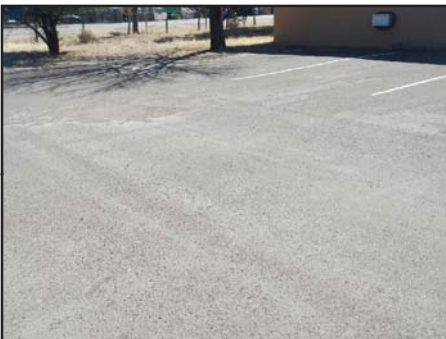
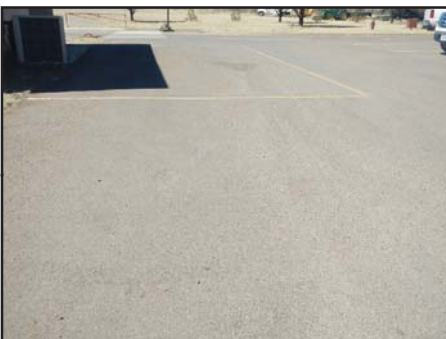
## ROUTE 0902: MAINTENANCE PAVED PARKING

Inspection Date	FMSS Number	User Access	Surface Type
2/25/2017	102938	NONPUBLIC	ASPHALT
Area (Sq. Ft.)	Lane Miles (11' Widths)	Curb Reveal (Inches)	Curb Recommendation
7,187	0.124	NOT APPLICABLE	NOT APPLICABLE
Curb Type		Curb & Gutter Type	
NO CURB		NO CURB AND GUTTER	
Pavement Recommendation		Condition Rating / PCR	
PREVENTIVE MAINTENANCE		GOOD / 90

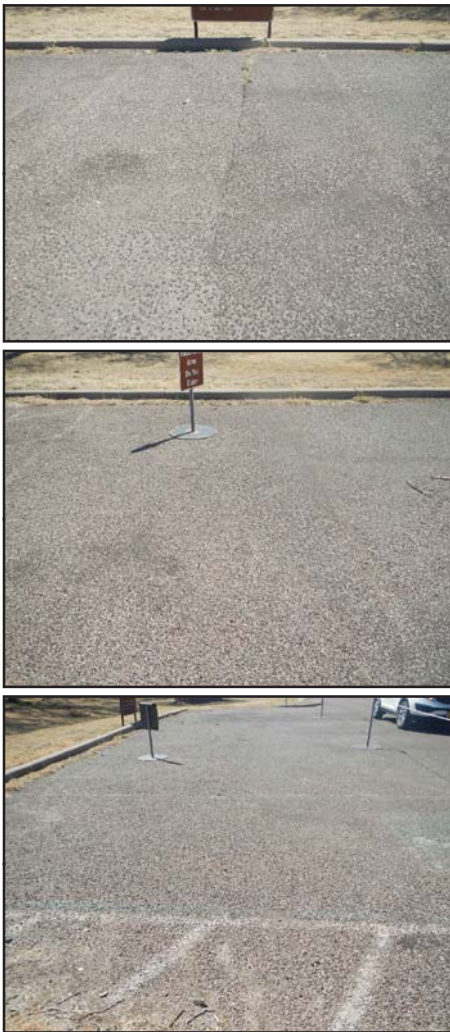
## ROUTE 0904: COTTONWOOD PICNIC AREA PARKING

Inspection Date	FMSS Number	User Access	Surface Type
2/25/2017	57171	NONPUBLIC	ASPHALT
Area (Sq. Ft.)	Lane Miles (11' Widths)	Curb Reveal (Inches)	Curb Recommendation
1,818	0.031	NOT APPLICABLE	DO NOTHING
Curb Type		Curb & Gutter Type	
NO CURB		CONCRETE	
Pavement Recommendation		Condition Rating / PCR	
PREVENTIVE MAINTENANCE		GOOD / 90
