# FODO Cycle 6

## Final Report

### Road Inventory and Condition Assessment of Paved Routes Fort Donelson National Battlefield

**Report Date: April 2021**

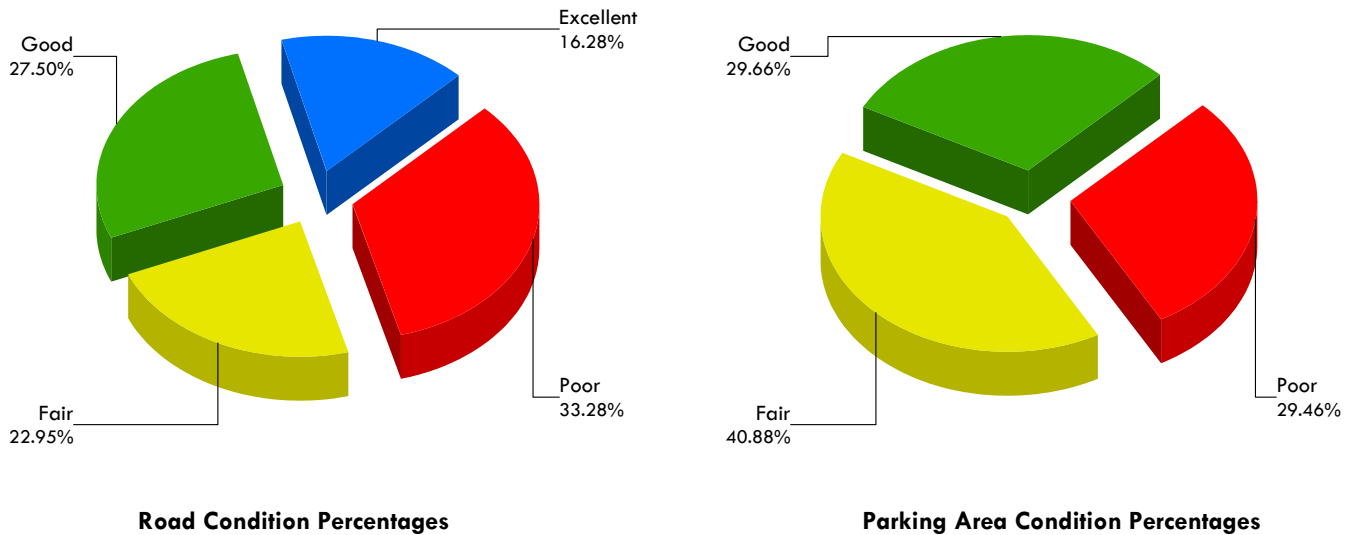
Figure 1: Pavement Condition Rating Breakdown for Paved Roads and Parking Areas

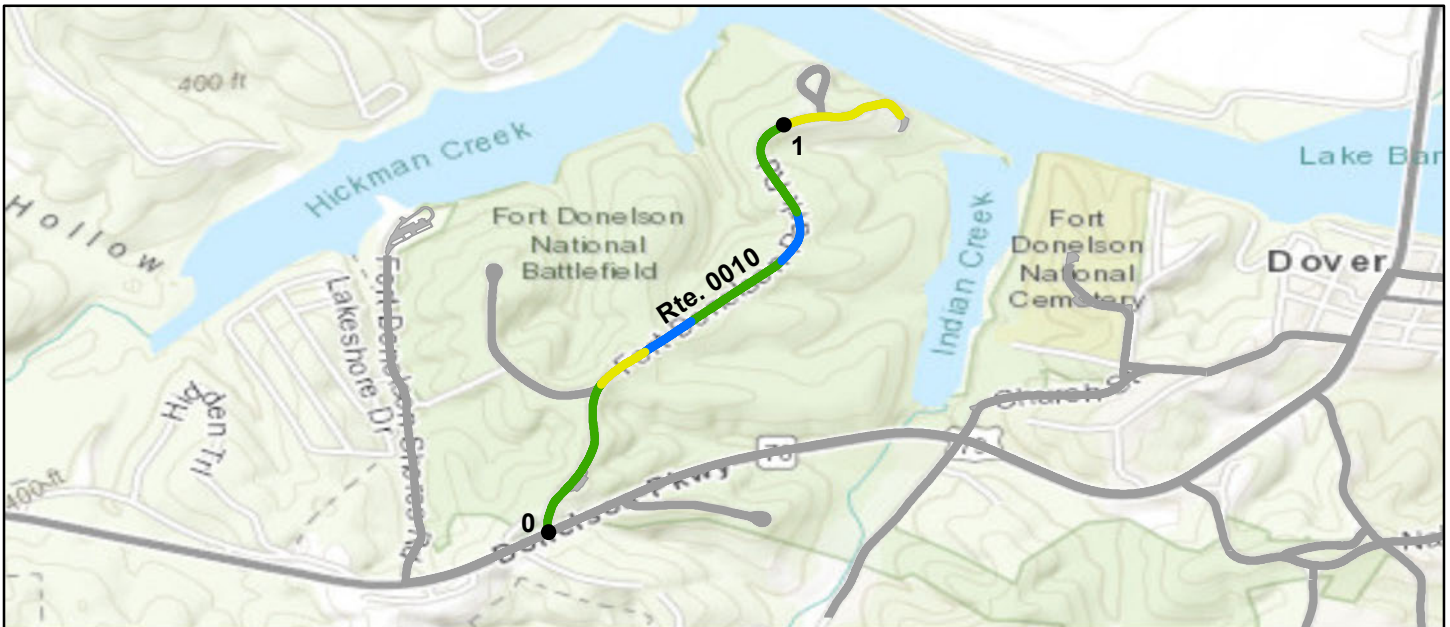
<b>Inspection Date:</b>	9/18/2020	<b>Beginning Section MP</b>	0	1			
<b>Paved Length (Miles):</b>	1.23	<b>Section Length (MI)</b>	1	0.23			
<b>Surface Type:</b>	ASPHALT	<b>Route Summary</b>					
<b>Roadway Condition Information</b>							
Pavement Condition Rating (PCR)	89	91	84				
Surface Condition Rating (SCR)	89	89	93				
Roughness Condition Index (RCI)	90	94	71				
<b>Distress Index Values</b>							
Structural Crack Index	94	93	97				
Alligator Crack Index	100	100	100				
Longitudinal Crack Index	94	93	97				
Transverse Cracking Index	92	92	94				
Patching Index	100	100	100				
Rutting Index	89	89	93				
International Roughness Index (IRI)	141	129	200				
<b>Lane &amp; Width Information</b>							
Number of Lanes	2	2	2				
Paved Width (ft)	18.7	18.7	18.7				
Lane Width (ft)	9.4	9.5	9.1

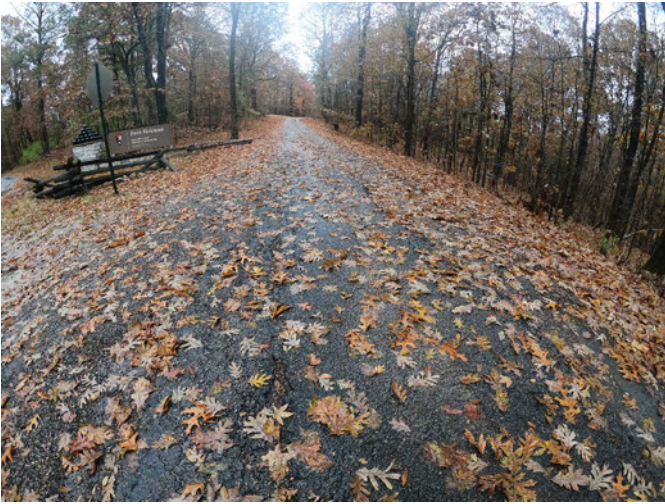
FODO\_0019AZ\_899.JPG

<b>Inspection Date:</b>	11/22/2019	<b>Beginning Section MP</b>	0.00				
<b>Paved Length (Miles):</b>	0.97	<b>Section Length (MI)</b>	0.97				
<b>Surface Type:</b>	ASPHALT	<b>Route Summary</b>					
<b>Roadway Condition Information</b>							
Pavement Condition Rating (PCR)	30	30					
Surface Condition Rating (SCR)	30	30					
Roughness Condition Index (RCI)	N/A	N/A					
<b>Distress Index Values</b>							
Structural Crack Index	N/A	N/A					
Alligator Crack Index	30	30					
Longitudinal Crack Index	73	73					
Transverse Cracking Index	73	73					
Patching Index	90	90					
Rutting Index	90	90					
International Roughness Index (IRI)	N/A	N/A					
<b>Lane &amp; Width Information</b>							
Number of Lanes	2	2					
Paved Width (ft)	15	15					
Lane Width (ft)	7.5	7.5

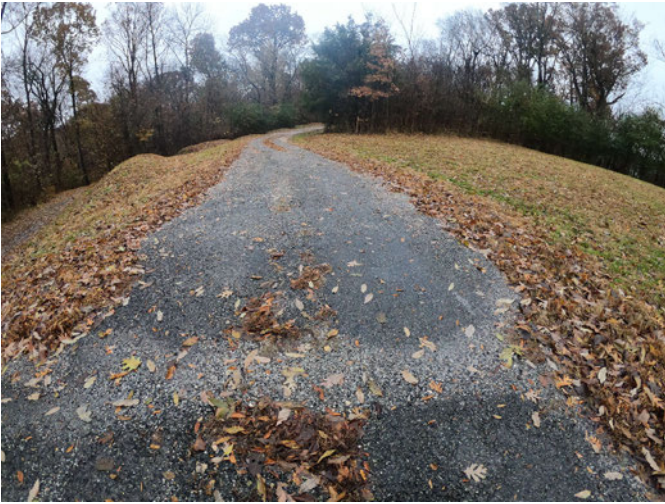
FODO\_0019BZ\_960.JPG

Route Condition Legend – Pavement Condition Rating (PCR)						
Poor (0 - 60)	Fair (61- 84)	Good (85 - 94)	Excellent (95 - 100)	Not Rated		
See Appendix for definitions and formulas						
<b>Inspection Date:</b> 11/22/2019	<b>Beginning Section MP</b>	0.00				
<b>Paved Length (Miles):</b> 0.19	<b>Section Length (MI)</b>	0.19				
<b>Surface Type:</b> ASPHALT	<b>Route Summary</b>					
<b>Roadway Condition Information</b>						
Pavement Condition Rating (PCR)	30	30				
Surface Condition Rating (SCR)	30	30				
Roughness Condition Index (RCI)	N/A	N/A				
<b>Distress Index Values</b>						
Structural Crack Index	N/A	N/A				
Alligator Crack Index	30	30				
Longitudinal Crack Index	73	73				
Transverse Cracking Index	73	73				
Patching Index	90	90				
Rutting Index	90	90				
International Roughness Index (IRI)	N/A	N/A				
<b>Lane &amp; Width Information</b>						
Number of Lanes	2	2				
Paved Width (ft)	15	15				
Lane Width (ft)	7.5	7.5

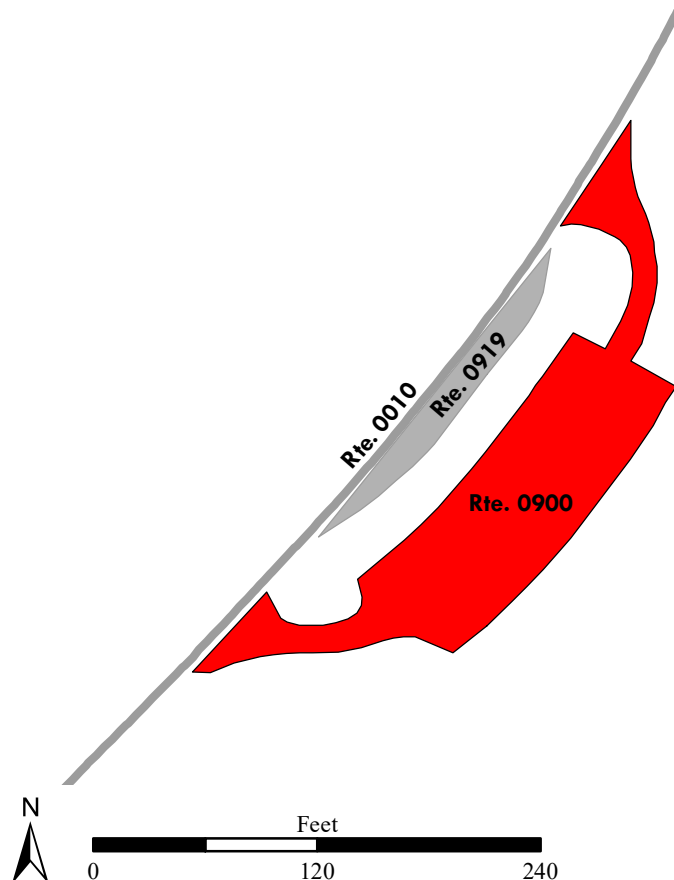
Inspection Date	FMSS Number	User Access	Surface Type
11/22/2019	65984	PUBLIC	ASPHALT
Area (Sq. Ft.)	Lane Miles (11' Widths)	Curb Reveal (Inches)	Curb Recommendation
13,013	0.224	4	LIGHT REPAIR
Curb Type		Curb & Gutter Type	
CONCRETE		NO CURB AND GUTTER	
Pavement Recommendation		Condition Rating / PCR	
HEAVY 3R TREATMENTS		POOR / 53
