FOFR Cycle 6

Final Report

Road Inventory and Condition Assessment of Paved Routes Fort Frederica National Monument

**Federal Highway Administration
Eastern Federal Lands Highway Division
Road Inventory Program (RIP)**

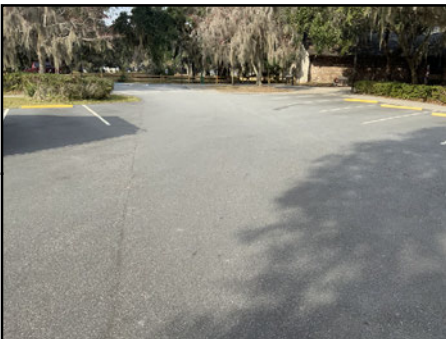
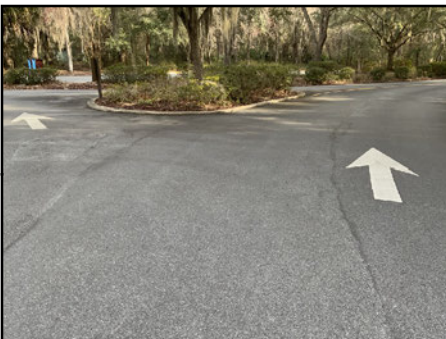
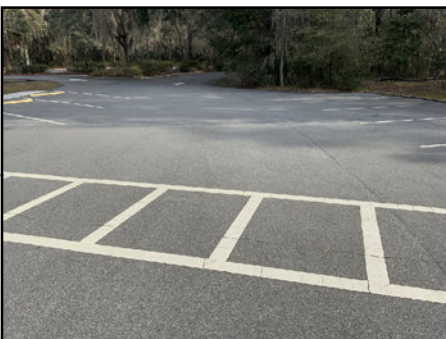
Inspection Date	FMSS Number	User Access	Surface Type
2/4/2021	66907	PUBLIC	ASPHALT
Area (Sq. Ft.)	Lane Miles (11' Widths)	Curb Reveal (Inches)	Curb Recommendation
39,740	0.684	4	LIGHT REPAIR
Curb Type		Curb & Gutter Type	
CONCRETE		NO CURB AND GUTTER	
Pavement Recommendation		Condition Rating / PCR	
PREVENTIVE MAINTENANCE		GOOD / 90

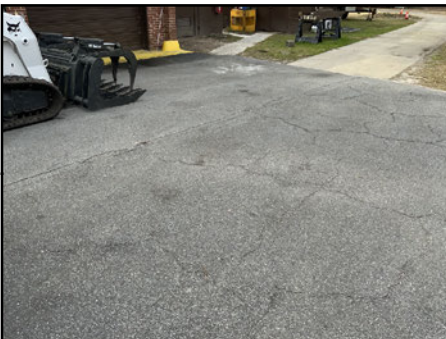
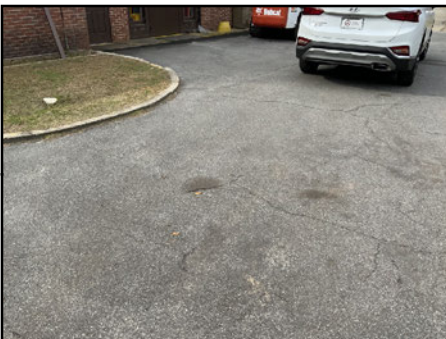
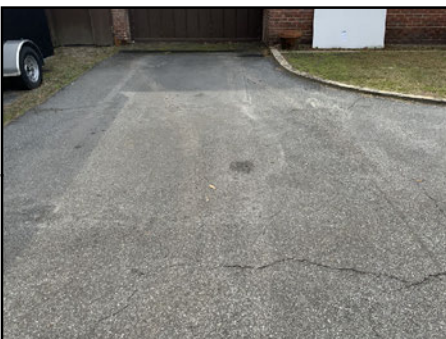
ROUTE 0902AZ: MAINTENANCE AREA HANDICAP PARKING A

Inspection Date	FMSS Number	User Access	Surface Type
2/4/2021	74030	NONPUBLIC	ASPHALT
Area (Sq. Ft.)	Lane Miles (11' Widths)	Curb Reveal (Inches)	Curb Recommendation
867	0.015	3	MODERATE REPAIR
Curb Type		Curb & Gutter Type	
CONCRETE		NO CURB AND GUTTER	
Pavement Recommendation		Condition Rating / PCR	
LIGHT 3R TREATMENTS		FAIR / 73

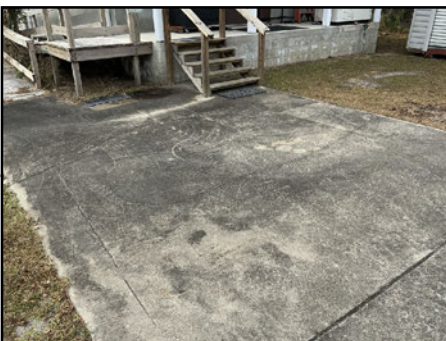
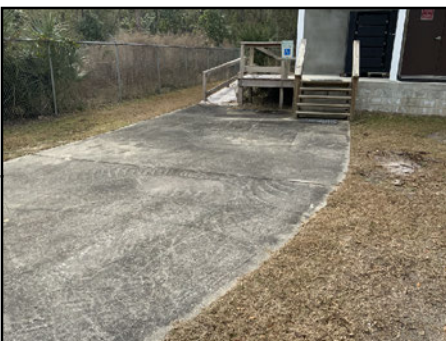
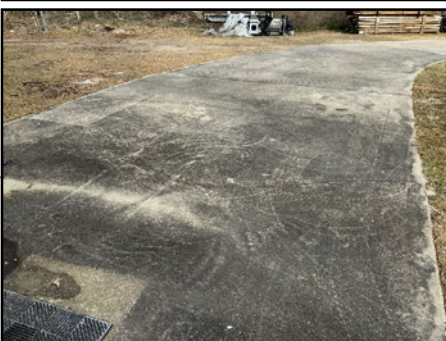
ROUTE 0902BZ: MAINTENANCE AREA HANDICAP PARKING B

Inspection Date	FMSS Number	User Access	Surface Type
2/4/2021	74030	NONPUBLIC	CONCRETE
Area (Sq. Ft.)	Lane Miles (11' Widths)	Curb Reveal (Inches)	Curb Recommendation
239	0.004	NOT APPLICABLE	NOT APPLICABLE
Curb Type		Curb & Gutter Type	
NO CURB		NO CURB AND GUTTER	
Pavement Recommendation		Condition Rating / PCR	
PREVENTIVE MAINTENANCE		GOOD / 90

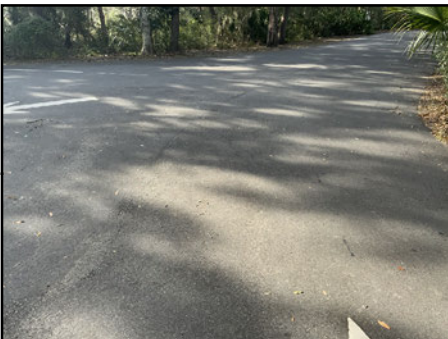
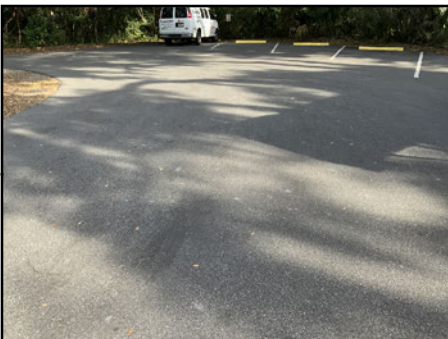
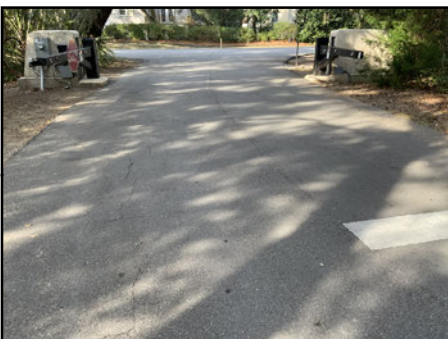
ROUTE 0903: BLOODY MARSH PARKING

Inspection Date	FMSS Number	User Access	Surface Type
2/4/2021	66910	PUBLIC	ASPHALT
Area (Sq. Ft.)	Lane Miles (11' Widths)	Curb Reveal (Inches)	Curb Recommendation
15,385	0.265	NOT APPLICABLE	NOT APPLICABLE
Curb Type		Curb & Gutter Type	
NO CURB		NO CURB AND GUTTER	
Pavement Recommendation		Condition Rating / PCR	
PREVENTIVE MAINTENANCE		GOOD / 90
