FOLS Cycle 6

Road Inventory and Condition Assessment of Paved Routes Fort Larned National Historic Site

Report Date: August 2018

Fort Larned National Historic Site in Kansas

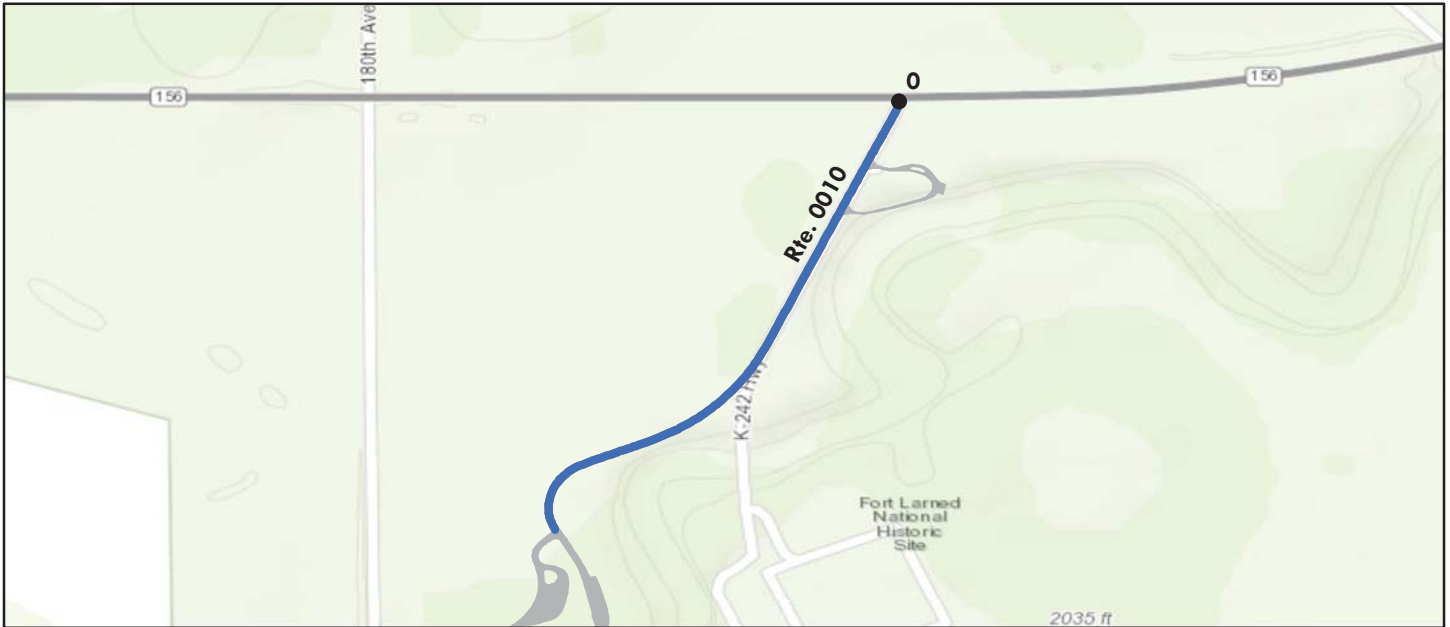
ROUTE 0010: ENTRANCE ROAD

Inspection Date: 12/6/2017	Beginning Section MP	0				
Paved Length (Miles): 0.42	Section Length (MI)	0.42				
Surface Type: ASPHALT	Route Summary					
Roadway Condition Information						
Pavement Condition Rating (PCR)	99	99				
Surface Condition Rating (SCR)	99	99				
Roughness Condition Index (RCI)	N/A	N/A				
Distress Index Values						
Structural Crack Index	100	100				
Alligator Crack Index	100	100				
Longitudinal Crack Index	100	100				
Transverse Cracking Index	99	99				
Patching Index	100	100				
Rutting Index	100	100				
International Roughness Index (IRI)	N/A	N/A				
Lane & Width Information						
Number of Lanes	2	2				
Paved Width (ft)	20.2	20.2				
Lane Width (ft)	9.2	9.2

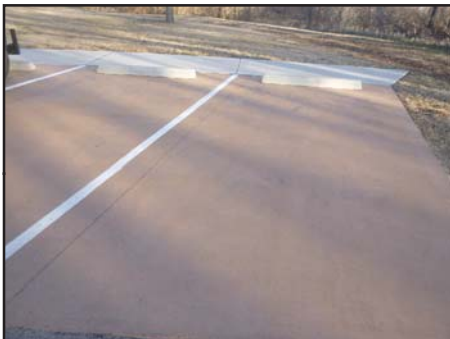
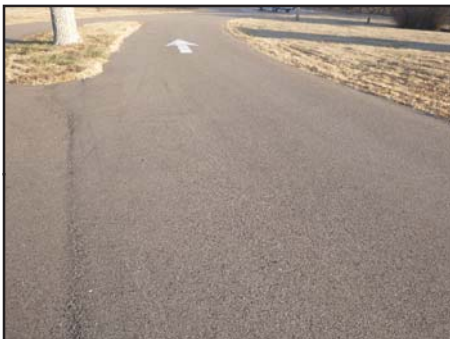
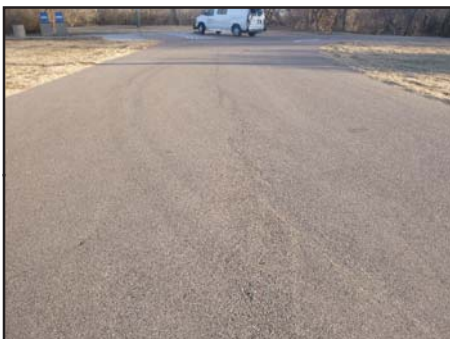
Inspection Date	FMSS Number	User Access	Surface Type
12/6/2017	78634	PUBLIC	ASPHALT
Area (Sq. Ft.)	Lane Miles (11' Widths)	Curb Reveal (Inches)	Curb Recommendation
11,567	0.199	NOT APPLICABLE	NOT APPLICABLE
Curb Type		Curb & Gutter Type	
NO CURB		NO CURB AND GUTTER	
Pavement Recommendation		Condition Rating / PCR	
PREVENTIVE MAINTENANCE		GOOD / 90

Note: Parking area consists of multiple surface types: 1 part Asphalt at 10,676 square feet; 1 part Concrete at 891 square feet.

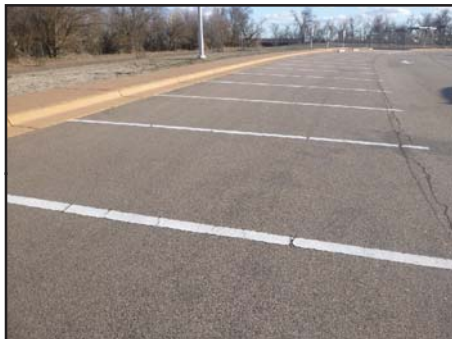
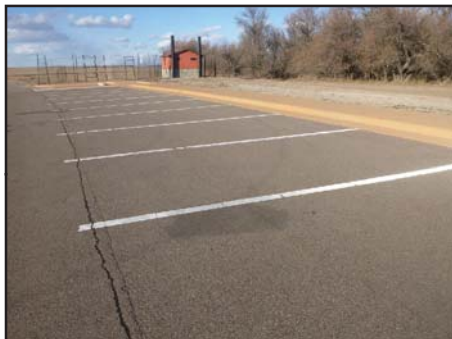
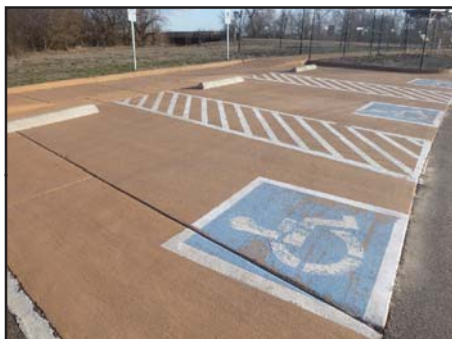
Inspection Date	FMSS Number	User Access	Surface Type
12/6/2017	105538	PUBLIC	ASPHALT
Area (Sq. Ft.)	Lane Miles (11' Widths)	Curb Reveal (Inches)	Curb Recommendation
62,000	1.067	NOT APPLICABLE	DO NOTHING
Curb Type		Curb & Gutter Type	
NO CURB		CONCRETE	
Pavement Recommendation		Condition Rating / PCR	
PREVENTIVE MAINTENANCE		GOOD / 90

Note: Parking area consists of multiple surface types: 1 part Asphalt at 60,870 square feet; 2 parts Concrete at 1,130 square feet.
