# FOPO Cycle 6

## Final Report

### Road Inventory and Condition Assessment of Paved Routes Fort Point National Historic Site

Report Date: August 2015

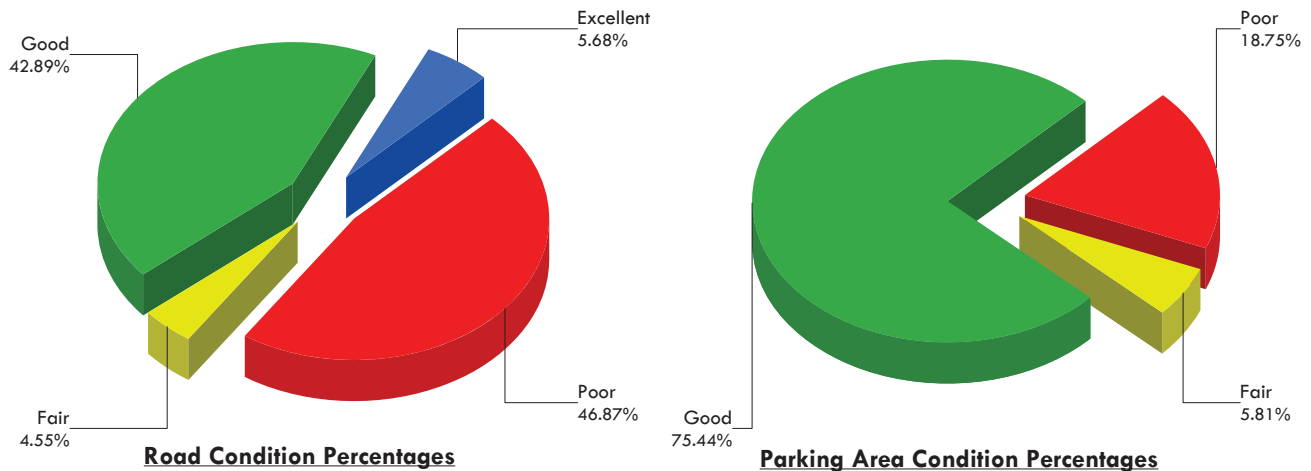
Figure 1: Pavement Condition Rating Breakdown for Paved Roads and Parking Areas

- Excellent / New: PCR of 95-100
  - Pavements in this range will require only spot repairs
- Good: PCR of 85-94
  - Pavements in this range will likely be candidates for Preventive Maintenance. Examples include Chip and Slurry Seals, Micro Surfacing and Thin Overlays.
- Fair: PCR of 61-84
  - Pavements in this range will likely be candidates of Light Rehabilitation (L3R). Examples include singlelift overlays up to 2.5 inches in total thickness, milling and overlays.
- Poor: PCR of 0-60
  - Pavements in this range will likely be candidates of Heavy Rehabilitation or Reconstruction (H3R or 4R). Examples include Pulverization, Multiple Lift Overlays, and Reconstruction.

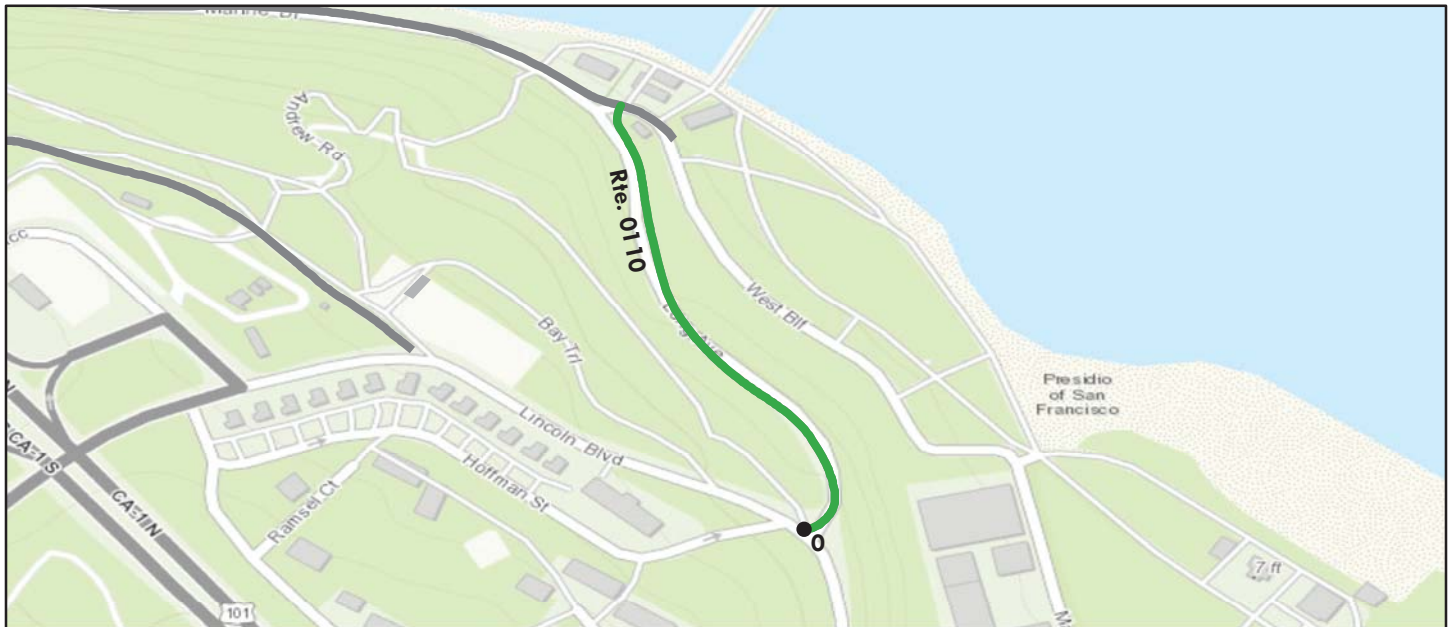
## ROUTE 0110: LONG AVENUE

| Pavement Condition Rating (PCR) | 90 | 90 | | | | |
| Surface Condition Rating (SCR) | 90 | 90 | | | | |
| Longitudinal Crack Index | 90 | 90 | | | | |
| Transverse Cracking Index | 93 | 93 | | | | |

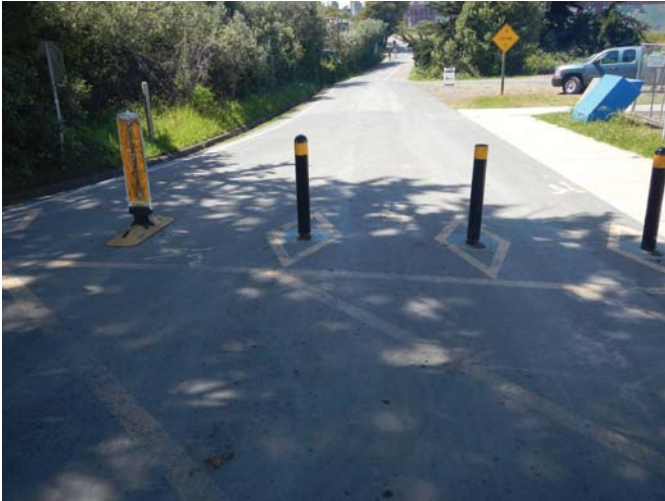
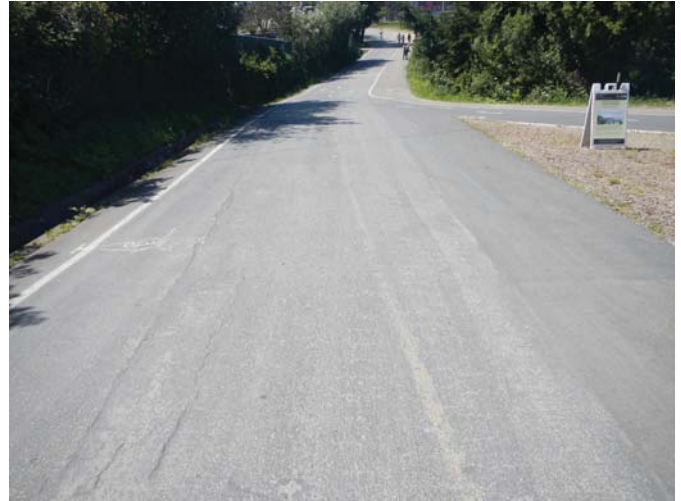
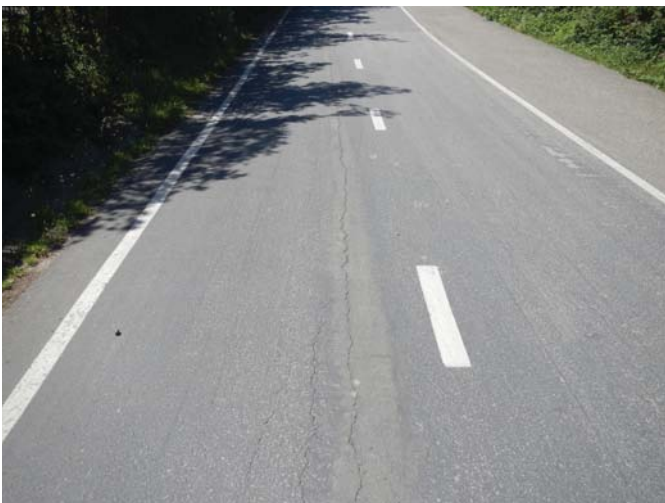
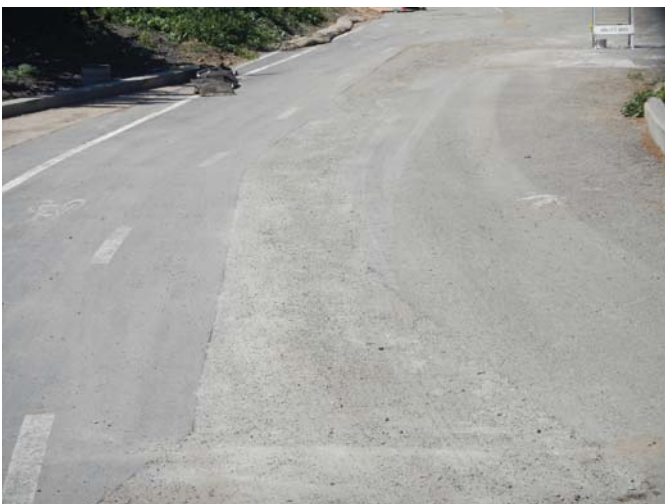
## ROUTE 0445: BATTERY EAST ROAD

| ROUTES MODIFIED FROM PREVIOUS INVENTORY: | | | |
|--|---|---|---|
| 0445 | BATTERY EAST<br>ROAD | COLLECTION<br>METHOD CHANGE | MANUALLY RATED IN CYCLE 6 DUE TO LOW<br>SPEED LIMIT. ROAD IS NORMALLY USED AS A<br>BIKE PATH. |

| <b>Route Condition Legend – Pavement Condition Rating (PCR)</b> | | | | | | |
|---|---|---|---|---|--|--|
| Pavement Condition Rating (PCR) | 90 | 90 | | | | |

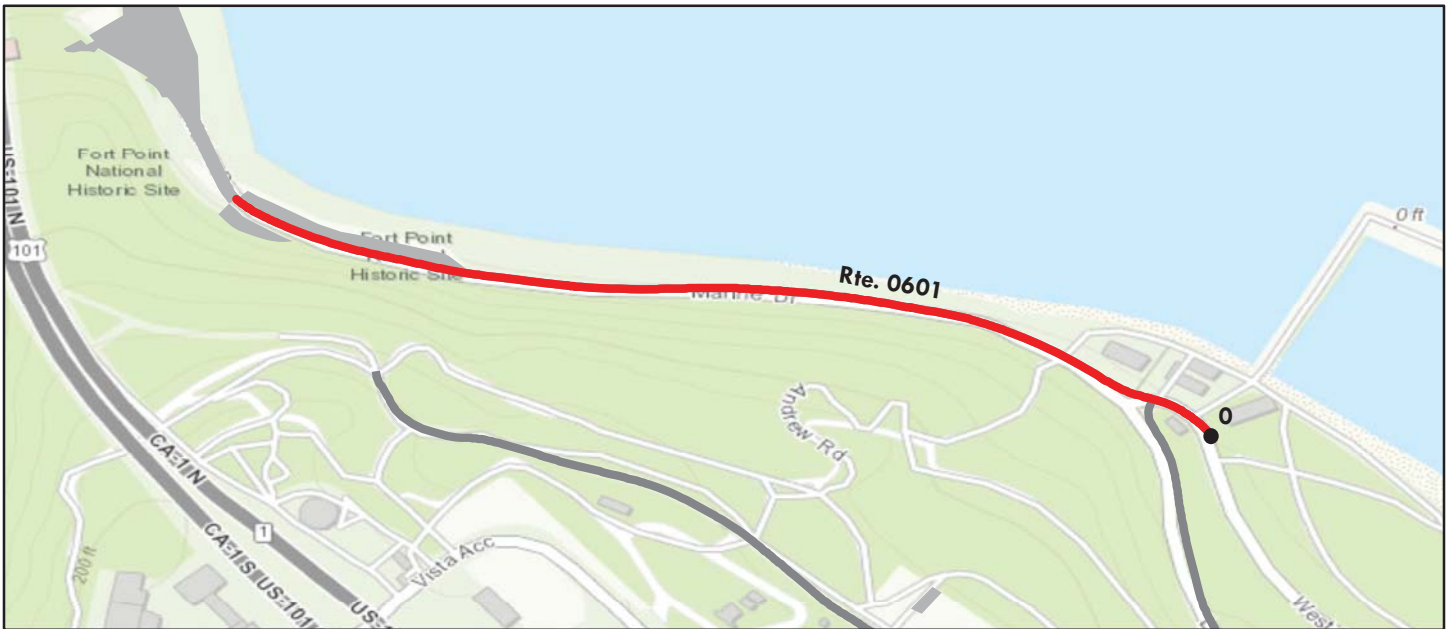
## ROUTE 0601: MARINE DRIVE

| Route Condition Legend – Pavement Condition Rating (PCR) | | | | | | |
|--|---|---|---|---|--|--|
| Pavement Condition Rating (PCR) | 0 | 0 | | | | |
| Surface Condition Rating (SCR) | 0 | 0 | | | | |
| Longitudinal Crack Index | 0 | 0 | | | | |
| Transverse Cracking Index | 0 | 0 | | | | |

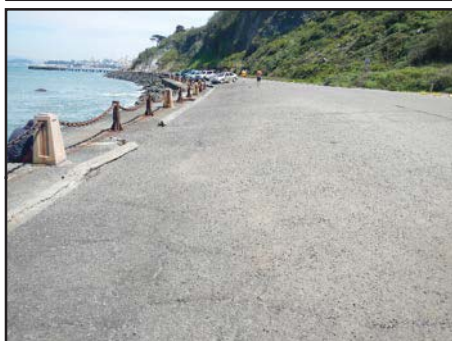
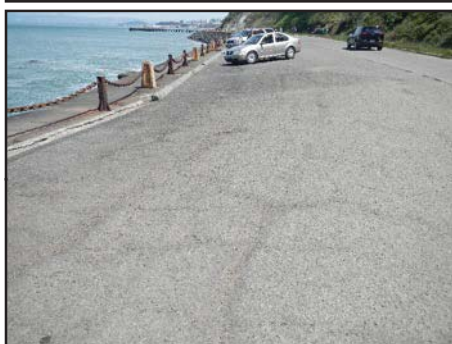
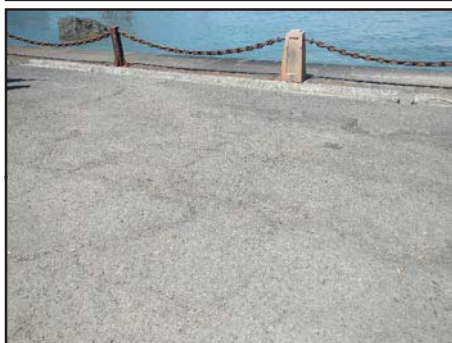
## ROUTE 0983BZ: MARINE DRIVE PARKING B

| Inspection Date | FMSS Number | User Access | Surface Type |
|---|---|---|---|
| 8,148 | 0.14 | 4 | REPLACE |
