FOSC Cycle 6

Final Report

Road Inventory and Condition Assessment of Paved Routes Fort Scott National Historic Site

Report Date: June 2018

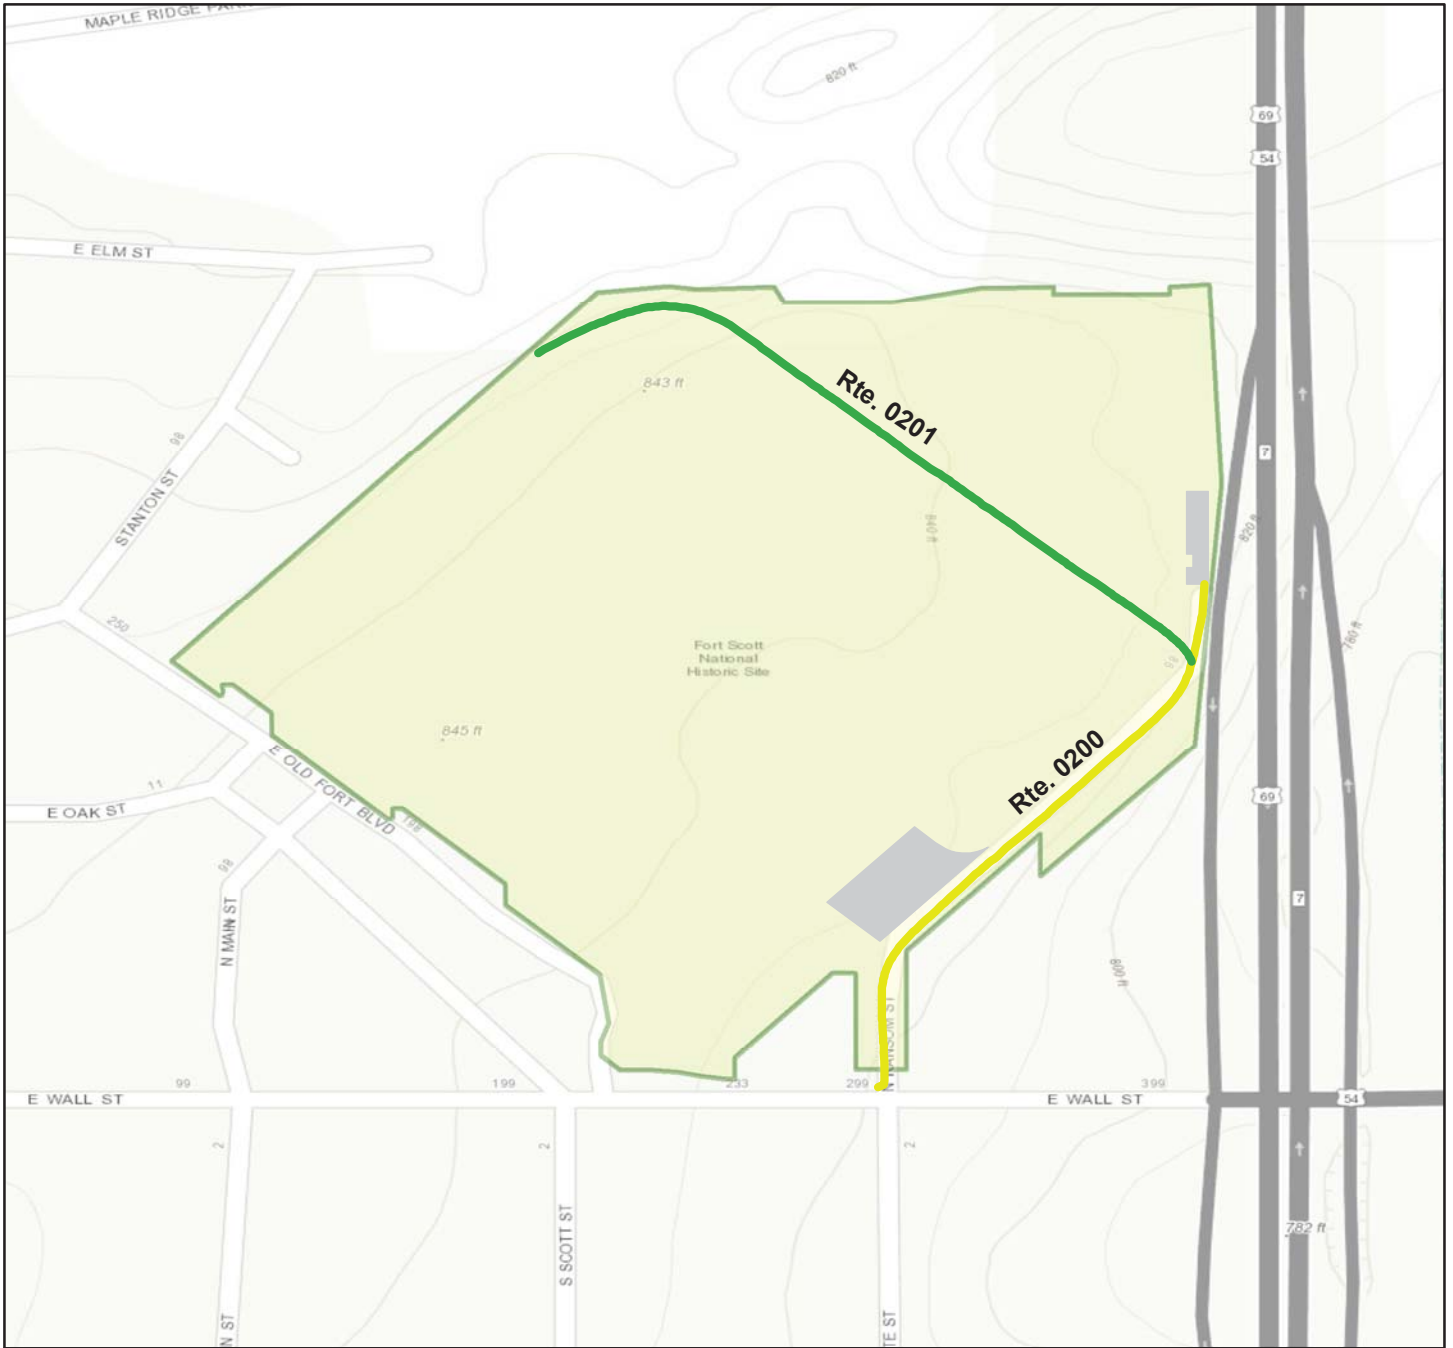
Area Map 1

ROUTE CONDITION MAP

PCR - MILE BY MILE

Route Condition Legend – Pavement Condition Rating (PCR)				
Poor (0 - 60)	Fair (61- 84)	Good (85 - 94)	Excellent (95 - 100)	Not Rated
See Appendix for definitions and formulas				
Only Data Collection Vehicle and Manually Rated Roads are displayed

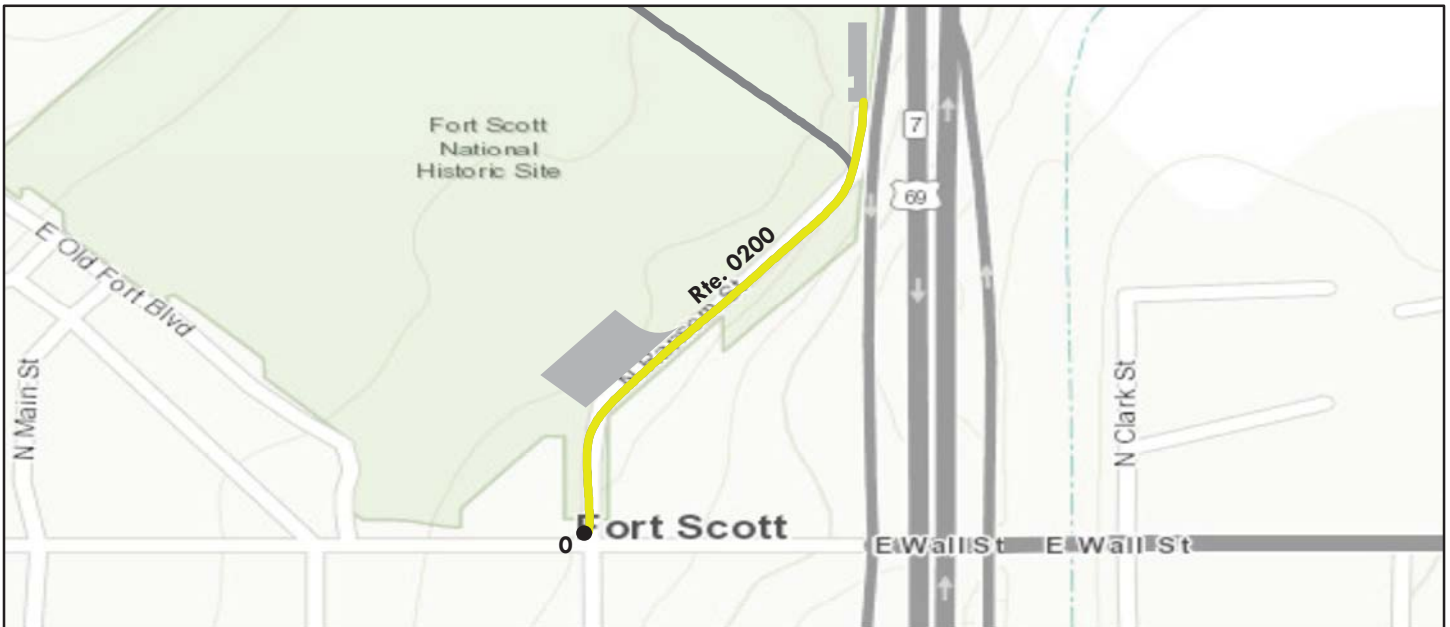
ROUTE 0200: SERVICE DELIVERY ROAD

Colors on map represent condition scores at 0.10-mile intervals. See Appendix for definitions and formulas.

Inspection Date:	11/4/2017	Beginning Section MP	0				
Paved Length (Miles):	0.14	Section Length (MI)	0.14				
Surface Type:	ASPHALT	Route Summary					
Roadway Condition Information							
Pavement Condition Rating (PCR)	82	82					
Surface Condition Rating (SCR)	82	82					
Roughness Condition Index (RCI)	N/A	N/A					
Distress Index Values							
Structural Crack Index	82	82					
Alligator Crack Index	99	99					
Longitudinal Crack Index	83	83					
Transverse Cracking Index	89	89					
Patching Index	100	100					
Rutting Index	87	87					
International Roughness Index (IRI)	N/A	N/A					
Lane & Width Information							
Number of Lanes	2	2					
Paved Width (ft)	18.1	18.1					
Lane Width (ft)	9	9

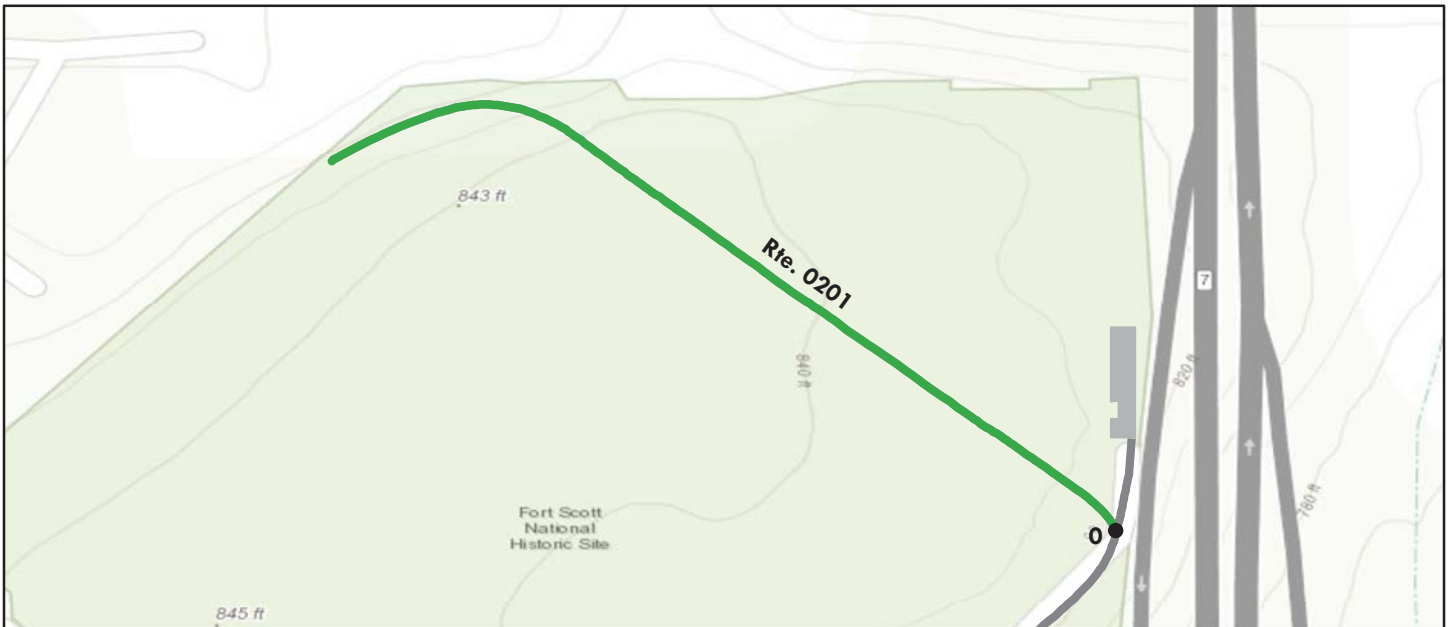
ROUTE 0201: SITE ACCESS ROAD

Colors on map represent condition scores at 0.10-mile intervals. See Appendix for definitions and formulas.

Inspection Date:	11/4/2017	Beginning Section MP	0				
Paved Length (Miles):	0.17	Section Length (MI)	0.17				
Surface Type:	ASPHALT	Route Summary					
Roadway Condition Information							
Pavement Condition Rating (PCR)	90	90					
Surface Condition Rating (SCR)	90	90					
Roughness Condition Index (RCI)	N/A	N/A					
Distress Index Values							
Structural Crack Index	90	90					
Alligator Crack Index	100	100					
Longitudinal Crack Index	90	90					
Transverse Cracking Index	94	94					
Patching Index	100	100					
Rutting Index	90	90					
International Roughness Index (IRI)	N/A	N/A					
Lane & Width Information							
Number of Lanes	1	1					
Paved Width (ft)	10.6	10.6					
Lane Width (ft)	10.6	10.6

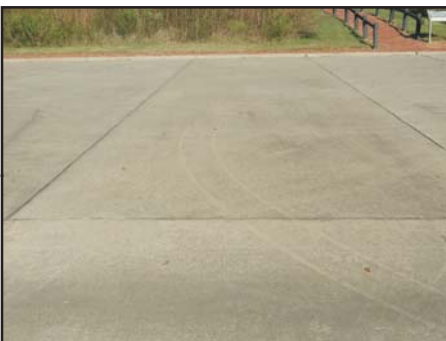
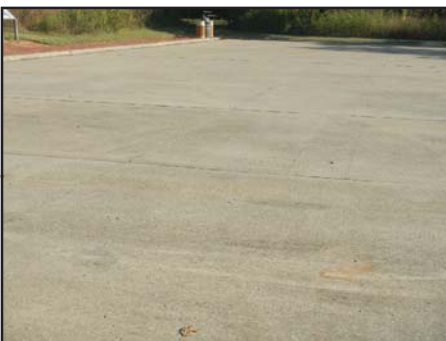
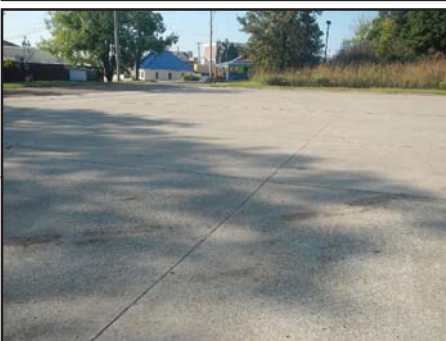
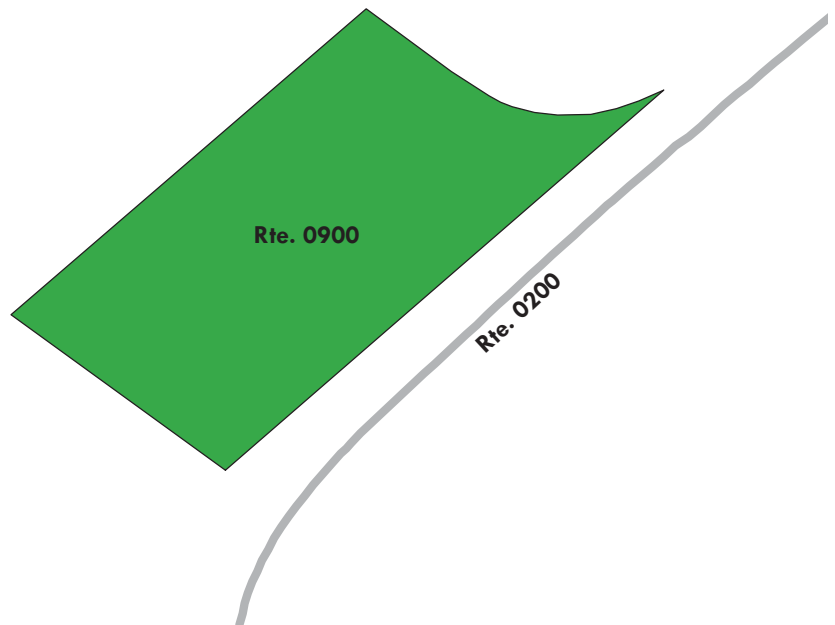
Inspection Date	FMSS Number	User Access	Surface Type
9/24/2017	30366	PUBLIC	CONCRETE
Area (Sq. Ft.)	Lane Miles (11' Widths)	Curb Reveal (Inches)	Curb Recommendation
10,180	0.175	NOT APPLICABLE	DO NOTHING
Curb Type		Curb & Gutter Type	
NO CURB		CONCRETE	
Pavement Recommendation		Condition Rating / PCR	
PREVENTIVE MAINTENANCE		GOOD / 90

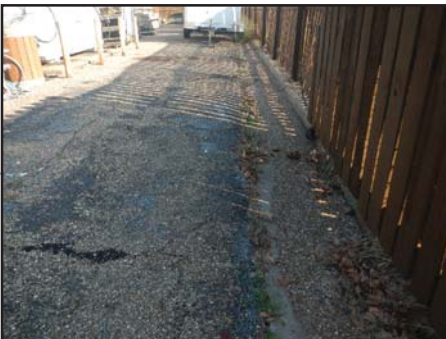
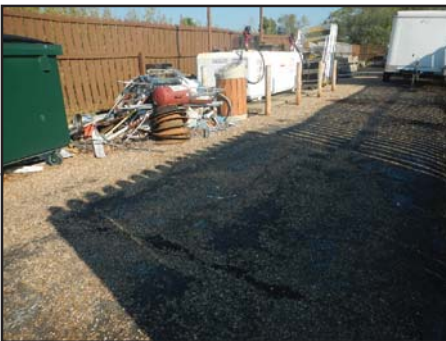
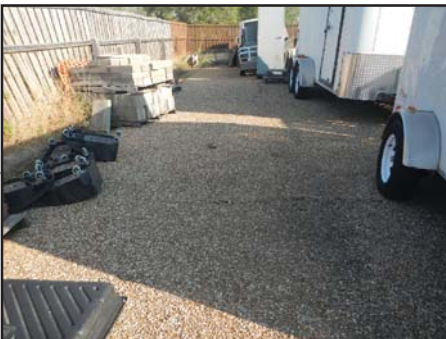
ROUTE 0901: BONEYARD PARKING

Inspection Date	FMSS Number	User Access	Surface Type
9/24/2017	102898	NONPUBLIC	ASPHALT
Area (Sq. Ft.)	Lane Miles (11' Widths)	Curb Reveal (Inches)	Curb Recommendation
2,592	0.045	NOT APPLICABLE	DO NOTHING
Curb Type		Curb & Gutter Type	
NO CURB		CONCRETE	
Pavement Recommendation		Condition Rating / PCR	
LIGHT 3R TREATMENTS		FAIR / 73
